Supplemental Information for Performing AC Inspection of HPR-Type Stations

Identification of Atmospheric Corrosion

Measuring Level of Corrosion

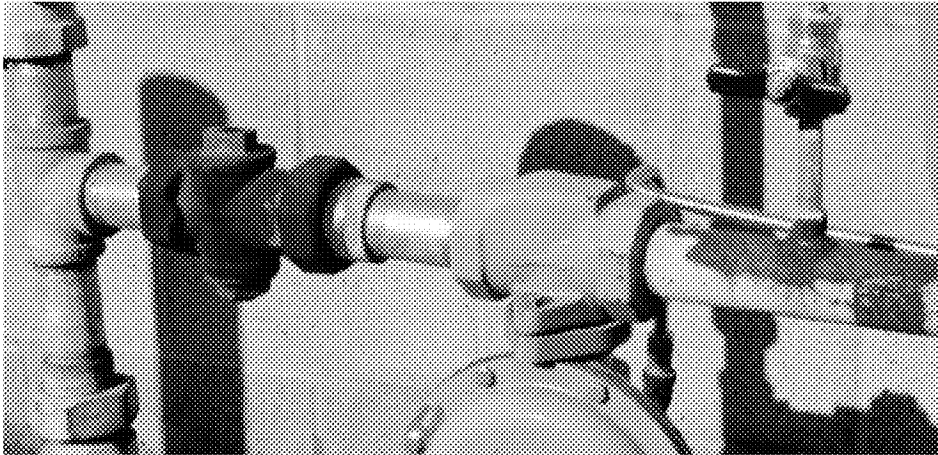
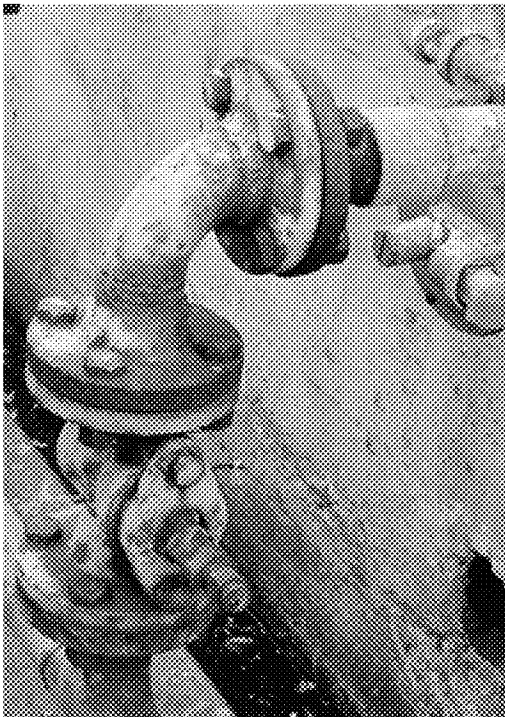
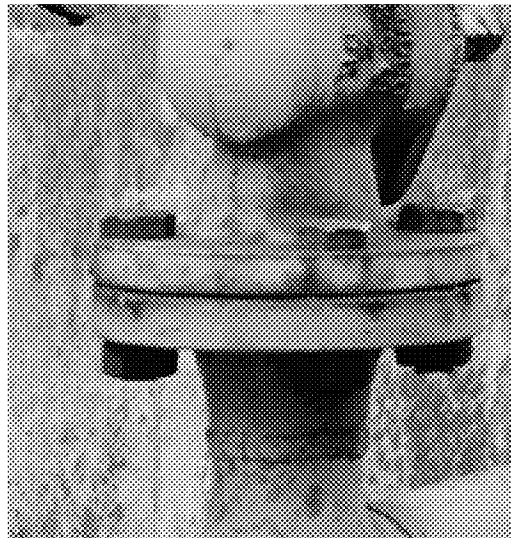
Oxidation/Surface Rust is a common occurrence, and does not require any action. Below are examples of oxidation or surface rust:

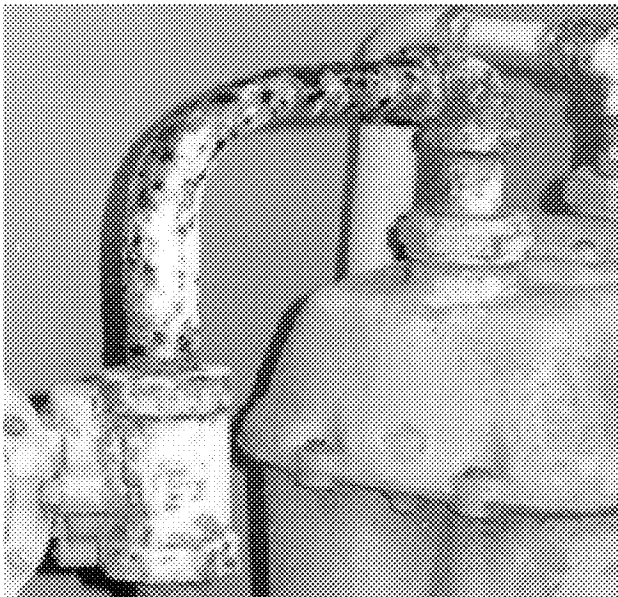
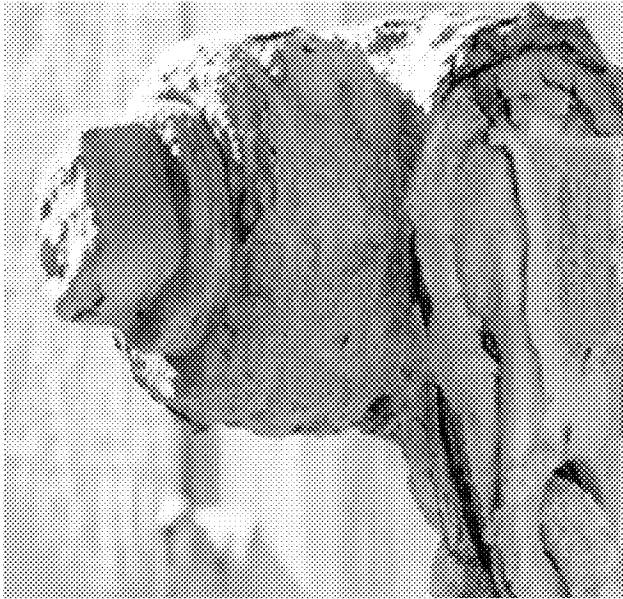
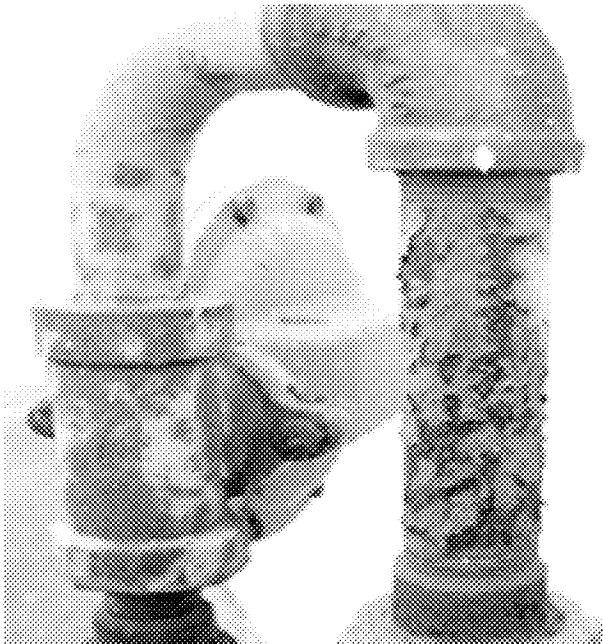
Atmospheric Corrosion compromises the integrity of the pipe, as it diminishes wall thickness of pipe. It consists of scaling, pitting, and/or blistering. Below are examples of atmospheric corrosion conditions that may require repairs:

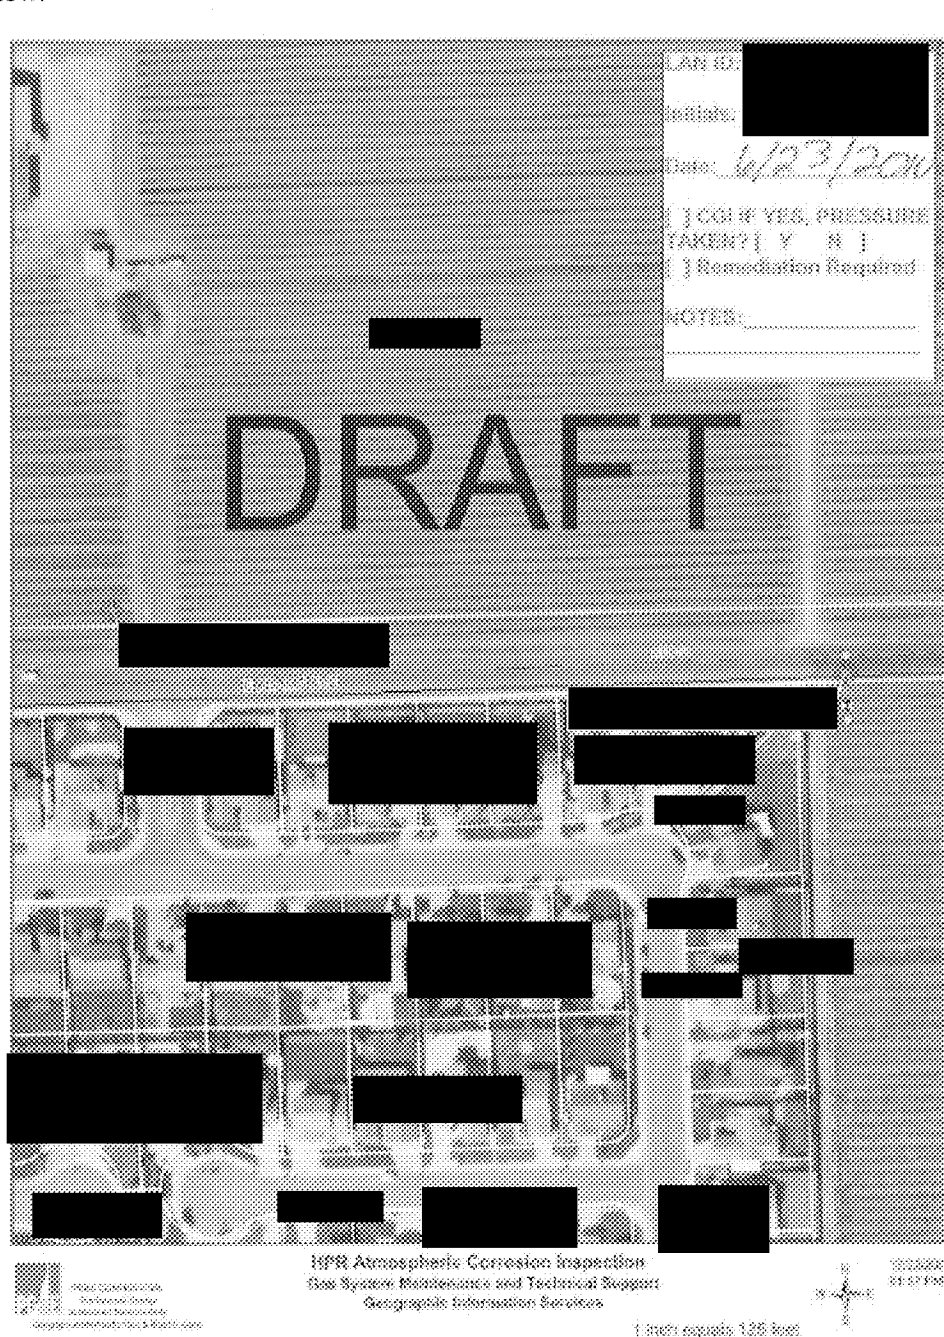
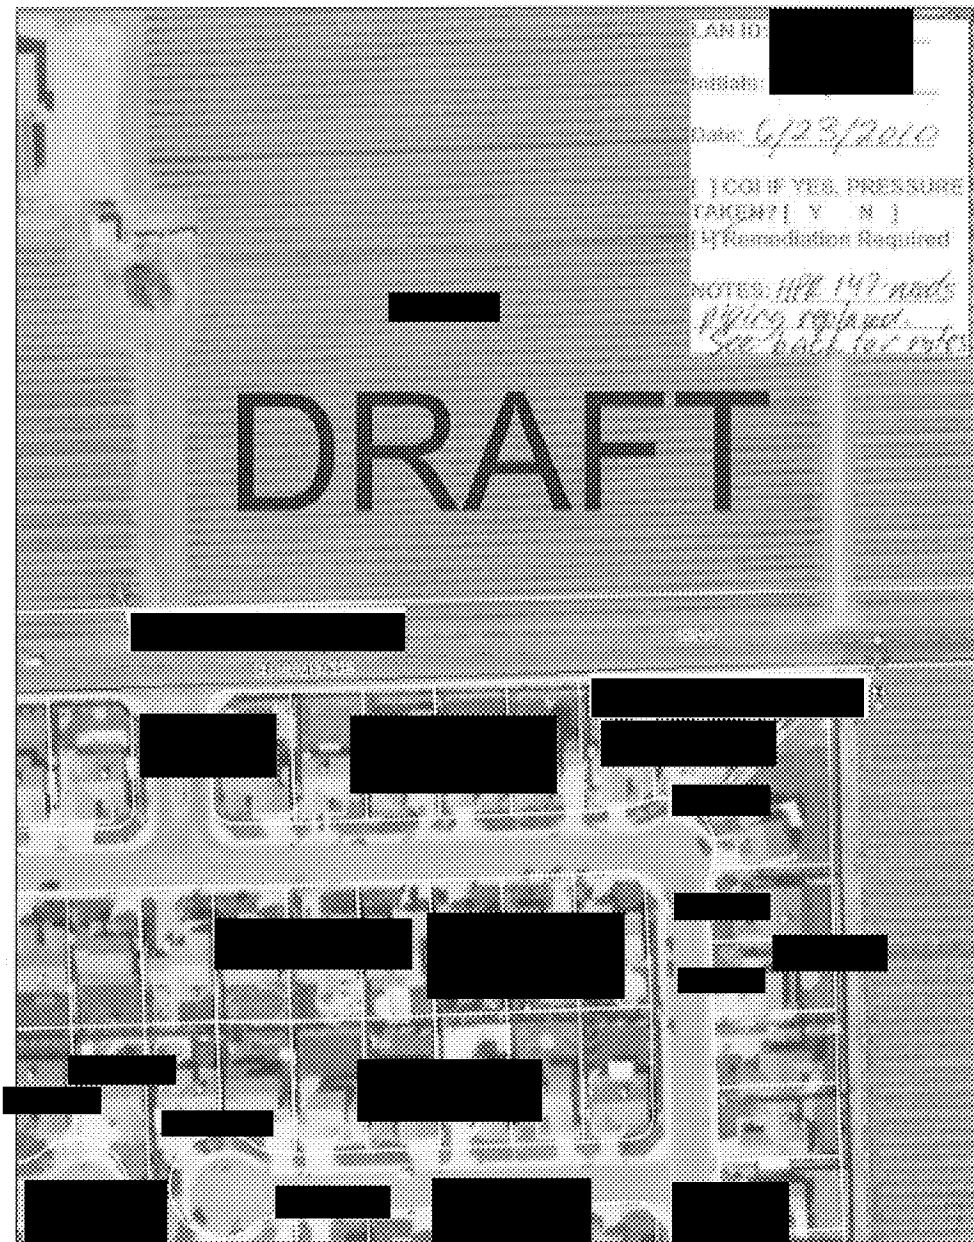
LAN ID: [REDACTED]
Initials: [REDACTED]
Date: 6/23/2010
 YES IF YES, PRESSURE
TAKEN? ()
 Remediation Required
NOTES: 100, 142
not found. Check around
to locate. 100146.01
