**AN INDEPENDENT, FULL SCOPE
ROOT CAUSE INVESTIGATION OF
SAN FRANCISCO
DECEMBER 8, 1998 OUTAGE**

(Interim Report)

AN INDEPENDENT, FULL SCOPE ROOT CAUSE INVESTIGATION OF THE SAN FRANCISCO DECEMBER 8, 1998 ELECTRICAL POWER OUTAGE

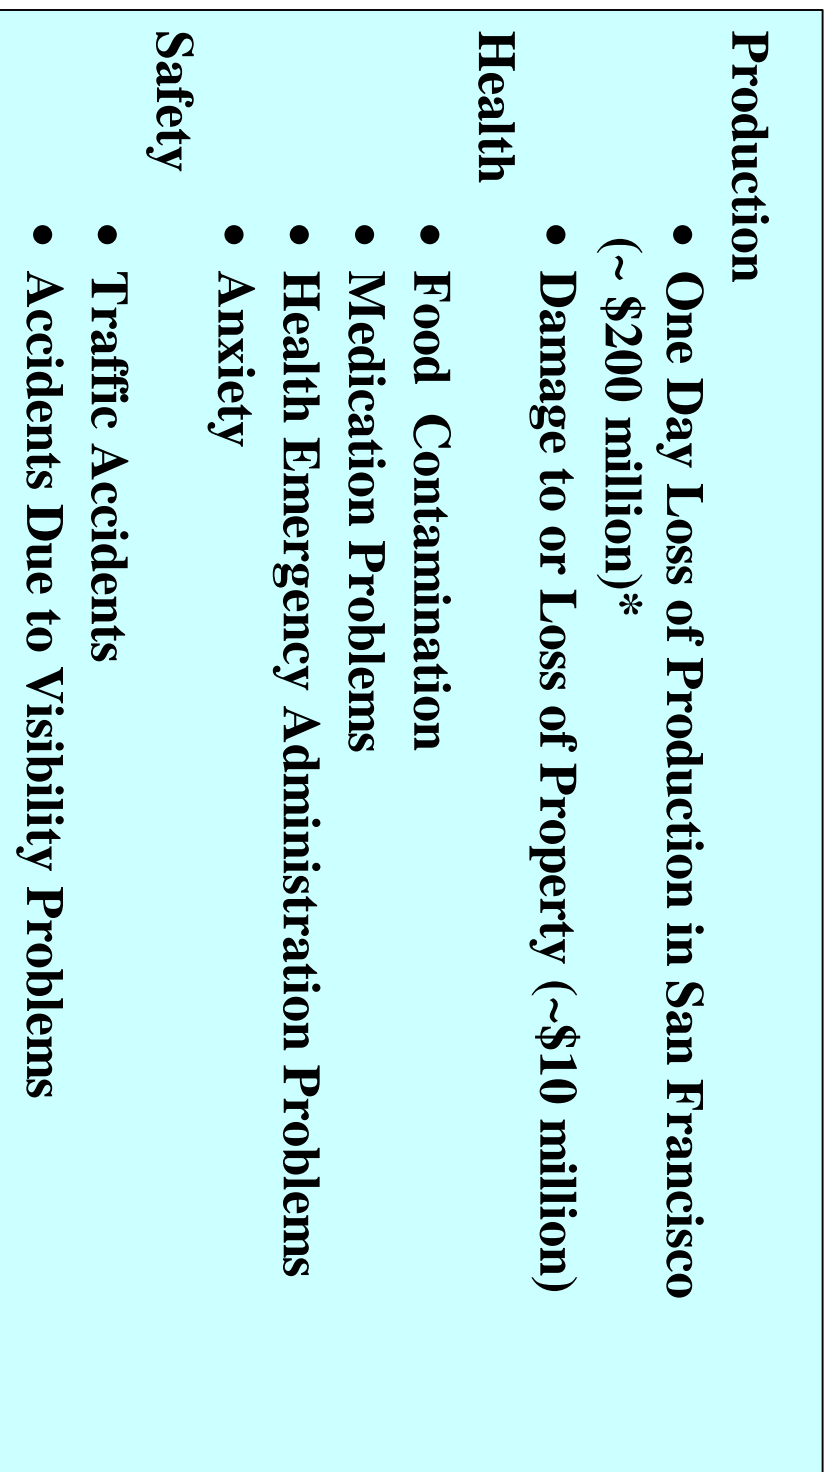
Figure 6

The total financial, health and safety impact of the San Francisco outage was estimated to be between \$200 million and \$400 million. **Figure 6** summarizes the simple method used by the investigation team to estimate the total impact. With this estimation, the investigation team believes that it is reasonable for PG&E to spend an average of \$10 to \$20 million over the next few years to upgrade its work force, management systems, and electrical protection systems to prevent recurrence.

ESTIMATED FINANCIAL, HEALTH AND SAFETY IMPACT OF SAN FRANCISCO OUTAGE (\$200 TO \$400 MILLION)

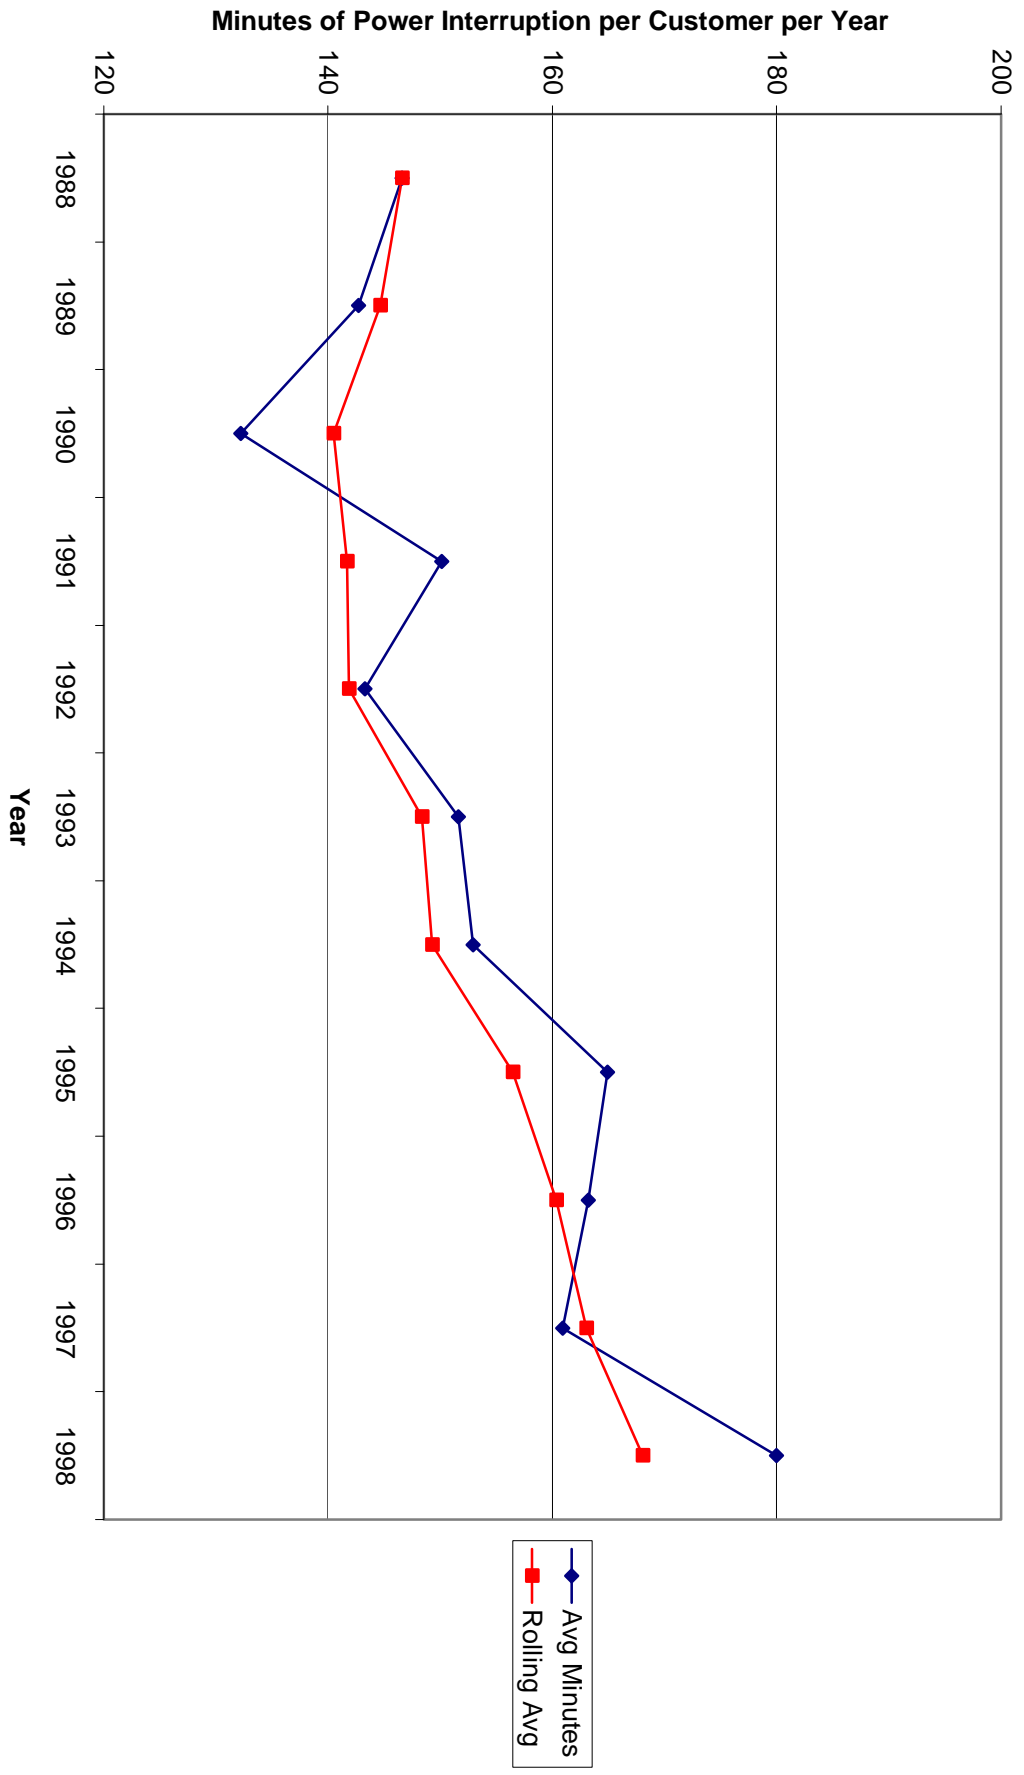
Figure 7 shows the trend of PG&E's SAIDI for the past ten years. As can be seen in this figure, an upward trend exists. In 1998, PG&E's SAIDI was 180 minutes, whereas the average SAIDI for other public utilities was 68 minutes. It should be noted that the 180 minutes versus 68 minutes is not an indication that PG&E is worse than other utilities. It only means that from a consumer's perspective, there is room for improvement.

PG&E System Average Interruption Duration Index (major disasters excluded) and 3-Year Rolling Average

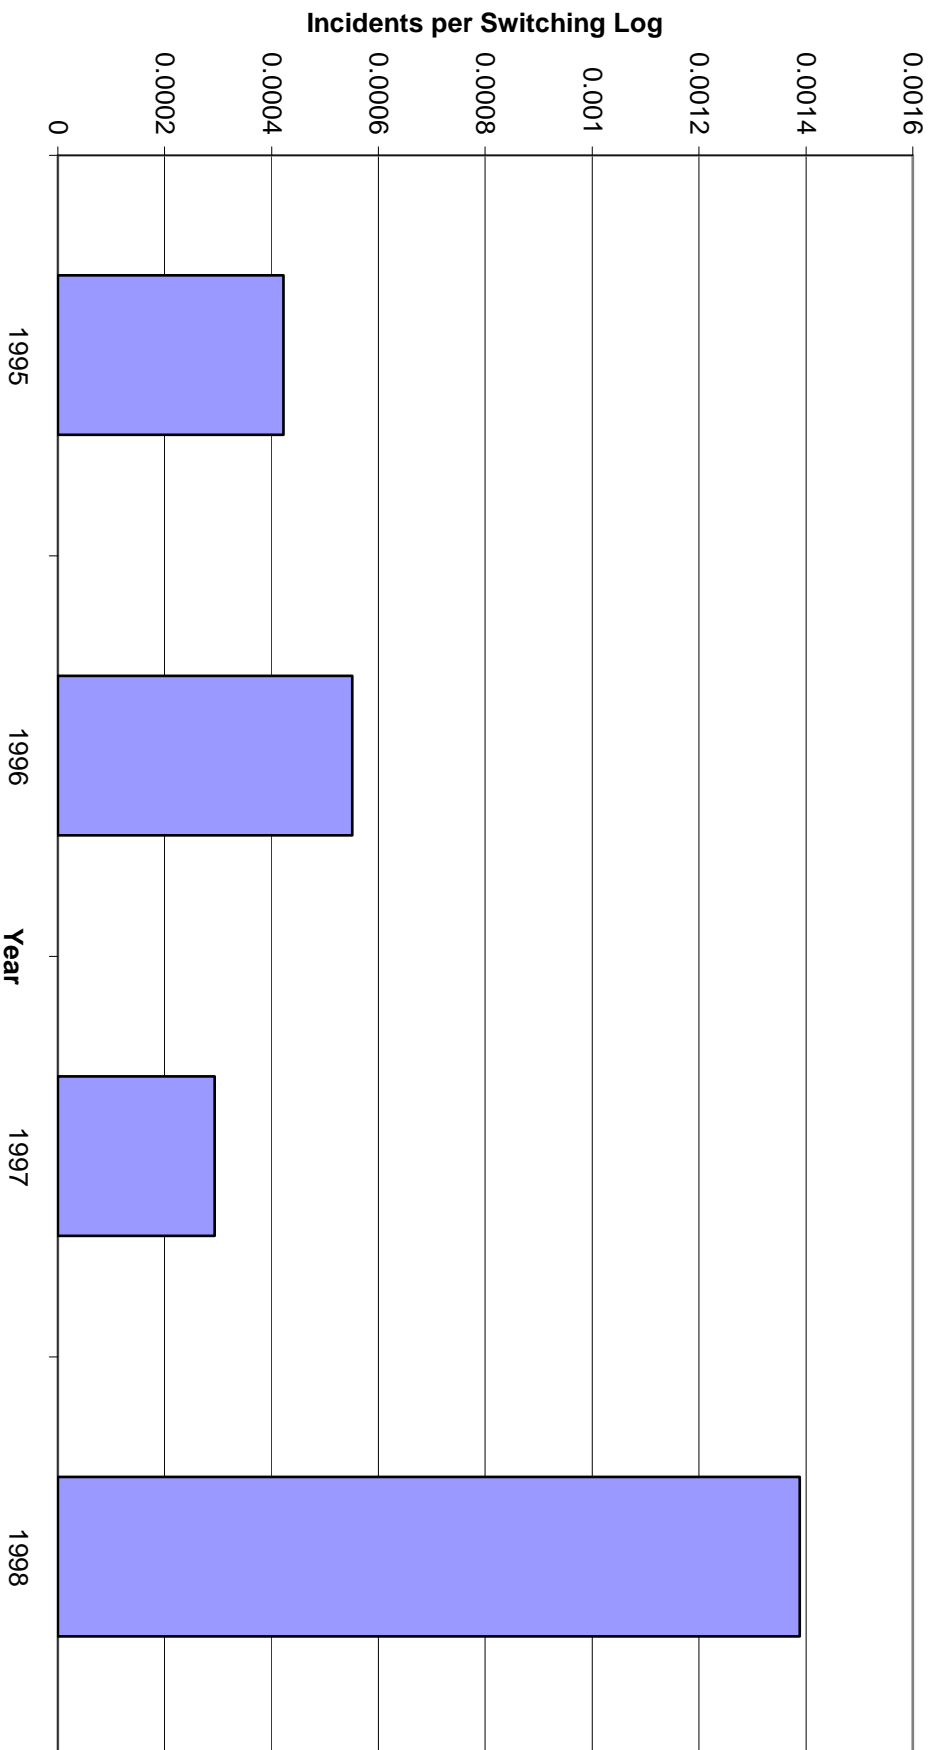
Figure 8 shows the trend of the switching error rate, which was derived from dividing the switching errors by the number of switching logs operated by PG&E on a yearly basis. As can be seen in **Figure 8**, the switching error rate rose in 1998.

System Operation and Distribution Operations Incidents per Switching Log

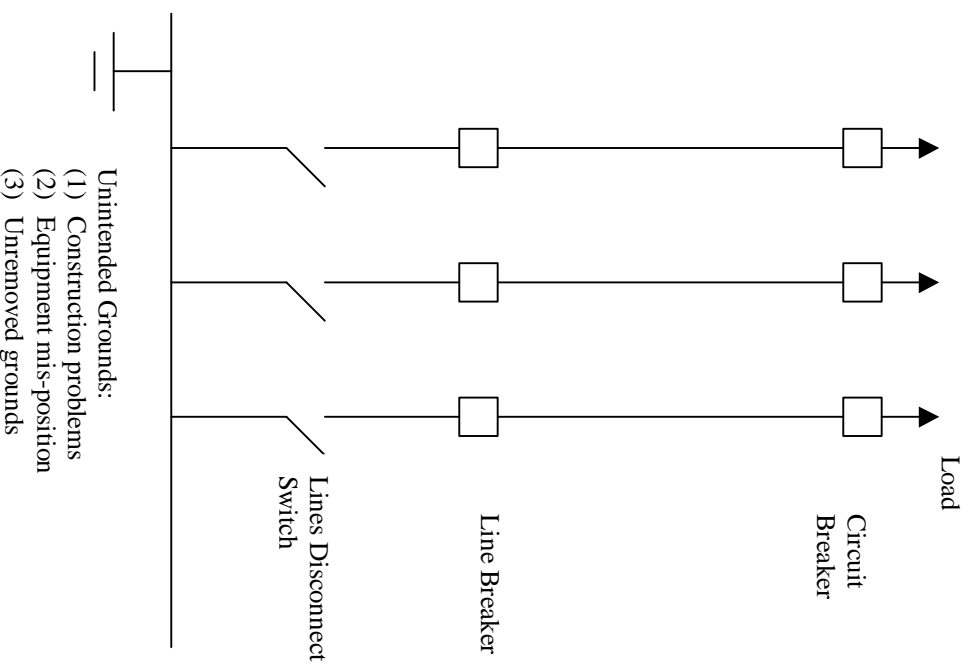
BUS TESTING STRATEGY (AN EXAMPLE) TO DETECT UNINTENDED GROUNDS

Moreover, it is recommended that PG&E review its test program to ensure there were no other exceptions that, if allowed, could lead to unexpected equipment failures. (Recommendation OFI-4.2)

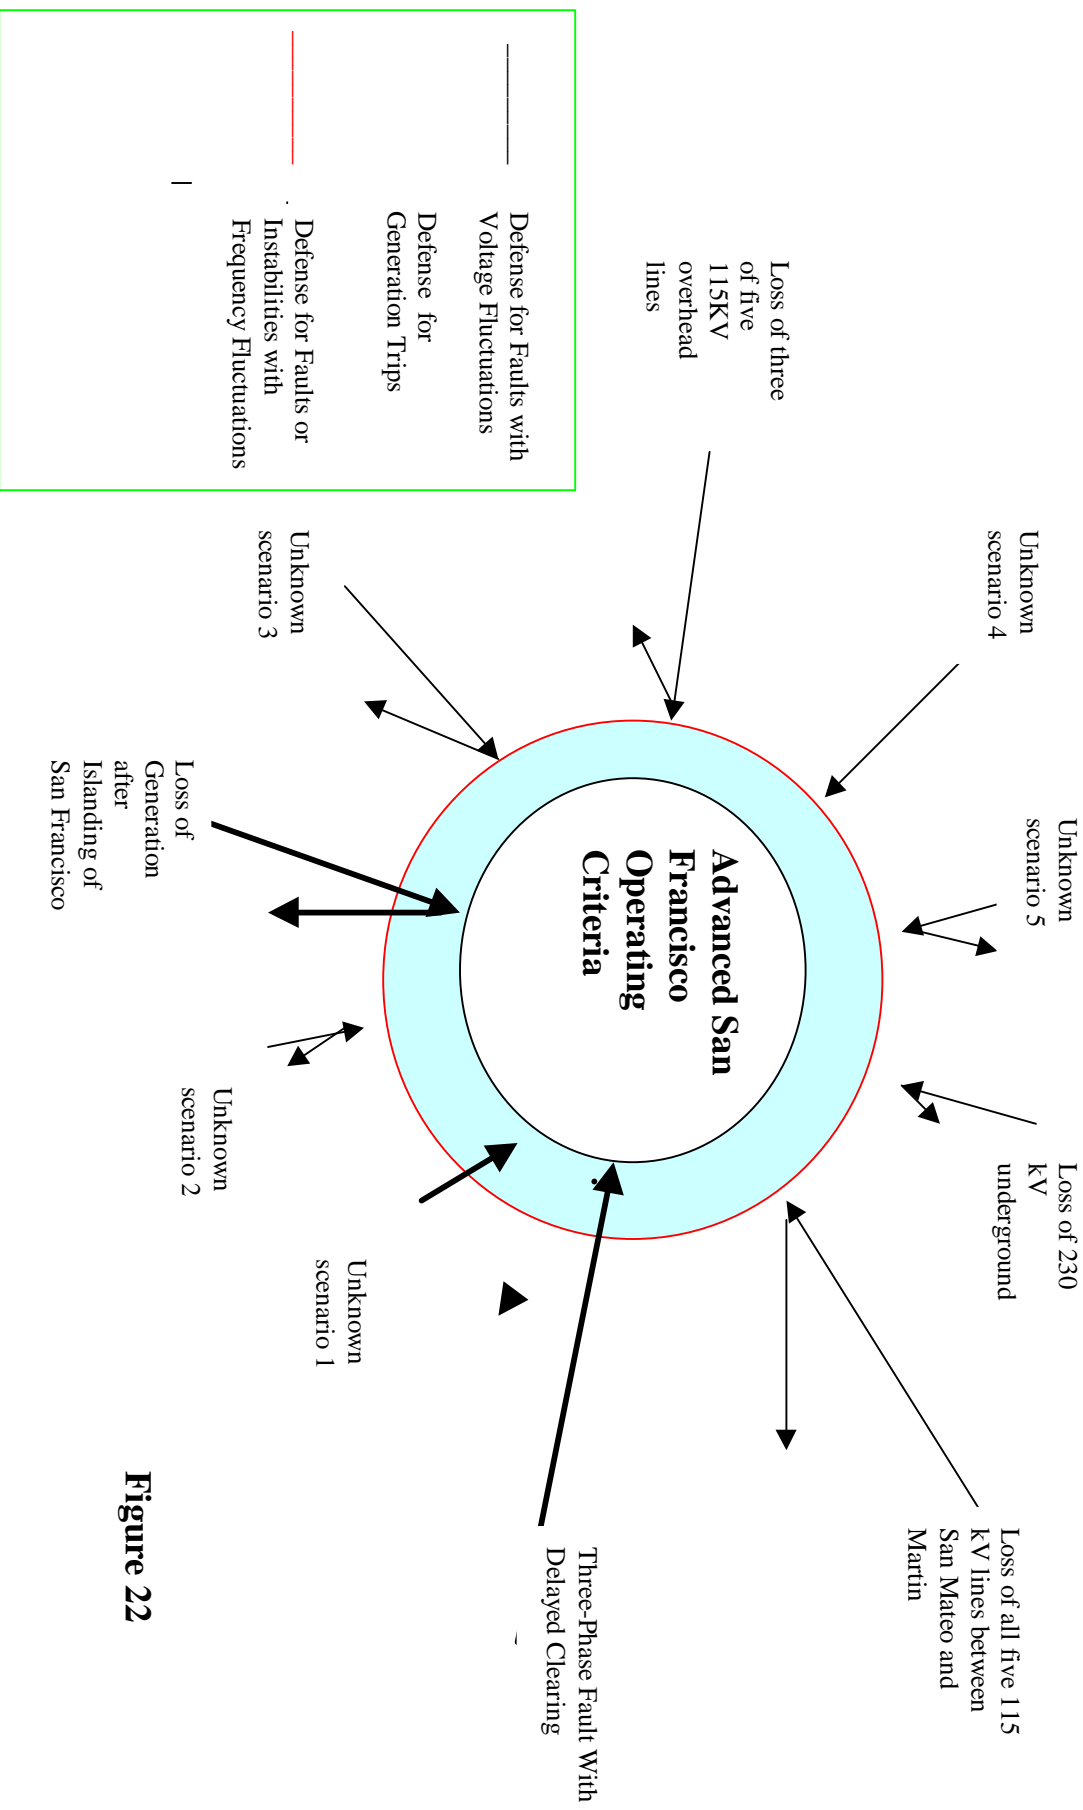
Figure 22

Comparing the SFSS responses in the two events in which they operated successfully and two events in which they failed, per design, to preserve the critical load, the investigation team found that the SFSS has two major design limits (illustrated in **Figure 22**).

To improve the existing SFOC, the investigation team adopted the defense-in-depth concept to conceptualize an advanced SFOC. The defense-in-depth concept, which has been used to improve safety and reliability of nuclear power plants, space shuttles, and aircraft, calls for incorporating a last ditch defense regardless of what type of disturbance (or failure scenario) is encountered. For example, the current SFOC (SFSS) is designed to guard against certain types of events, such as loss of all five 115 kV lines, loss of the underground 230 kV line, etc. As such, when an event that is not analyzed or is

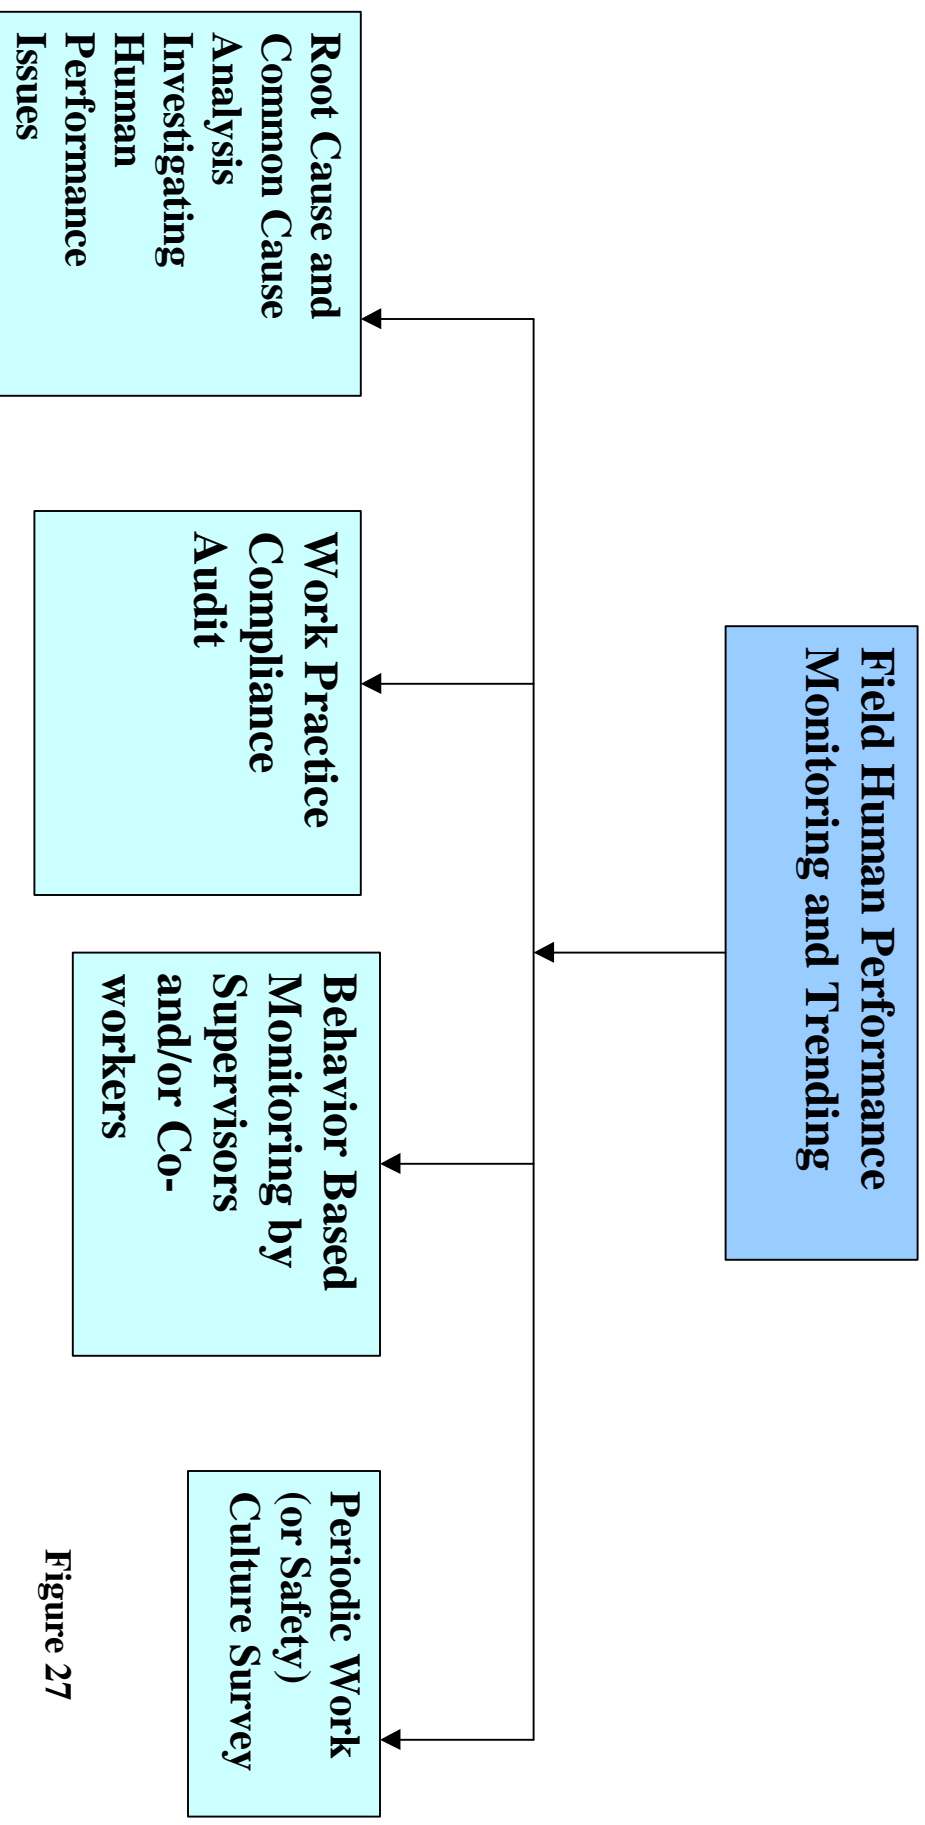
Figure 27

- PG&E has a root cause program in place. However, based on a review of 100 sample root cause analyses, more than 97% of the reports reported only what happened, not

why the event occurred. These root cause analyses documented mainly what broke and when and how it was fixed. No or little analysis of the root causes (such as process problems, human performance problems, human error inducers, etc.) of events was included in the reports.

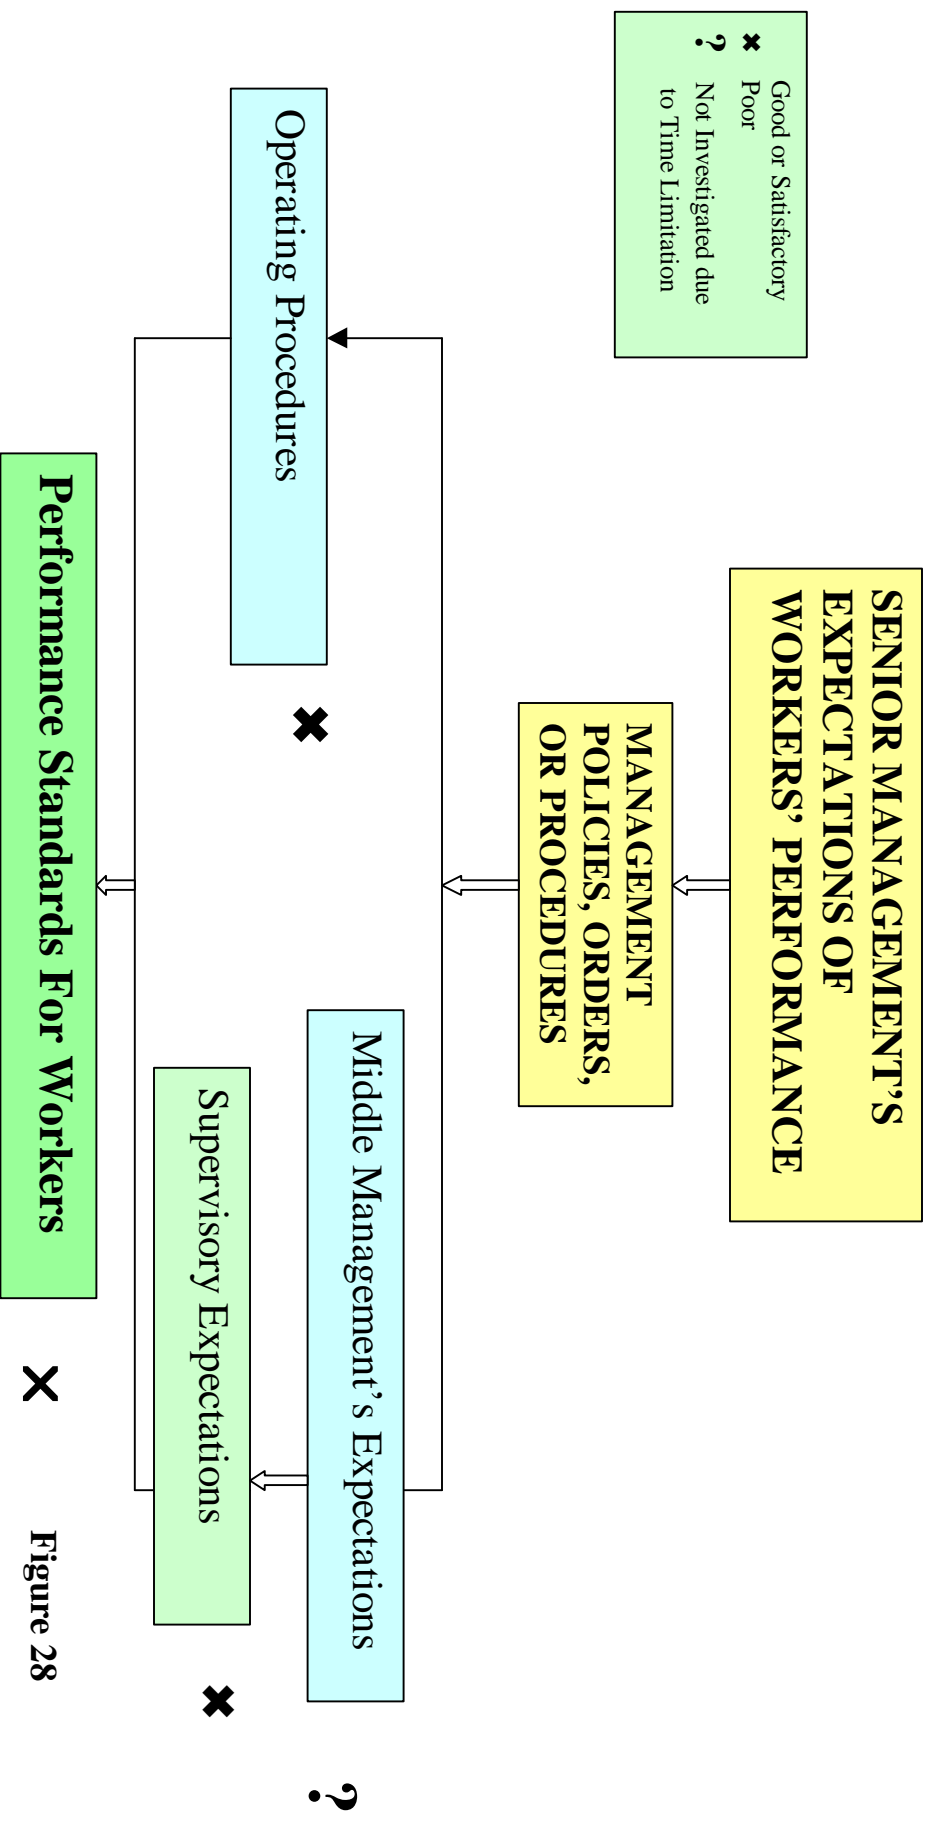
Figure 28 shows how senior management’s expectations can be translated into behavior standards in the field. As can be seen in this figure, the senior management’s expectations of workers’ performance are usually written down in a high-level policy procedure. At PG&E, this high level policy is its General Operating Instructions (GOI), written by two PG&E officers in 1990 for all transmission and distribution personnel. This GOI is still valid and used within PG&E.

It is recommended that a PG&E senior management team perform an analysis to review the expectations of their workers and ensure that these expectations are still valid. Then, modify the GOI, low level operating procedures, and middle management and supervisor training accordingly. (Recommendation OFI-18.1)
