**AN INDEPENDENT, FULL SCOPE
ROOT CAUSE INVESTIGATION OF
SAN FRANCISCO
DECEMBER 8, 1998 OUTAGE**

(Interim Report)

AN INDEPENDENT, FULL SCOPE ROOT CAUSE INVESTIGATION OF THE SAN FRANCISCO DECEMBER 8, 1998 ELECTRICAL POWER OUTAGE

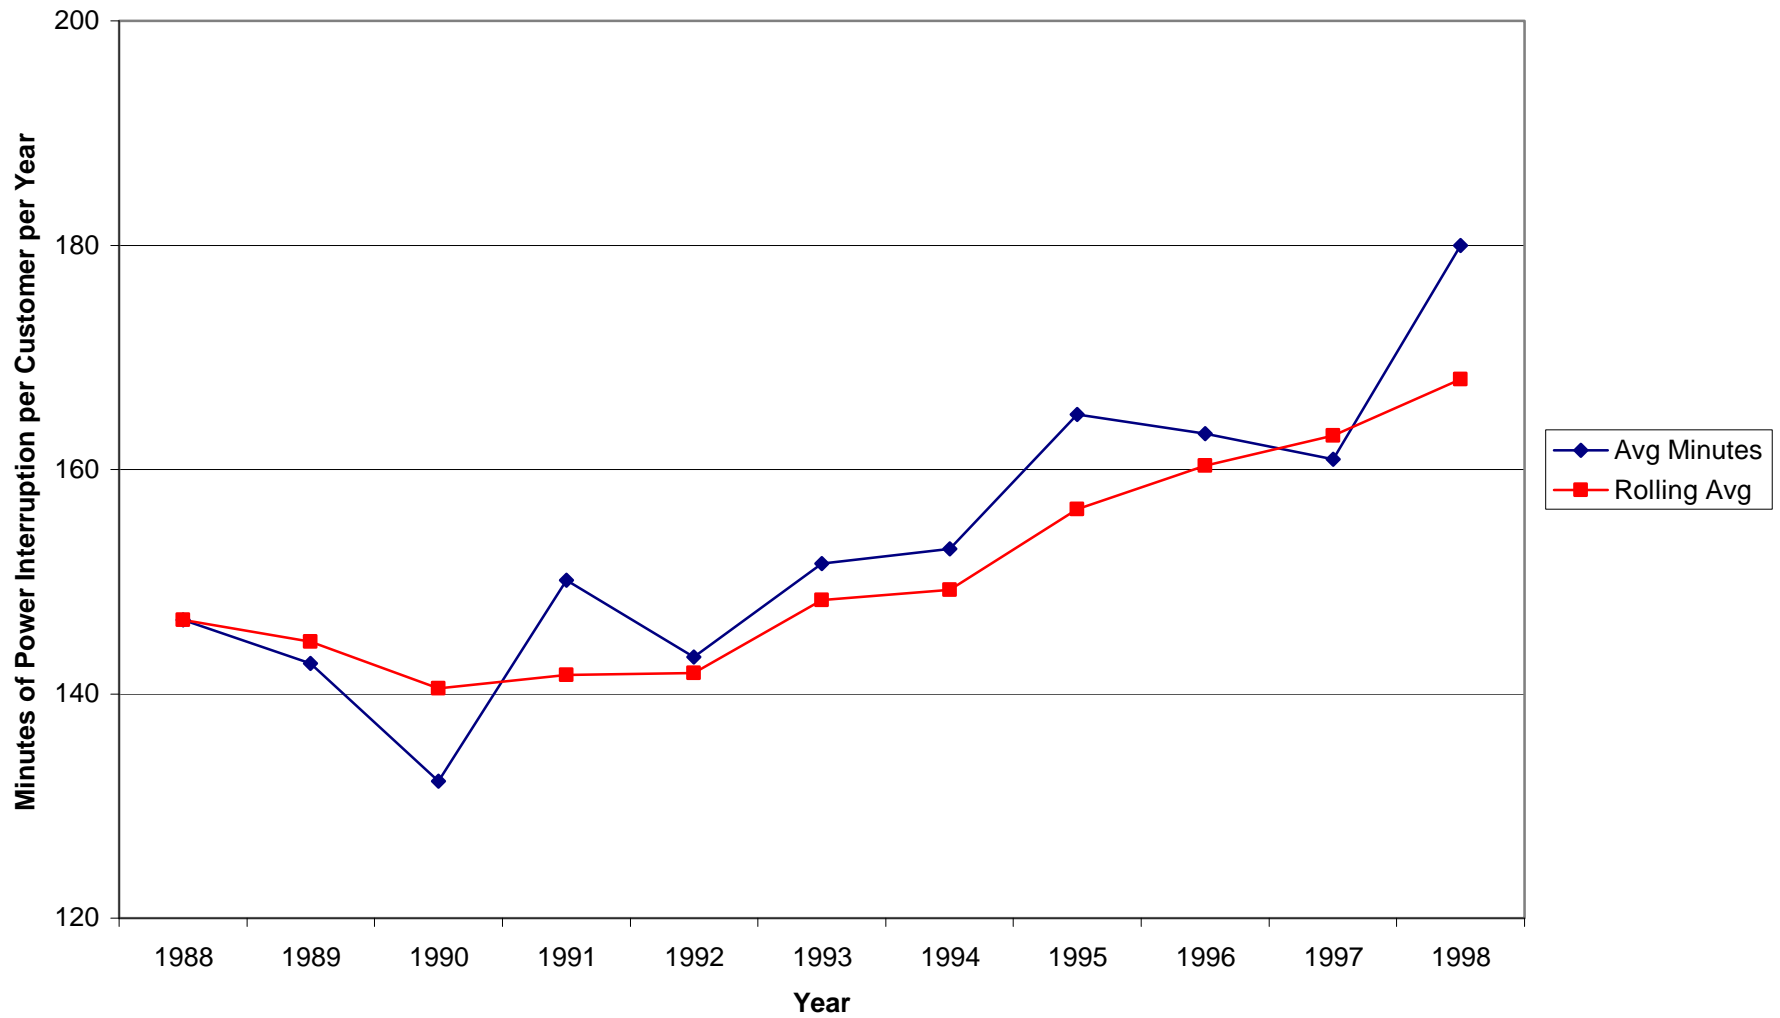
Figure 7 shows the trend of PG&E's SAIDI for the past ten years. As can be seen in this figure, an upward trend exists. In 1998, PG&E's SAIDI was 180 minutes, whereas the average SAIDI for other public utilities was 68 minutes. It should be noted that the 180 minutes versus 68 minutes is not an indication that PG&E is worse than other utilities. It only means that from a consumer's perspective, there is room for improvement.

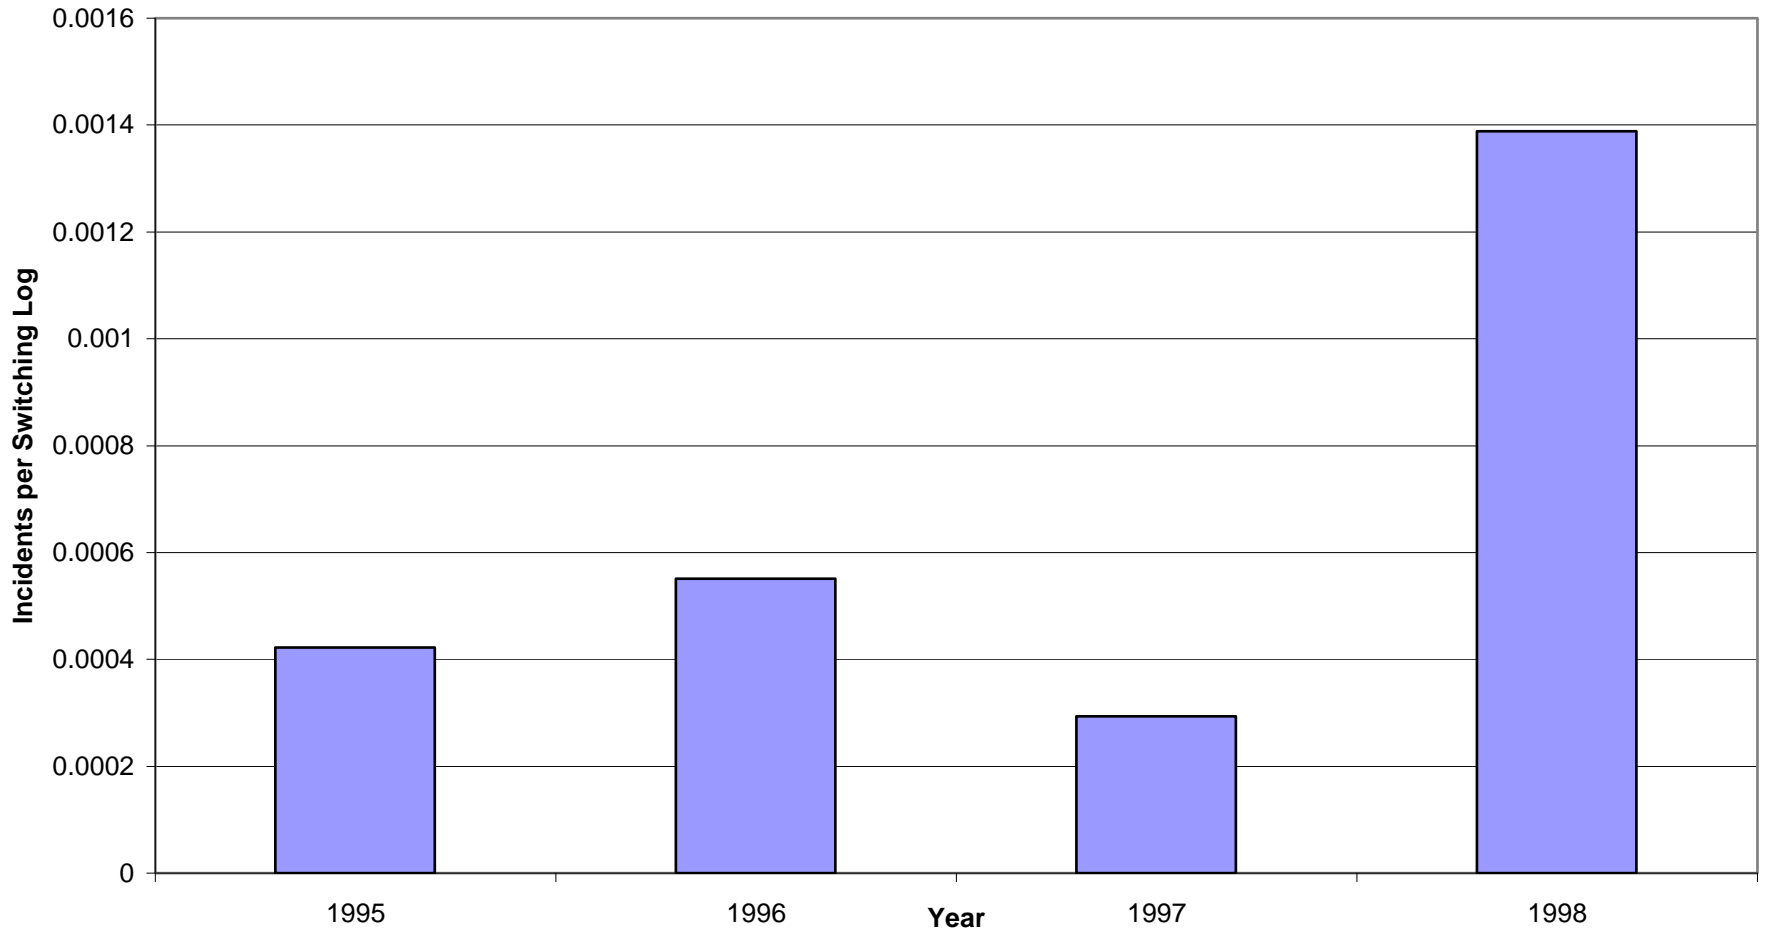
Figure 8 shows the trend of the switching error rate, which was derived from dividing the switching errors by the number of switching logs operated by PG&E on a yearly basis. As can be seen in **Figure 8**, the switching error rate rose in 1998.

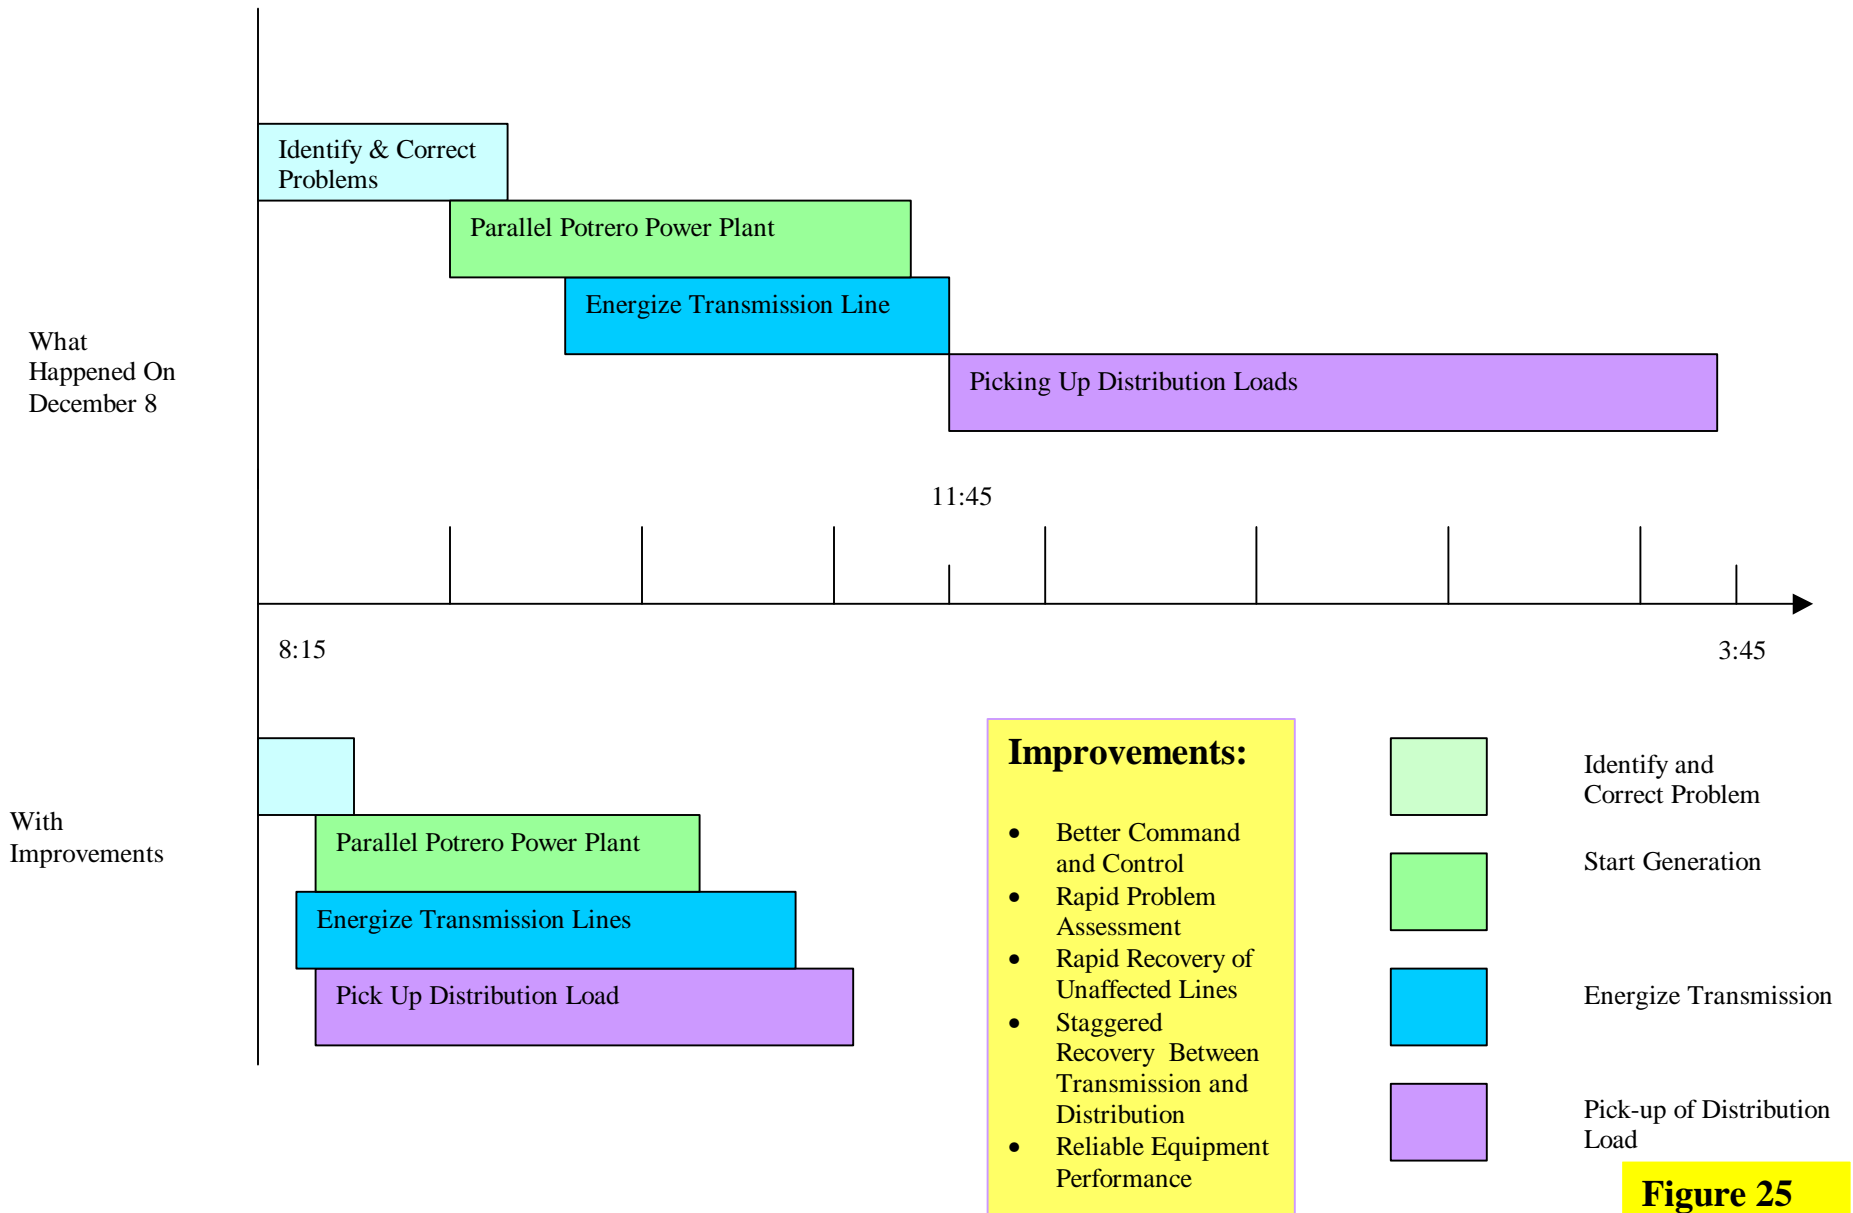
Figure 25

Had the above OFIs been avoided or corrected, the total recovery time would have been reduced to about 3 hours. **Figure 25** shows the comparison of four major categories of recovery activities (in terms of problem identification and resolution, generation re-start, energizing transmission, and recovery of the distribution load) actual and the “should-be” situations during recovery. **Figure 26** shows a comparison of the number of the consumers versus outage time between the actual and “should-be” recoveries.

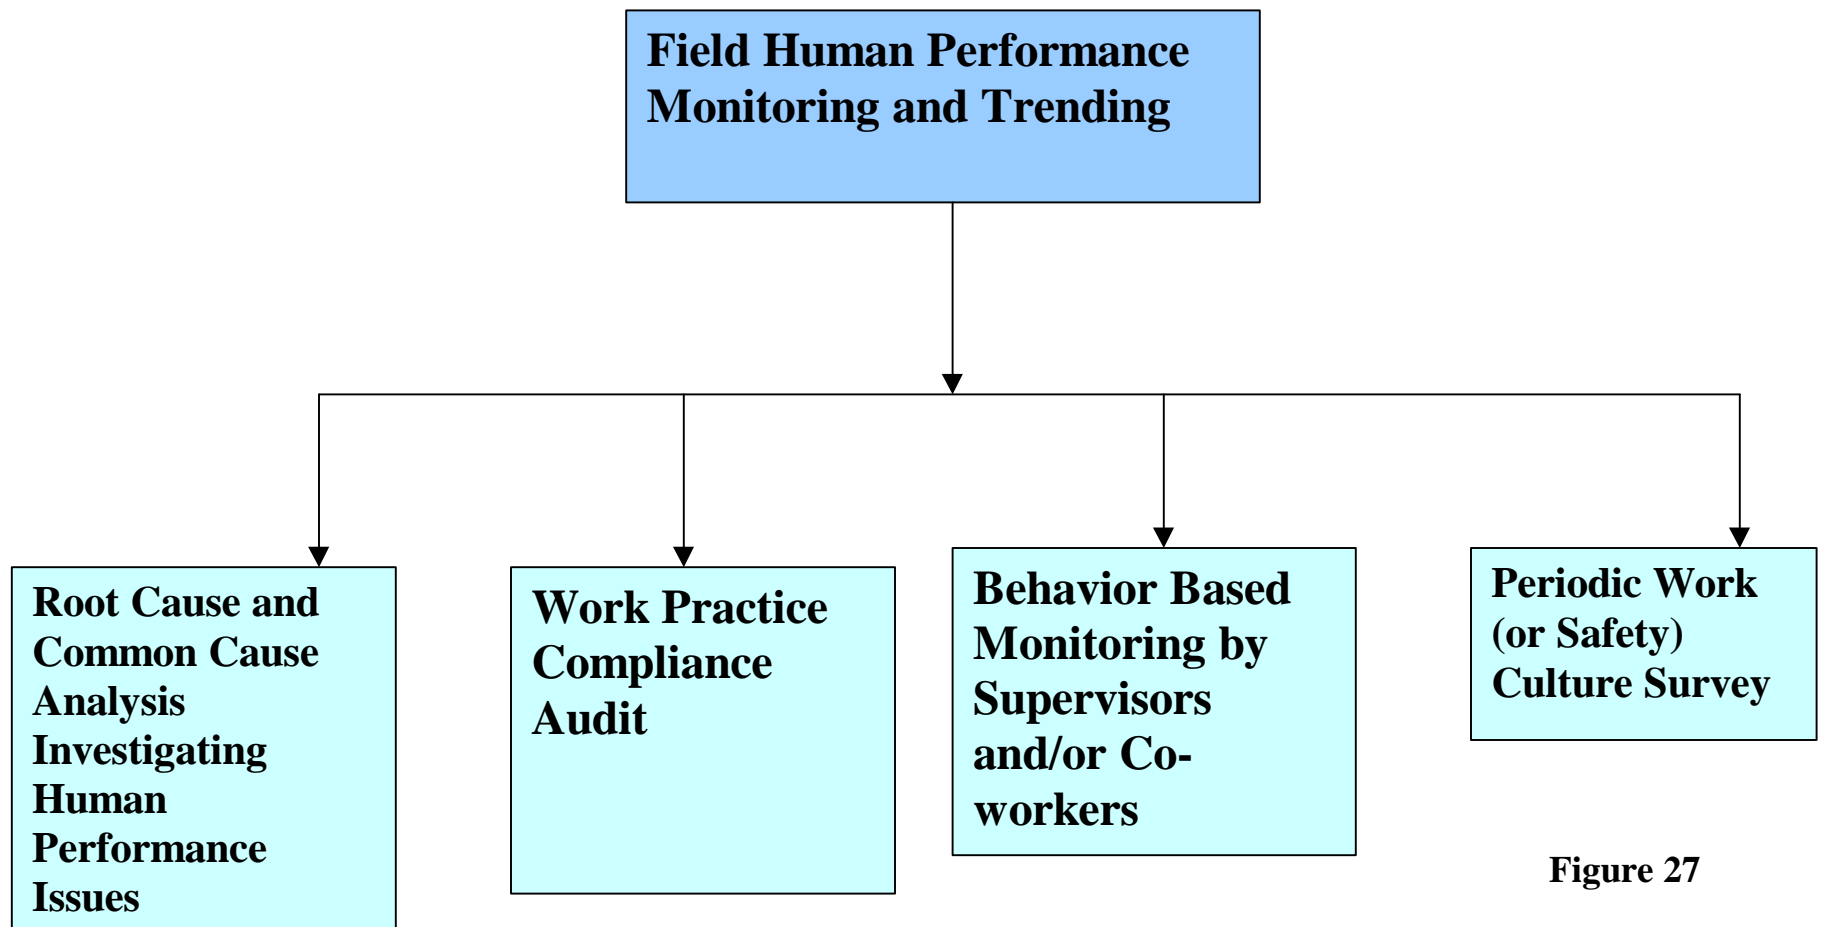
Figure 27

- PG&E has a root cause program in place. However, based on a review of 100 sample root cause analyses, more than 97% of the reports reported only what happened, not

why the event occurred. These root cause analyses documented mainly what broke and when and how it was fixed. No or little analysis of the root causes (such as process problems, human performance problems, human error inducers, etc.) of events was included in the reports.

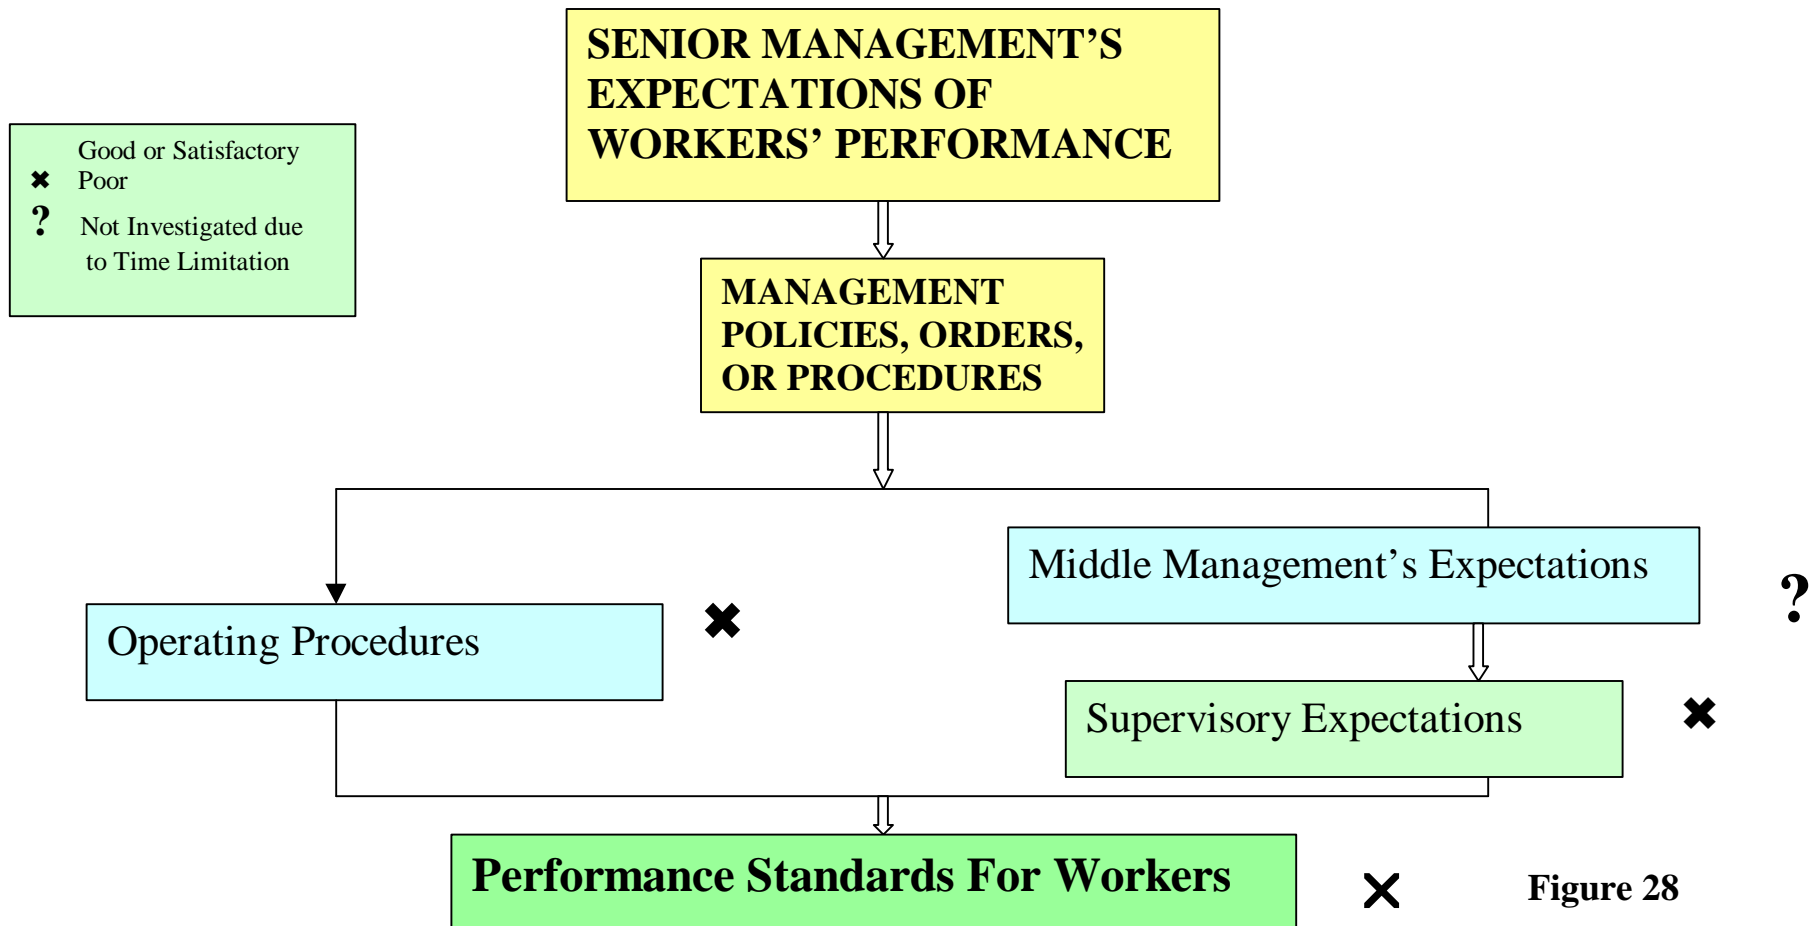
Figure 28

PROPAGATION OF SENIOR MANAGEMENT EXPECTATIONS HAS NOT ALWAYS BEEN EFFECTIVE – A FEW EXAMPLES.

It is recommended that a PG&E senior management team perform an analysis to review the expectations of their workers and ensure that these expectations are still valid. Then, modify the GOI, low level operating procedures, and middle management and supervisor training accordingly. (Recommendation OFI-18.1)

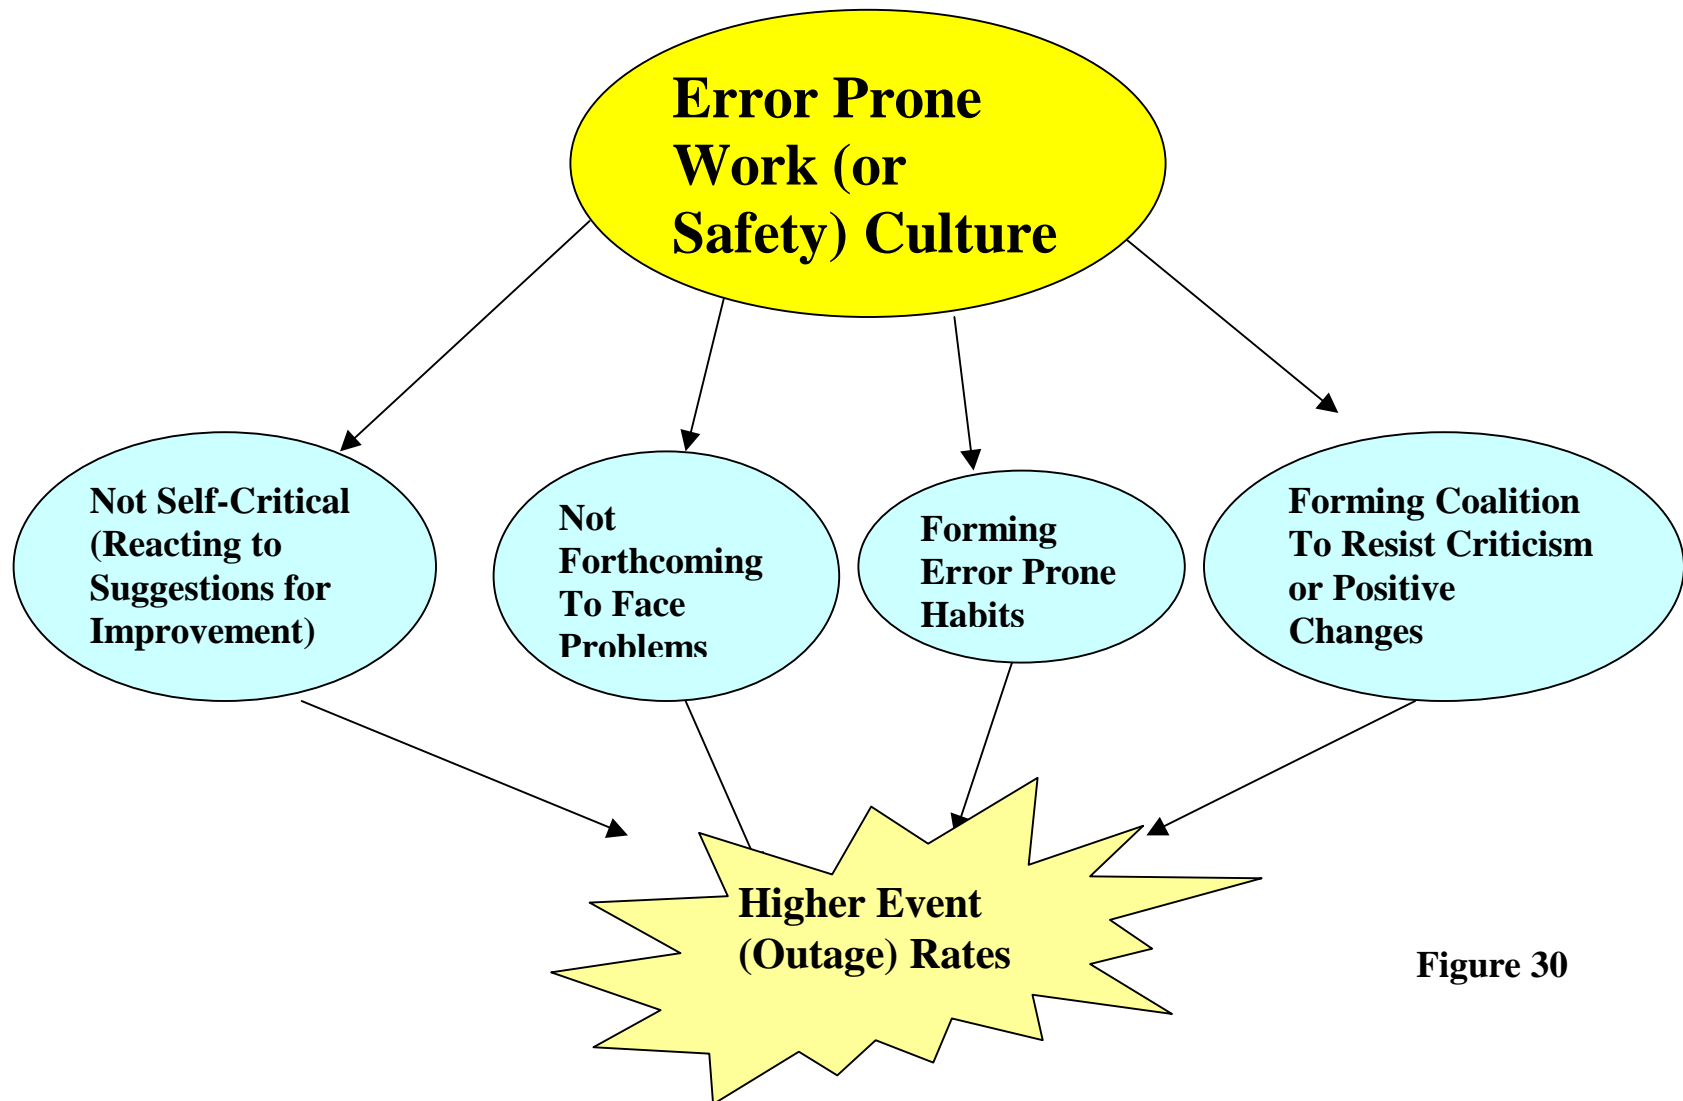
Figure 30

How do we know there are work culture issues? **Figure 30** shows the four common symptoms of poor work culture. These symptoms are:

- After the outage, the San Mateo operators decided to falsify a switching log. They were not forthcoming or self-critical regarding the errors they made that initiated the outage.
- The PG&E investigation did not cover problematic areas in the work culture or management system. Instead, its investigation focused on human errors made by workers.
- Even though it was required by PG&E's senior management to use the repeat-back technique to avoid communication errors, it was not used by the TOC or SMSC throughout the event. This means that a habit of not using the repeat-back

communication technique has been formed over time. This habit (not repeating back in critical communications) is very human error prone.

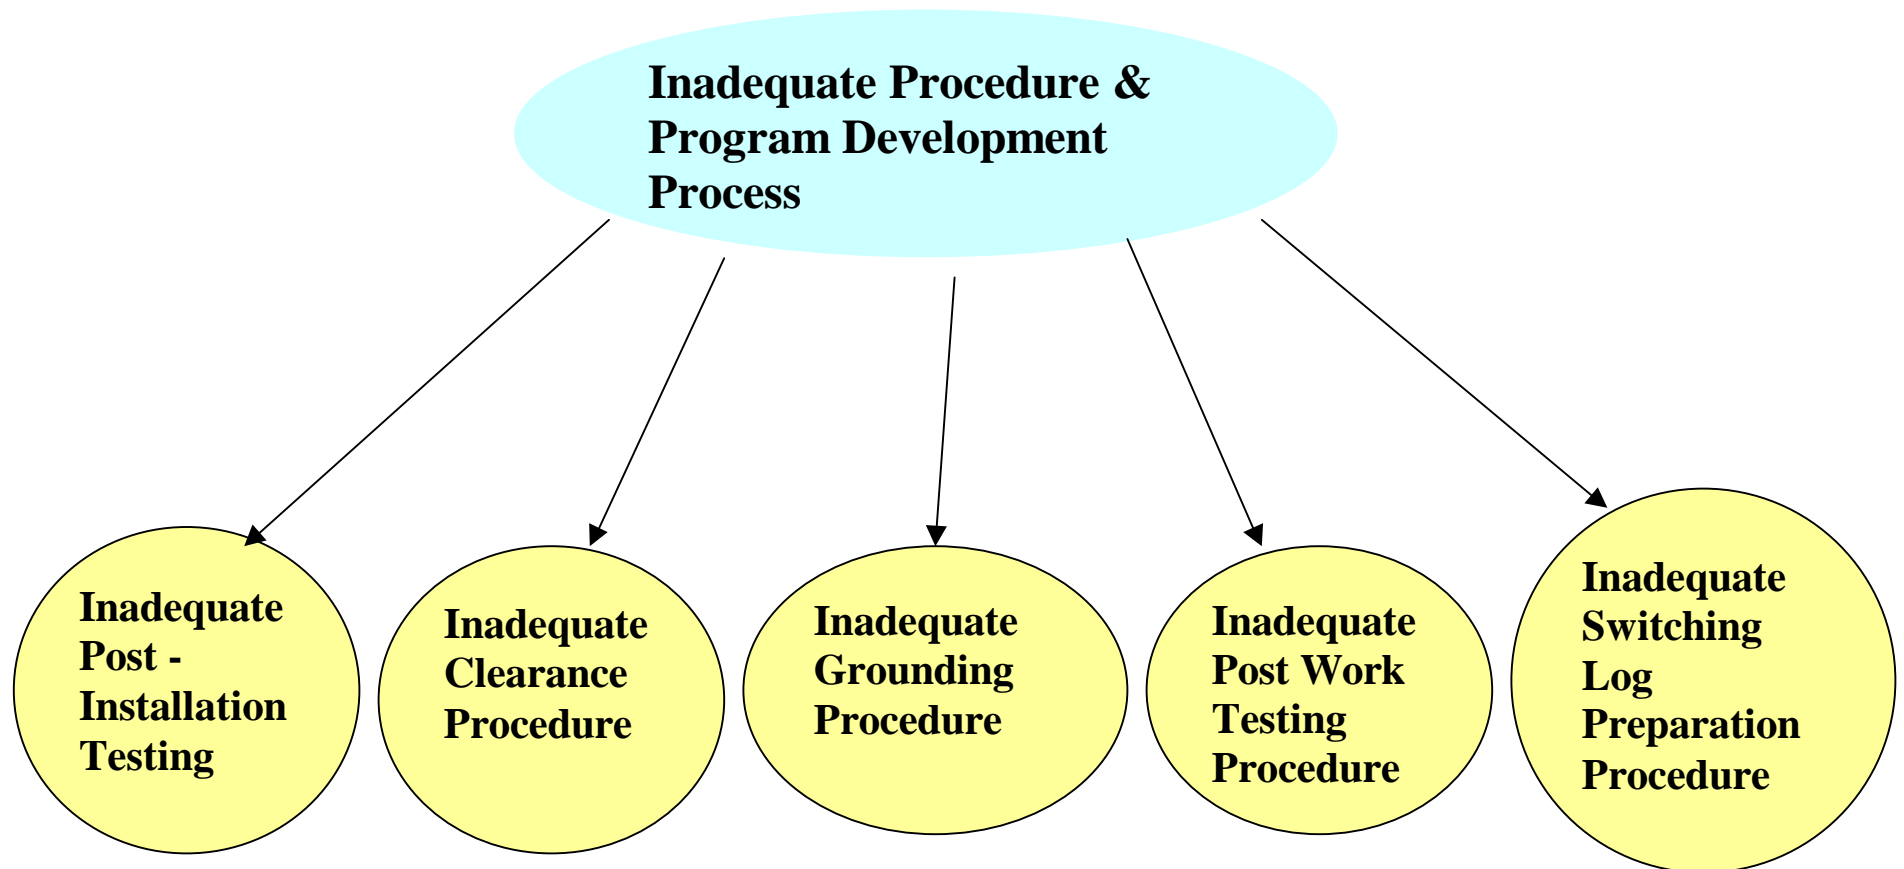
Figure 31 shows five procedures or programs that are error prone. Each of the five procedures or programs induced errors during the San Francisco outage. The following are a few examples:

Switching log preparation program-

- The program allows the operators to use previously used switching logs and to modify them for new application without pointing out and compensating for the human error traps (such as check for changes, configuration changes, assumptions, etc.).
