GEOTECHNICAL SITING STUDY

**SAN DIEGO GAS & ELECTRIC
PROPOSED OCEAN RANCH SUBSTATION
PACIFIC COAST BUSINESS PARK – PARCELS 7, 16 AND 17
OCEANSIDE, CALIFORNIA**

June 26, 2012

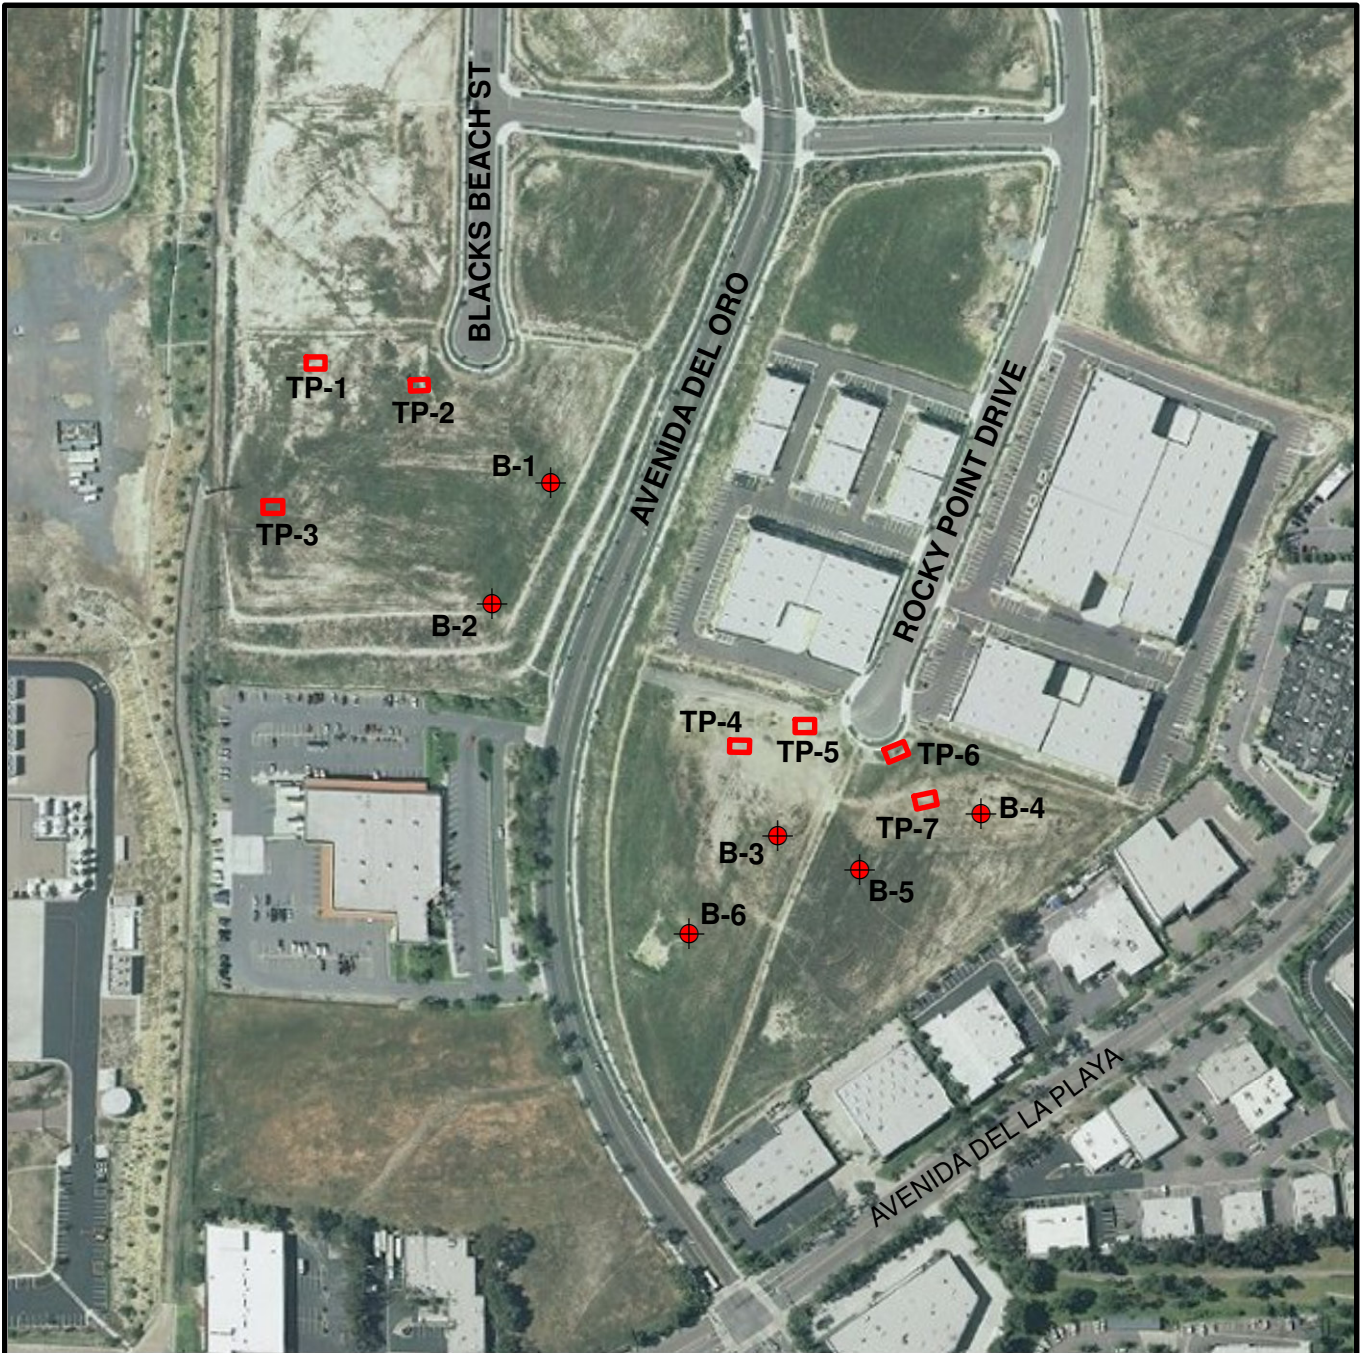
- B-1** APPROXIMATE BORING LOCATION
- TP-1** APPROXIMATE TEST PIT LOCATION

Parcel 7 is located along the west side of Avenida del Oro at the south end of Blacks Beach Street. Parcels 16 and 17 share a property boundary and are located east of Parcel 7 and Avenida del Oro, at the south end of Rocky Point Drive. The three parcels are shown on Plate 1, Site Vicinity Map and on Plate 2, Field Exploration Map.

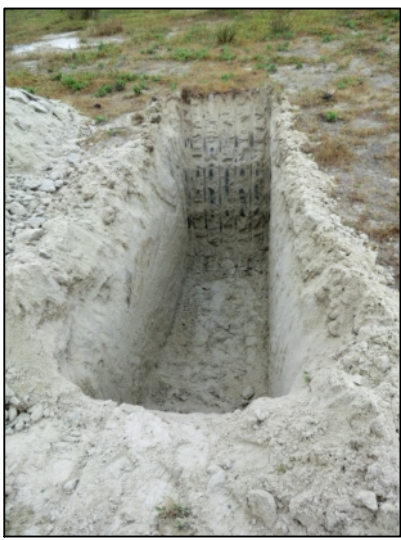
TP-1

Santiago Formation Clayey SAND (SC): fine to coarse grained, low plasticity fines, gray, moist, dense, homogeneous, weakly to moderately cemented, some Clay in seams	1										Expansion Index (5)
375	10		The test pit was terminated at approximately 5 feet below ground surface. Test Pit was backfilled with excavated material on April 23, 2012.				GROUNDWATER LEVEL INFORMATION: Groundwater was not encountered during excavation. GENERAL NOTES: The test pit location and elevation are approximate and were estimated by BHA, Inc. A Garmin etrex GPS unit was used to locate the test pit with an accuracy of 5 to 10 feet. There was no shoring used for the test pit exploration.

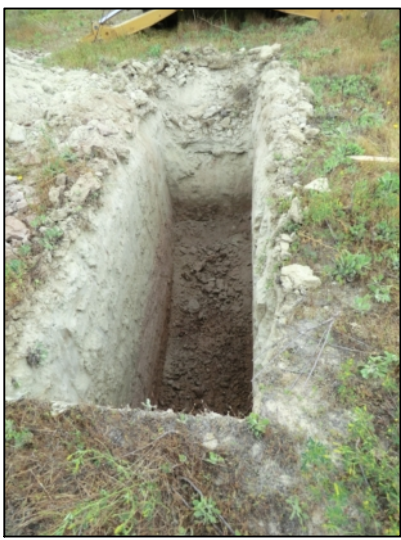
TP-2

CLAYSTONE (CL-CH): fine grained, medium to high plasticity fines, brown to reddish brown, moist, very hard, blocky, strongly cemented	2									
370	10		The test pit was terminated at approximately 8 feet below ground surface. Test Pit was backfilled with excavated material on April 23, 2012.				GROUNDWATER LEVEL INFORMATION: Groundwater was not encountered during excavation. GENERAL NOTES: The test pit location and elevation are approximate and were estimated by BHA, Inc. A Garmin etrex GPS unit was used to locate the test pit with an accuracy of 5 to 10 feet. There was no shoring used for the test pit exploration.

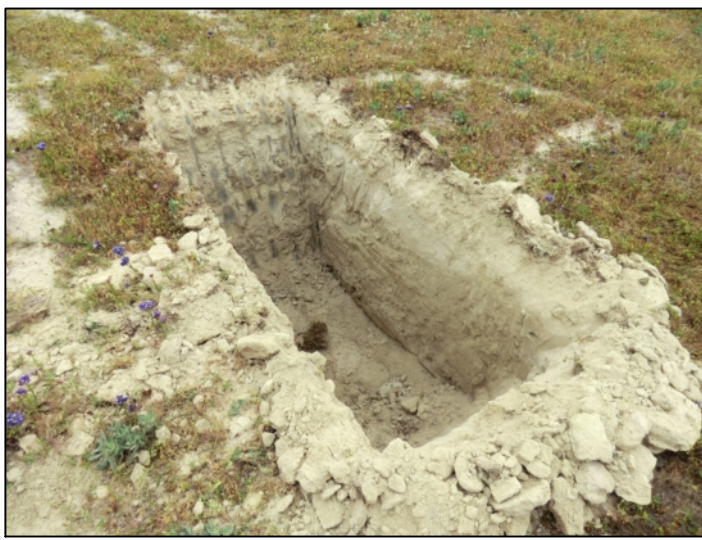
TP-3

CLAYSTONE (CL-CH): fine grained, medium to high plasticity fines, brown to reddish brown, moist, very hard, blocky, strongly cemented	2											
380															
			<p>The test pit was terminated at approximately 6 feet below ground surface. Test Pit was backfilled with excavated material on April 23, 2012.</p>				<p>GROUNDWATER LEVEL INFORMATION: Groundwater was not encountered during excavation. GENERAL NOTES: The test pit location and elevation are approximate and were estimated by BHA, Inc. A Garmin etrex GPS unit was used to locate the test pit with an accuracy of 5 to 10 feet. There was no shoring used for the test pit exploration.</p>

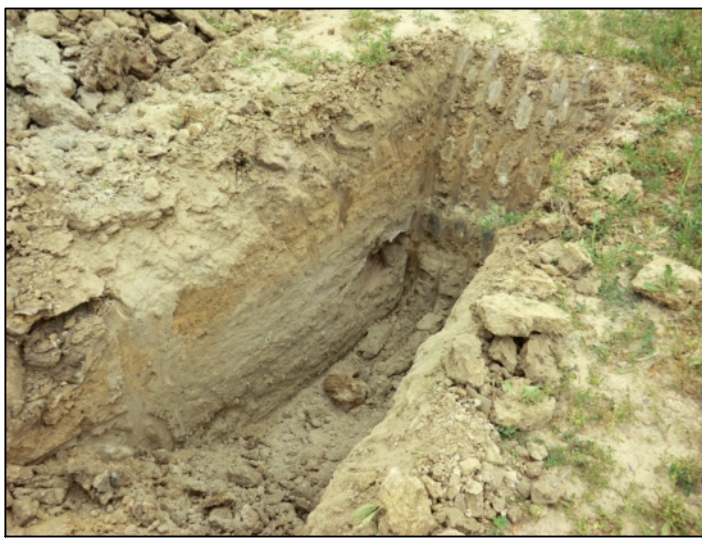
TP-5

Santiago Formation Silty SAND (SM): fine to coarse grained, low plasticity fines, gray, moist, dense, pockets of dark gray Clay, concreteion observed at approximately 5.5 feet	2									
360	10		The test pit was terminated at approximately 6 feet below ground surface. Test Pit was backfilled with excavated material on April 23, 2012.				GROUNDWATER LEVEL INFORMATION: Groundwater was not encountered during excavation. GENERAL NOTES: The test pit location and elevation are approximate and were estimated by BHA, Inc. A Garmin etrex GPS unit was used to locate the test pit with an accuracy of 5 to 10 feet. There was no shoring used for the test pit exploration.

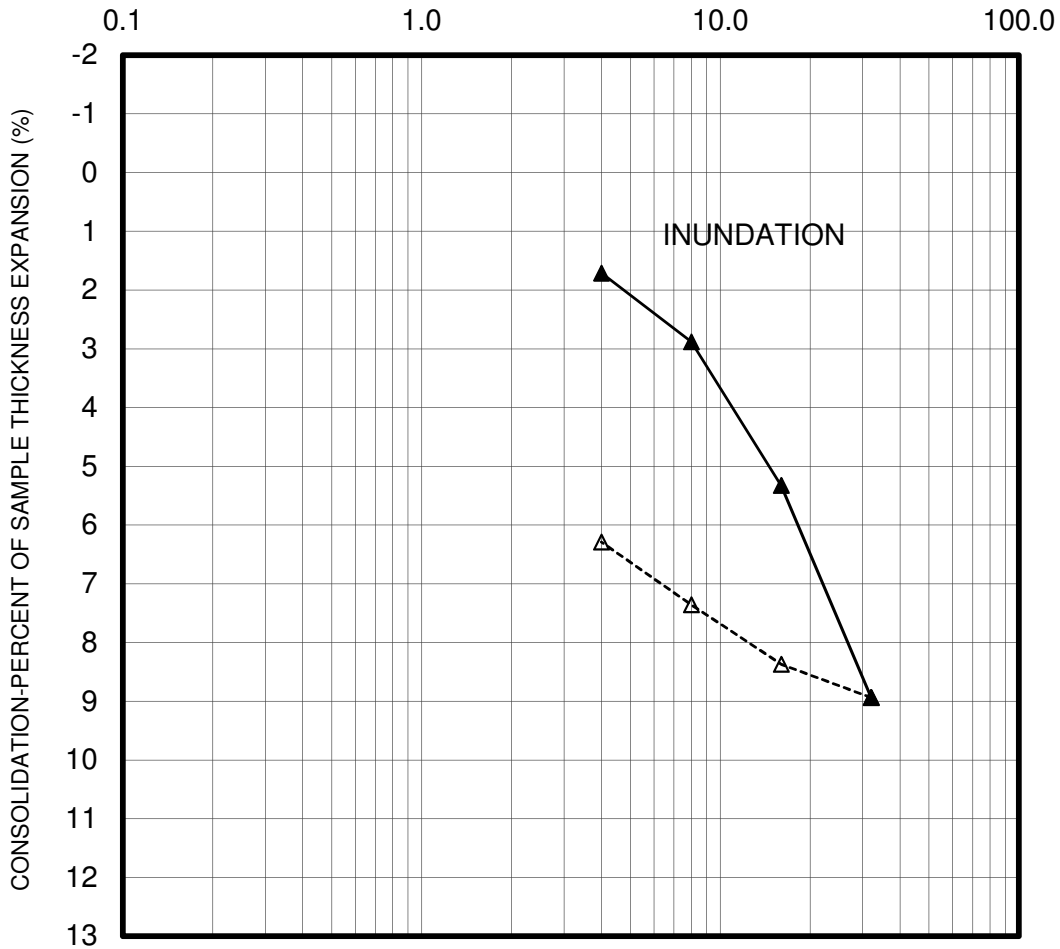
Plate
B1

Boring No. B4
Sample No. 17
Depth 75'-76.5'
Sample Description very dark brown clay

Two consolidation tests were performed on soils samples of the alluvium / colluvium to aid in evaluating the compressibility of the soils when subjected to new loads. The tests were performed in general accordance with ASTM Test Method D 2435. The results of the test are presented on Plates B1 and B2.

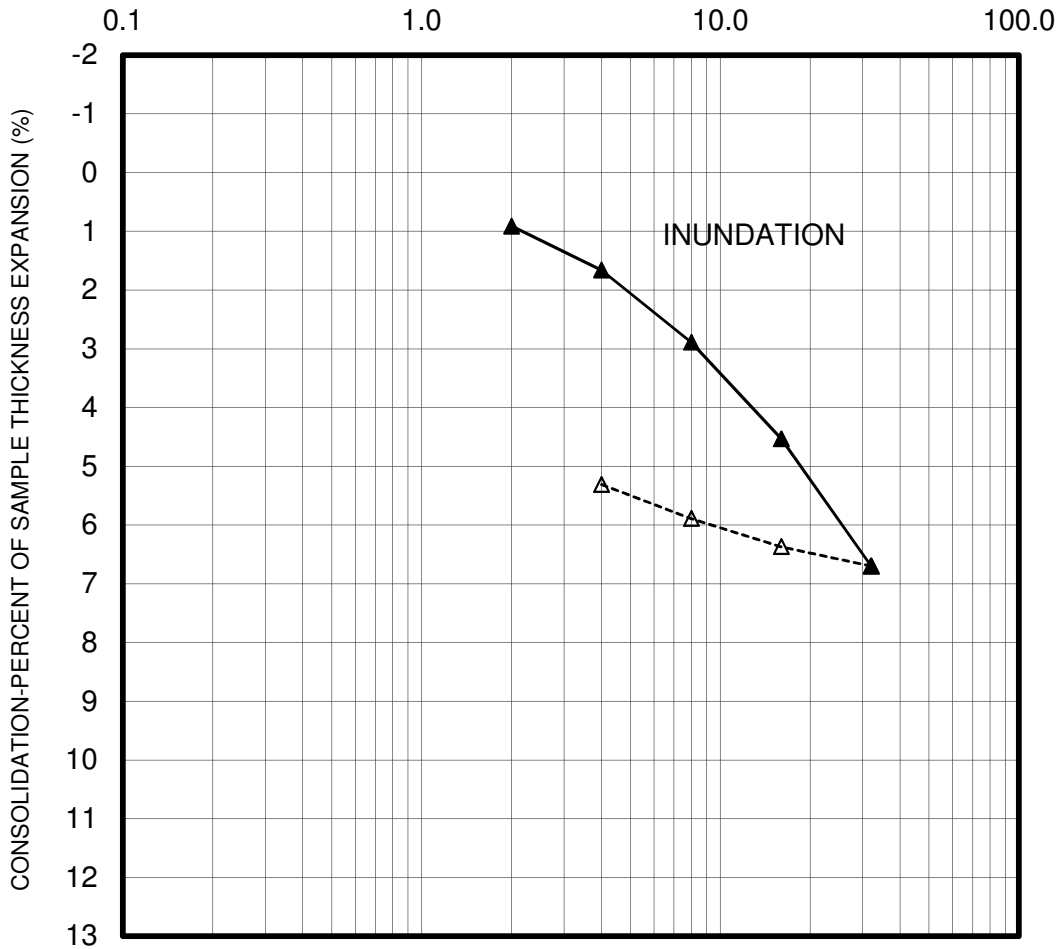
Boring No. B6
Sample No. 11
Depth 75'-76.5'
Sample Description dark yellowish brown sandy clay

PERFORMED IN GENERAL ACCORDANCE WITH ASTM D 2435
