Figure 3.14-20a
Existing Conditions
for KOP-Center-5
Northbound Angeles
Forest Highway
(Alternative 2, Segment 6)

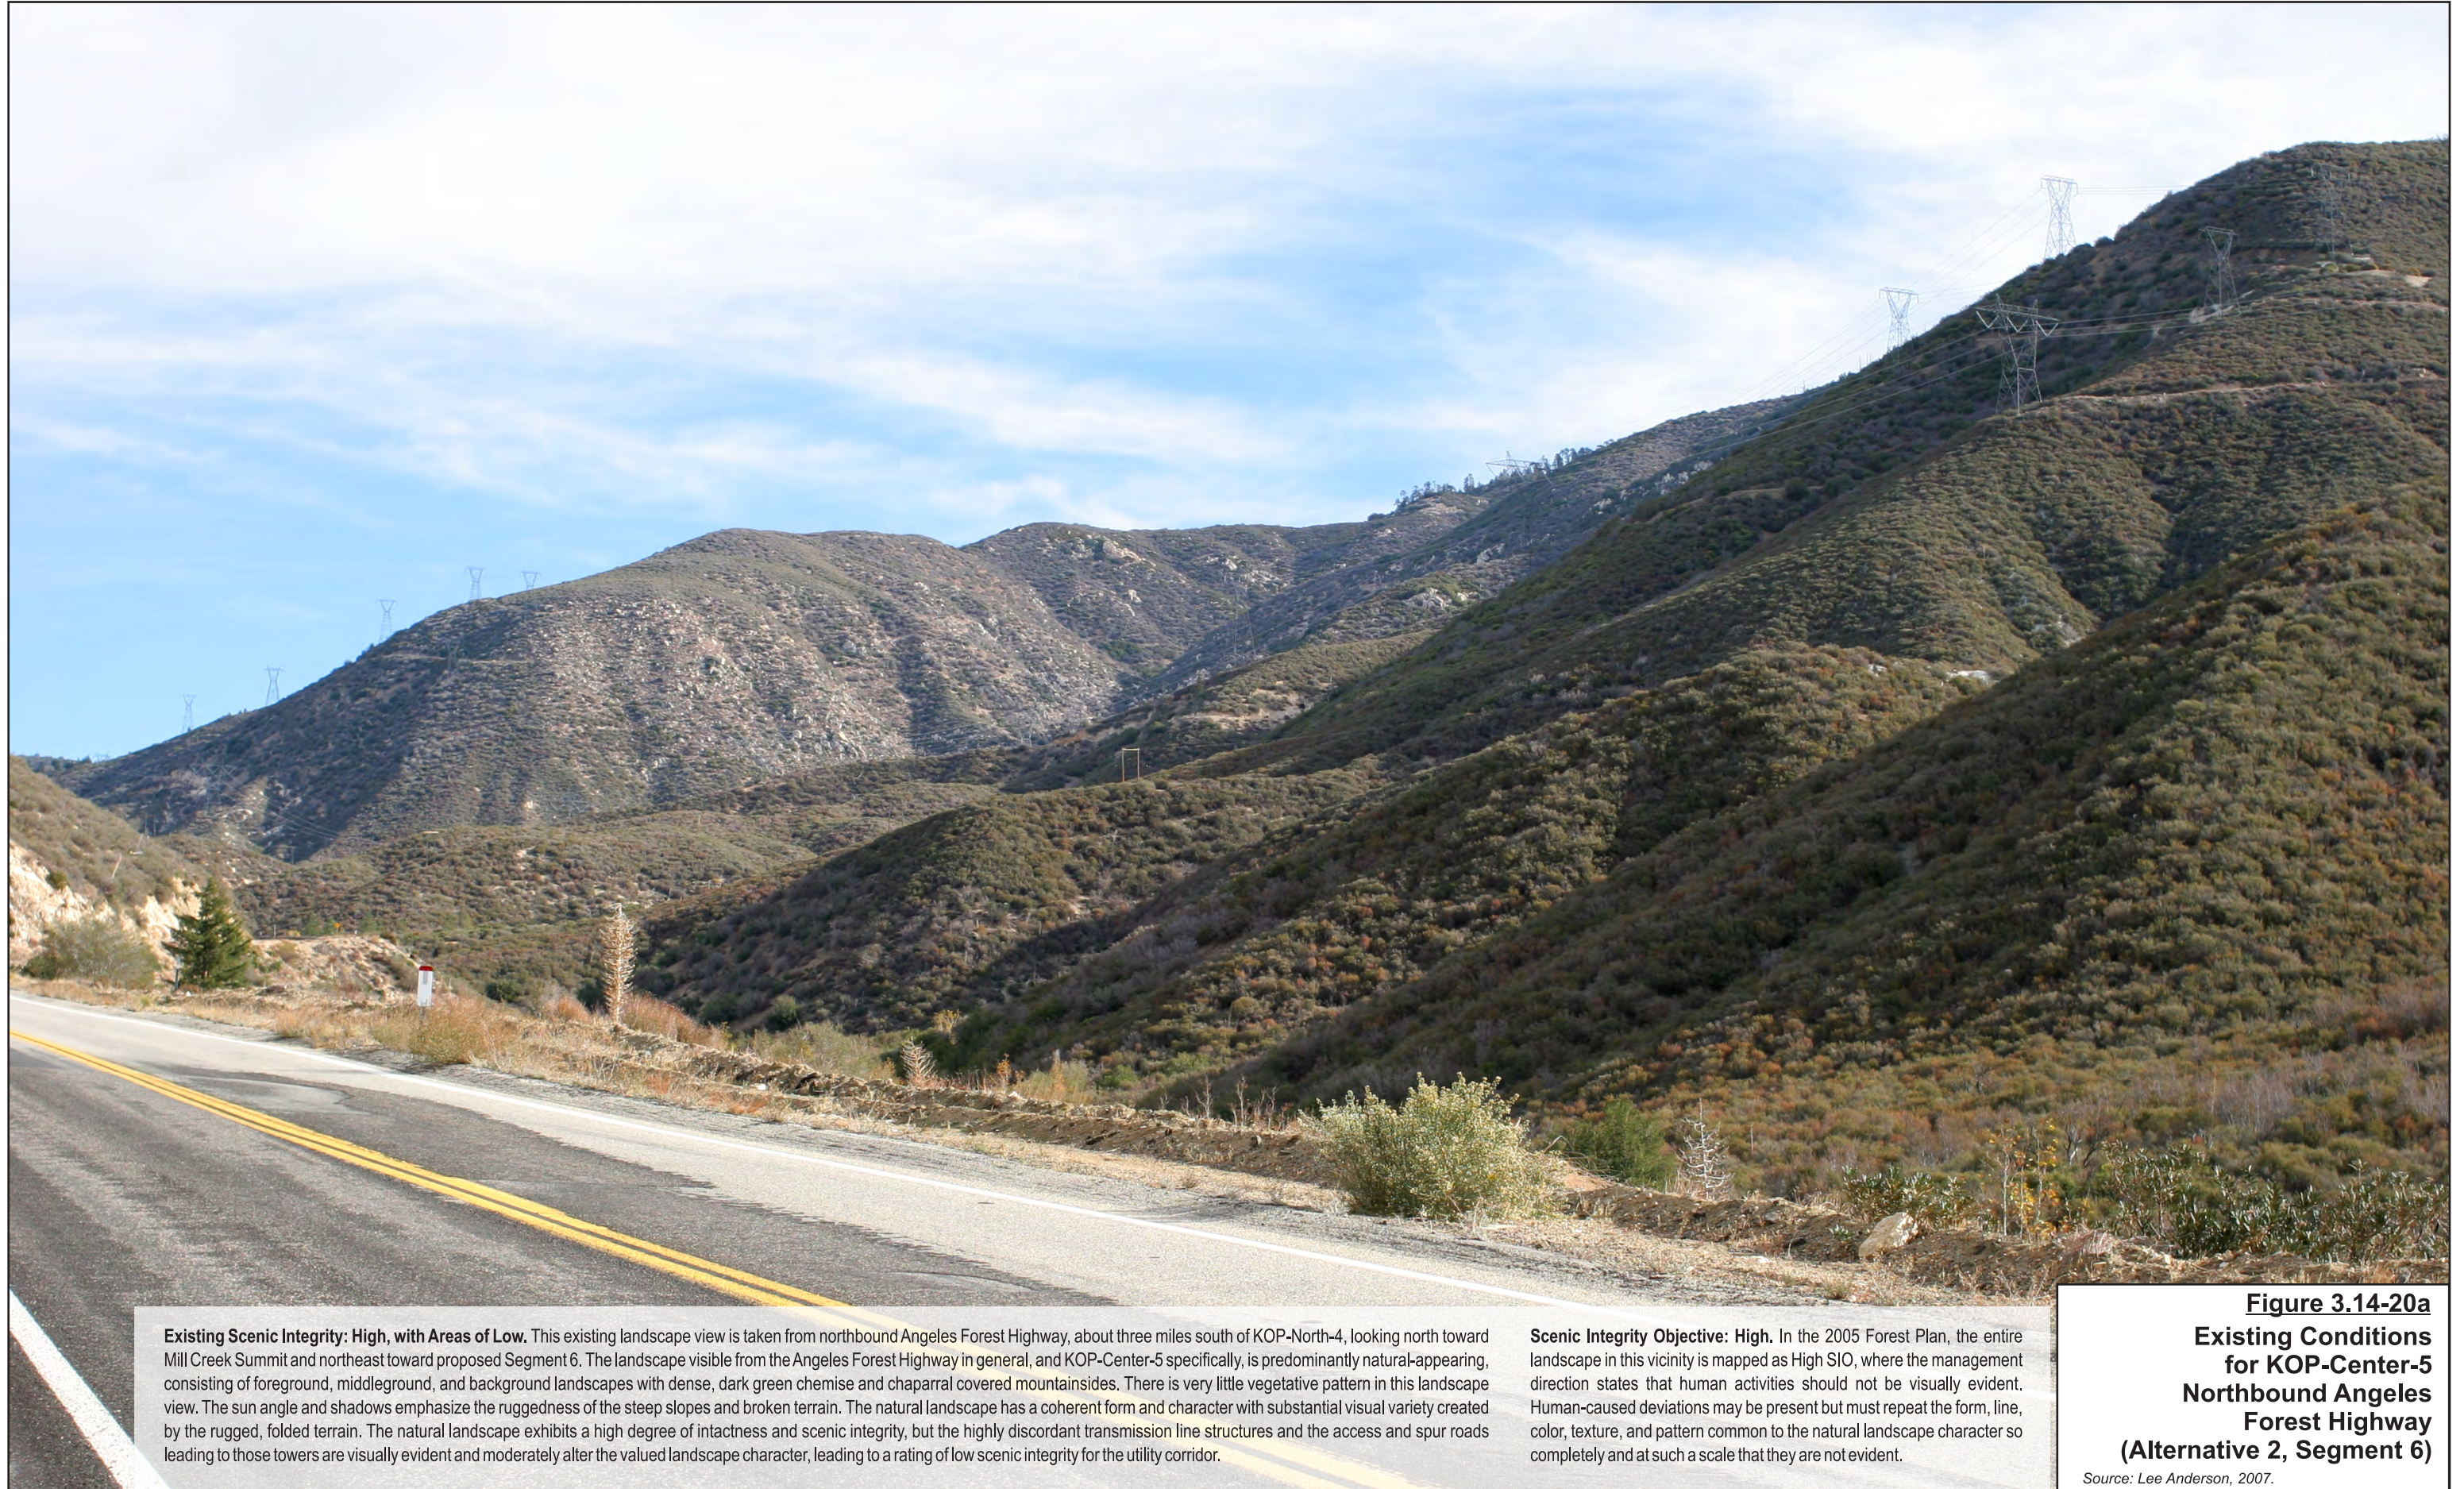
Existing Scenic Integrity: High, with Areas of Low. This existing landscape view is taken from northbound Angeles Forest Highway, about three miles south of KOP-North-4, looking north toward Mill Creek Summit and northeast toward proposed Segment 6. The landscape visible from the Angeles Forest Highway in general, and KOP-Center-5 specifically, is predominantly natural-appearing, consisting of foreground, middleground, and background landscapes with dense, dark green chemise and chaparral covered mountainsides. There is very little vegetative pattern in this landscape view. The sun angle and shadows emphasize the ruggedness of the steep slopes and broken terrain. The natural landscape has a coherent form and character with substantial visual variety created by the rugged, folded terrain. The natural landscape exhibits a high degree of intactness and scenic integrity, but the highly discordant transmission line structures and the access and spur roads leading to those towers are visually evident and moderately alter the valued landscape character, leading to a rating of low scenic integrity for the utility corridor.

Scenic Integrity Objective: High. In the 2005 Forest Plan, the entire landscape in this vicinity is mapped as High SIO, where the management direction states that human activities should not be visually evident. Human-caused deviations may be present but must repeat the form, line, color, texture, and pattern common to the natural landscape character so completely and at such a scale that they are not evident.
