**Figure 3.14-21a (Revised)**  
**Existing Conditions**  
**for KOP-Center-6**  
**Southbound Upper Big**  
**Tujunga Canyon Road**  
**(Alternative 2, Segment 6)**

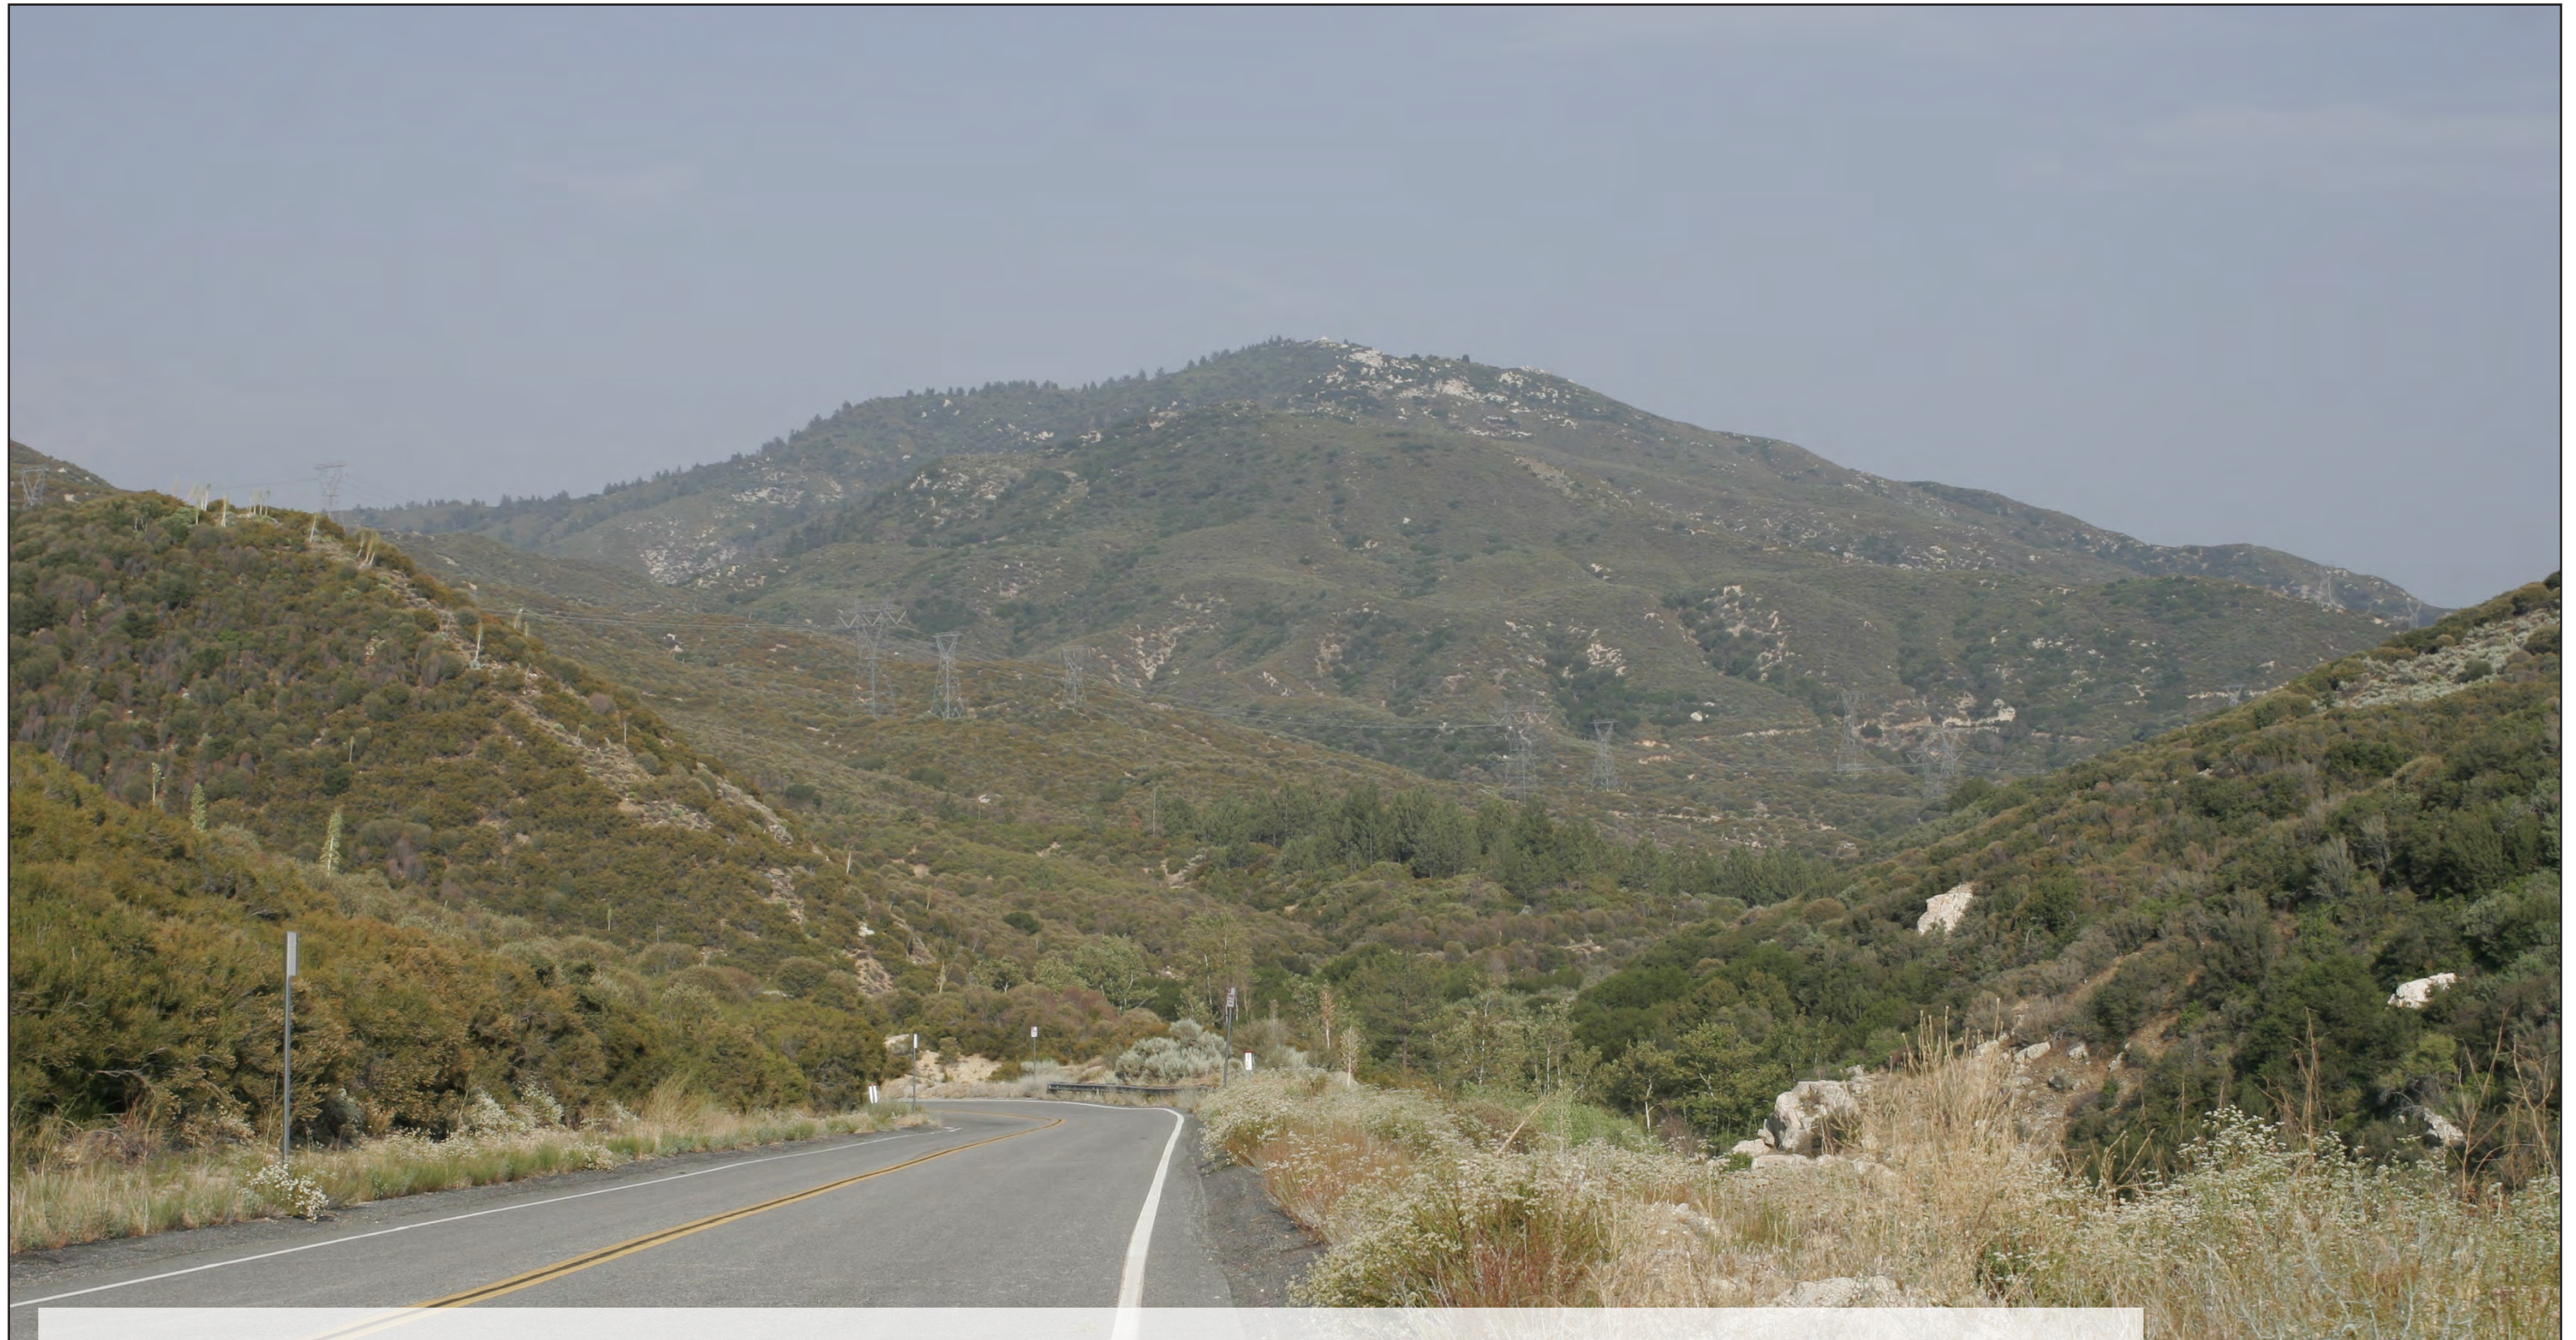
**Existing Scenic Integrity: High, with Areas of Low.** KOP-Center-6 is located on Upper Big Tujunga Canyon Road, approximately one mile northwest of KOP-Center-7 and approximately two-air-miles north of the Angeles Crest Scenic Byway. This view is typical for the southbound traveler on Upper Big Tujunga Canyon Road, looking south. The landscape visible from Upper Big Tujunga Canyon Road in general, and KOP-Center-6 specifically, is predominantly natural-appearing, consisting of foreground, middleground, and background landscapes with dense, dark green chaparral and evergreen tree-covered mountainsides. There are interesting vegetative patterns in this landscape view that are created by the folded terrain and microclimates. The sun angle and shadows emphasize the ruggedness of the steep slopes and broken terrain. The moderate slopes and rolling terrain are not as visually dominant as the terrain in many other parts of the Forest and therefore the existing transmission lines in this corridor have a stronger visual presence. The natural landscape has a coherent form and character with substantial visual variety created by the rugged, folded terrain. In this utility corridor, the existing 220-kV and 500-kV transmission lines were constructed prior to development and application of the Forest Service Visual Management System or the new Scenery Management System. The natural landscape exhibits a high degree of intactness and scenic integrity, except for the discordant transmission line structures and access road cutslopes, which further detract from scenic integrity, leading to a rating of low scenic integrity for the utility corridor.
