Figure 3.14-35b
Visual Simulation
for KOP-Center-20
Forest Road to
Millard Campground
(Alternative 2, Segment 11)

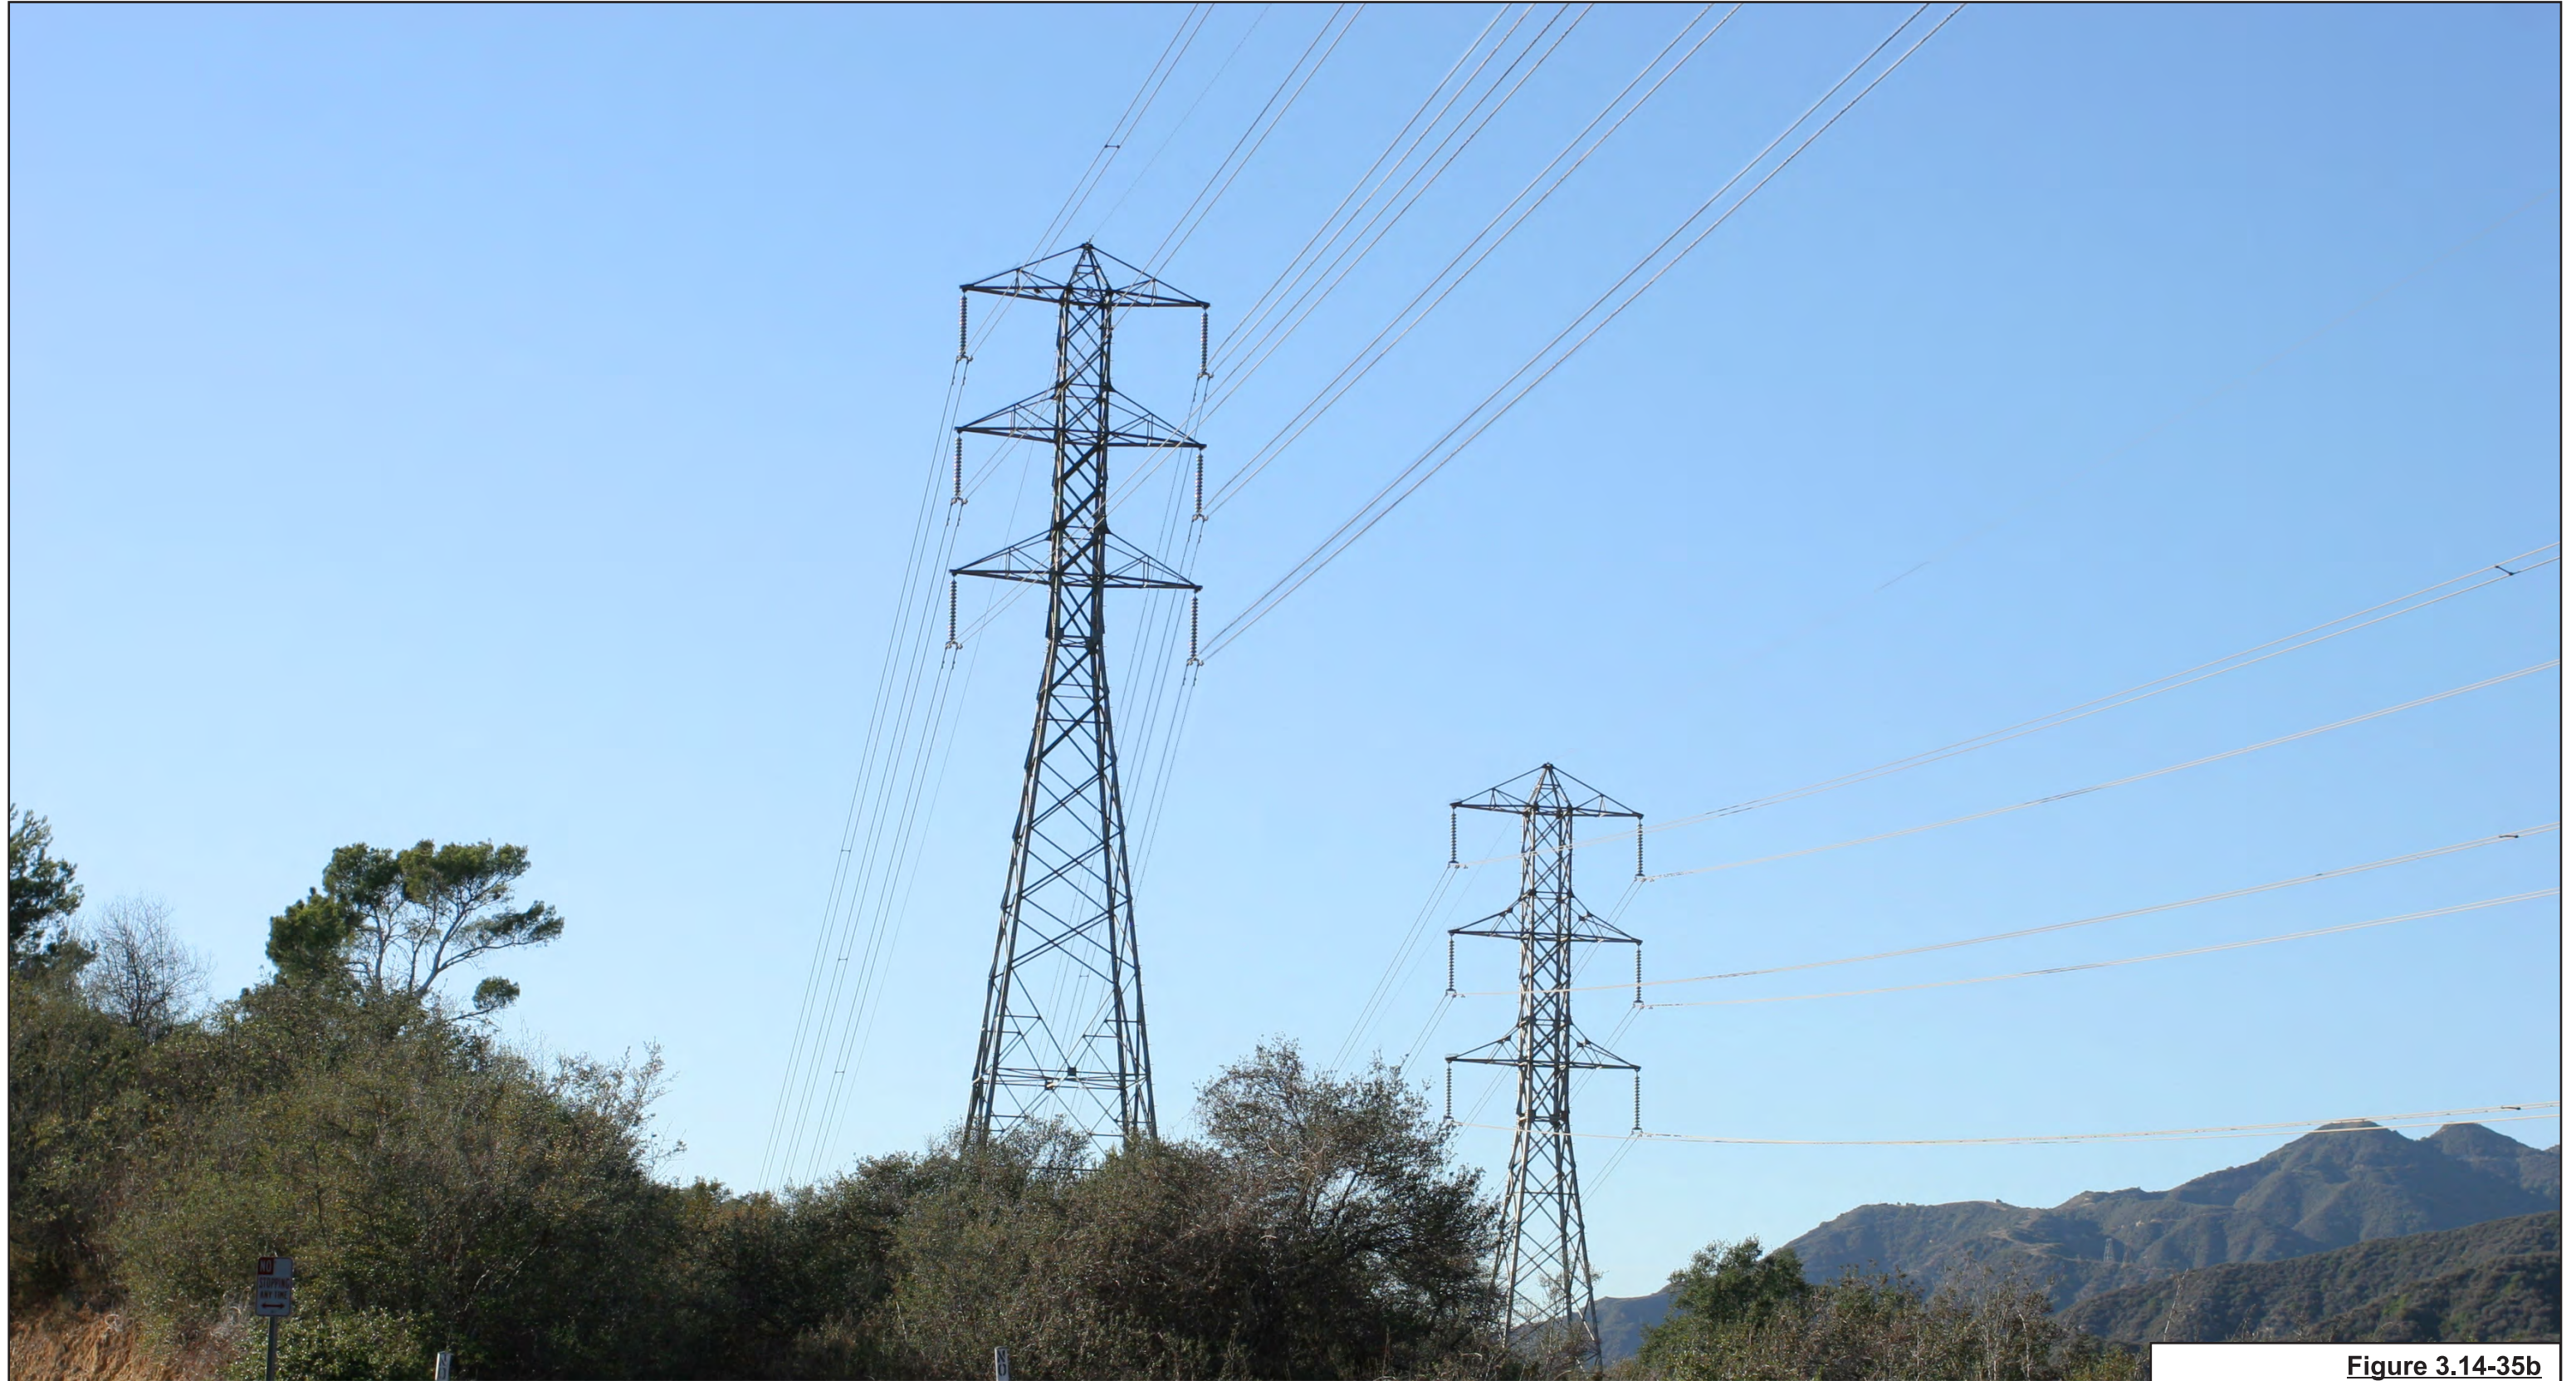
Future Scenic Integrity: High, with Areas of Unacceptably Low. In this portion of Segment 11, and for all areas from the Gould Substation to the Mesa Substation, new insulators would be hung on the vacant positions of these existing 220-kV double circuit towers and new conductors would be strung. The only visible change would be new insulators and conductors on existing LSTs. Access and spur roads are not visible from this vantage point.
