**Figure 3.14-78a (Revised)**  
**Existing Conditions**  
**for KOP-Center-15**  
**Eastbound Mount Gleason Road**  
**(Alternative 6, Segment 11)**

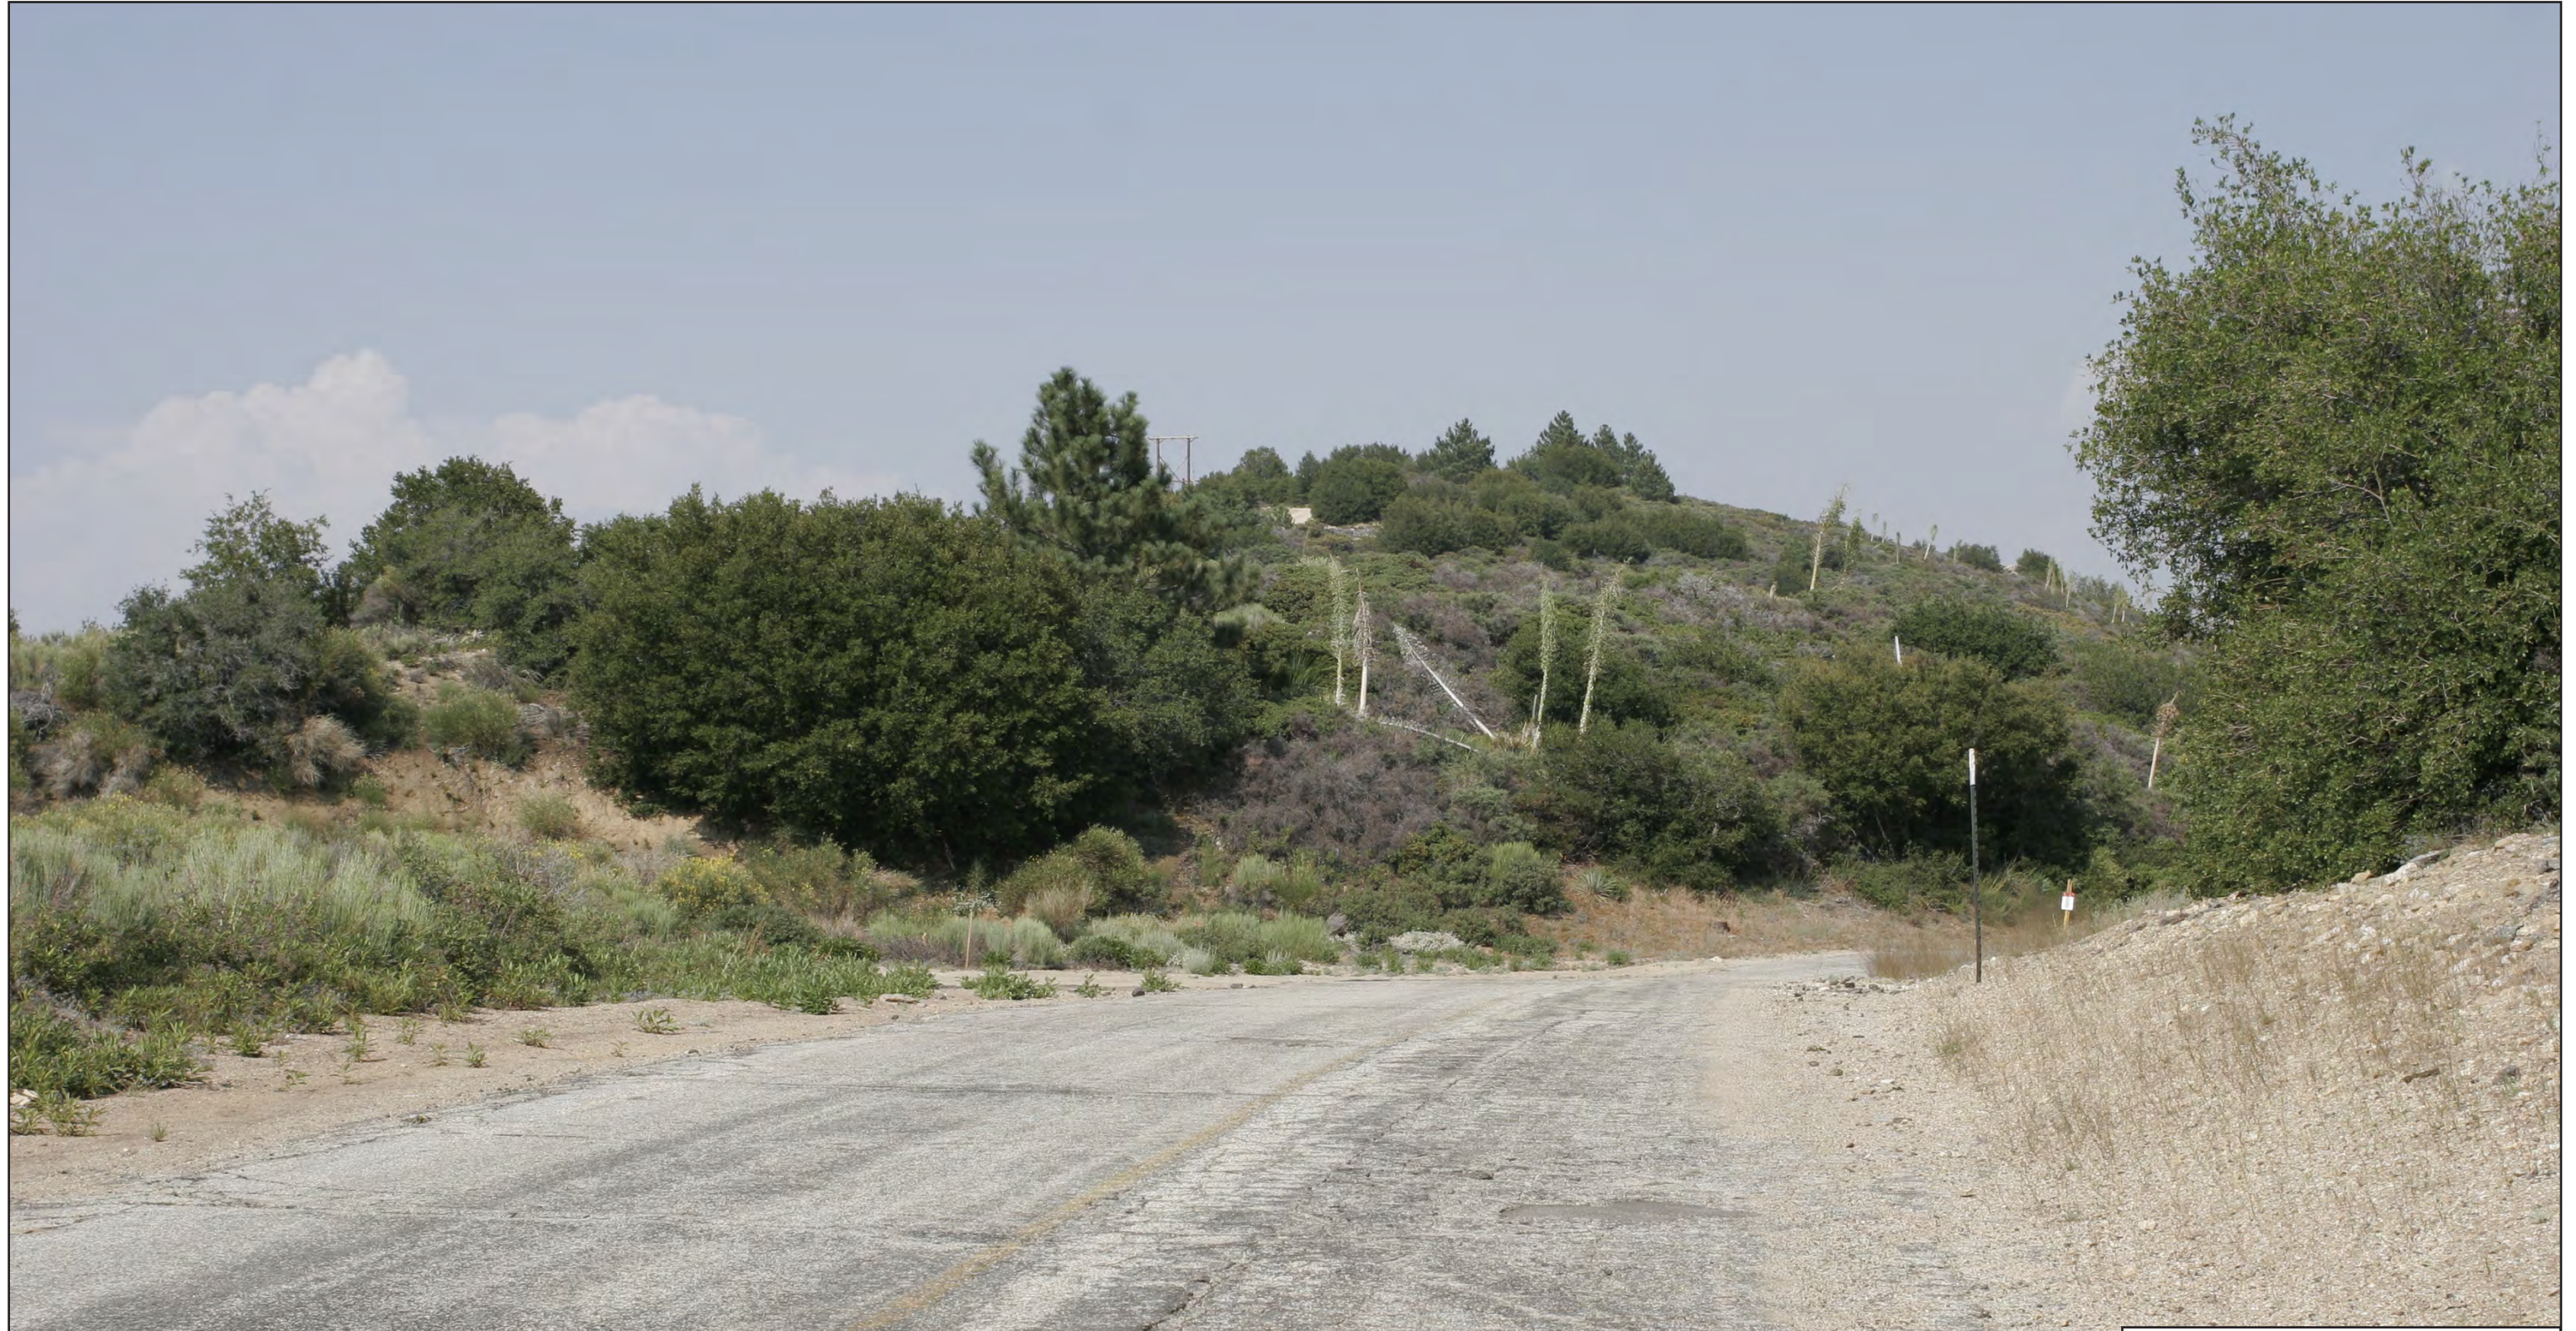
**Existing Scenic Integrity: High, with Areas of Borderline Moderate to Low.** The landscape visible from the Mount Gleason Road is predominantly natural-appearing, consisting of large-scale, panoramic views to middleground and background landscape, such as shown at KOP-Center-3. However, this is a foreground view toward the proposed Project's (Alternative 2) helicopter staging area and it does not show panoramic views; rather, it shows details in the landscape that are somewhat discordant. The dense, dark green brushfields are interrupted by cut and fill slopes of the road itself, and by an access road that follows along the ridgeline and powerline with wooden poles that interrupt the skyline. The natural landscape exhibits a moderate degree of intactness, or scenic integrity, except for the distinct manmade features: the power line with its H-frame wooden poles, and the cut and fill slopes with bare earth. These discordant features distract from the harmony of the natural form and character of the landscape and do not borrow form, line, color or texture from the natural-appearing landscape; therefore, this scene is on the borderline between moderate and low inherent scenic integrity.
