PACIFICORP'S MORRISON CREEK SUBSTATION PROJECT
MITIGATION MONITORING REPORT
CPUC A.07-07-018

Prepared for:
California Public Utilities Commission

November 2009

PacifiCorp has completed construction of the Morrison Creek Substation a 69 kilovolt (kV) to 12.5 kV distribution substation in northwest Del Norte County approximately one quarter mile southeast of the community of Smith River, California, and has removed the nearby Simonson Substation. The objective of the Project was to increase system reliability in order to continue safe and reliable electric service to customers in the area.

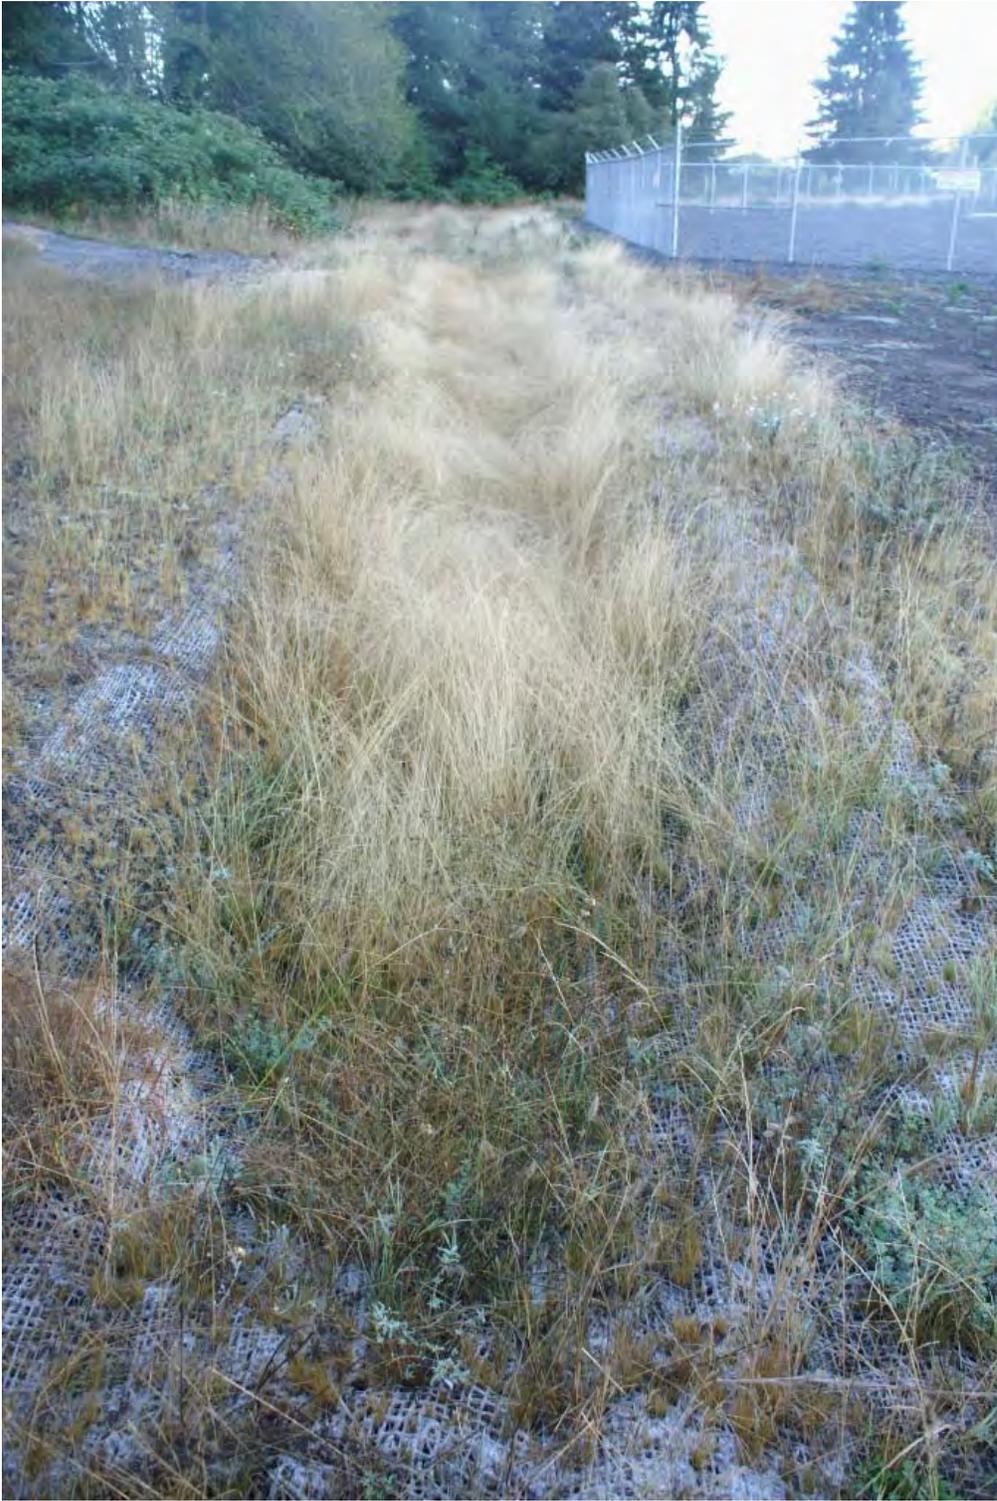
Pic0005

Pic 0005: Drainage channel with erosion control matting. Middle of channel is heavily grown in with annual grasses, likely from hydroseeding.

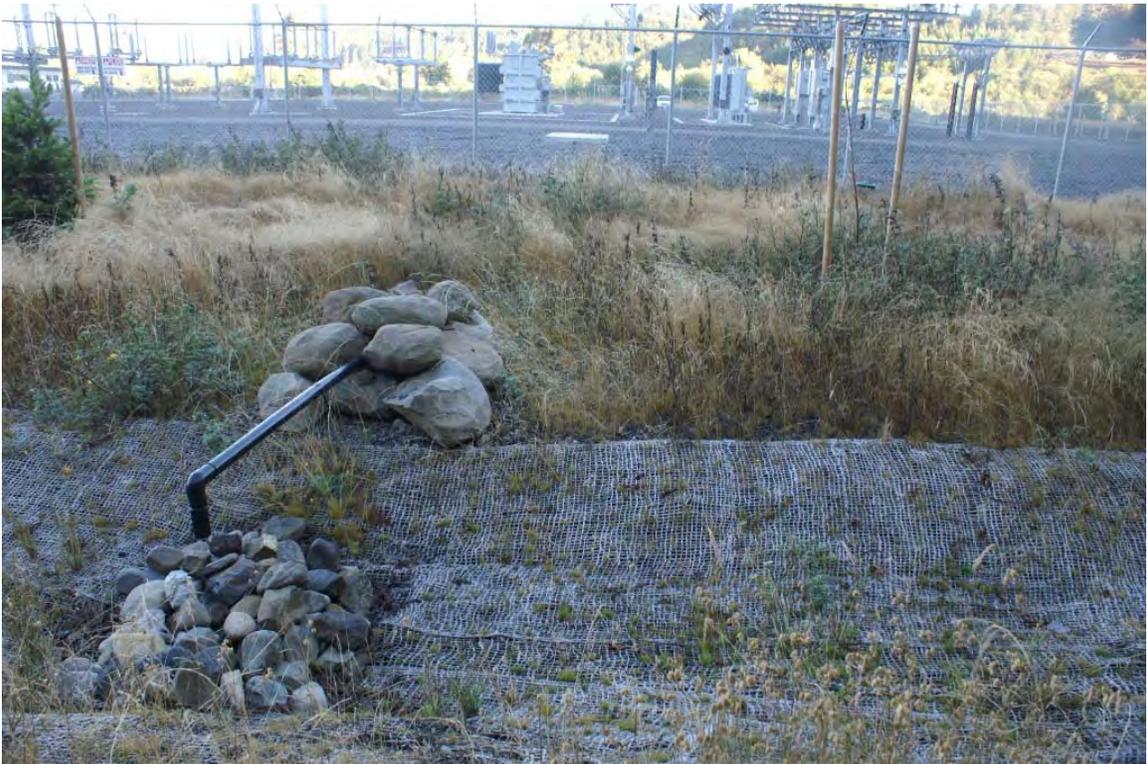
Pic0015

Pic 0015: Pipe draining water from substation site into drainage channel.

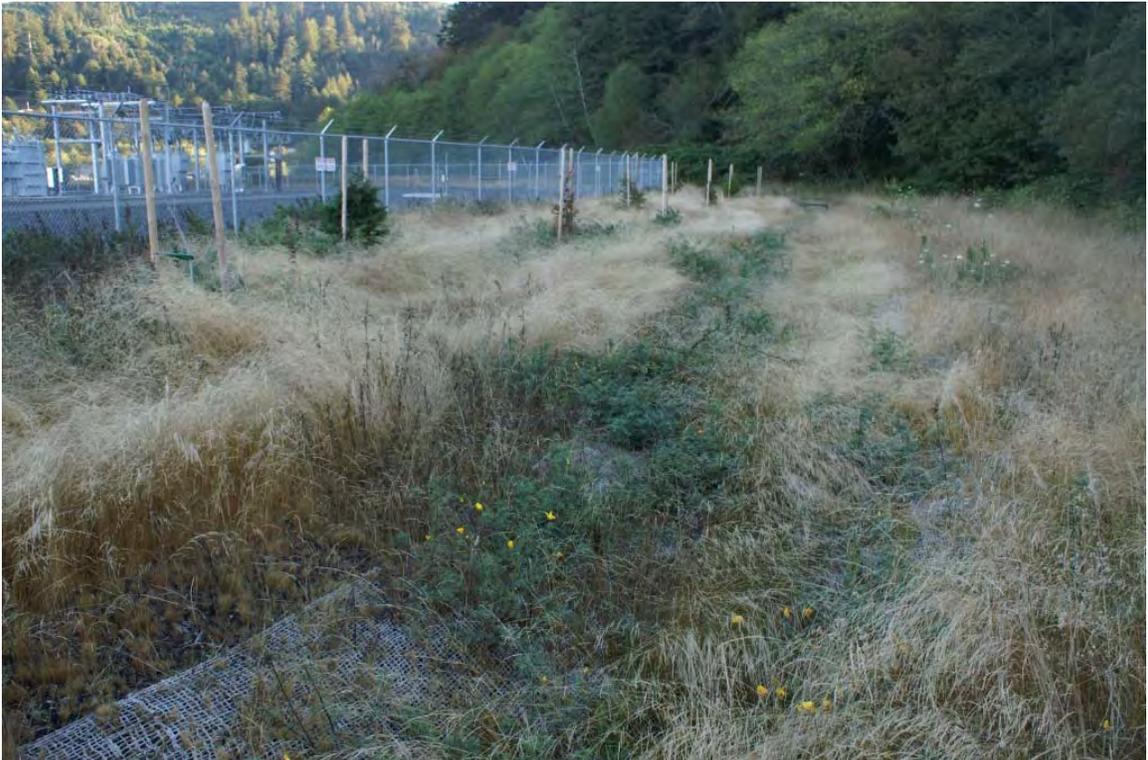
Pic0017

Pic 0017: Drainage channel along south side of substation.

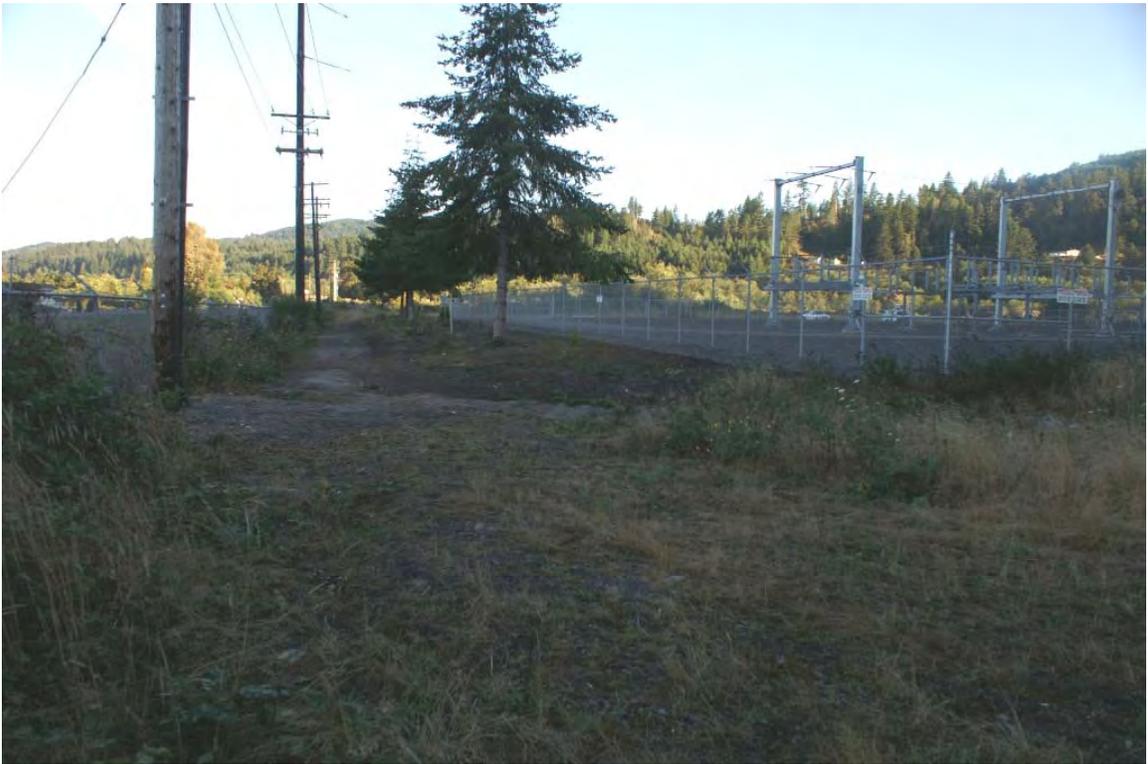
Pic0019

Pic 0019: Drainage channel outlet, landscaping, and existing trees on west side of substation parallel to Highway 101.

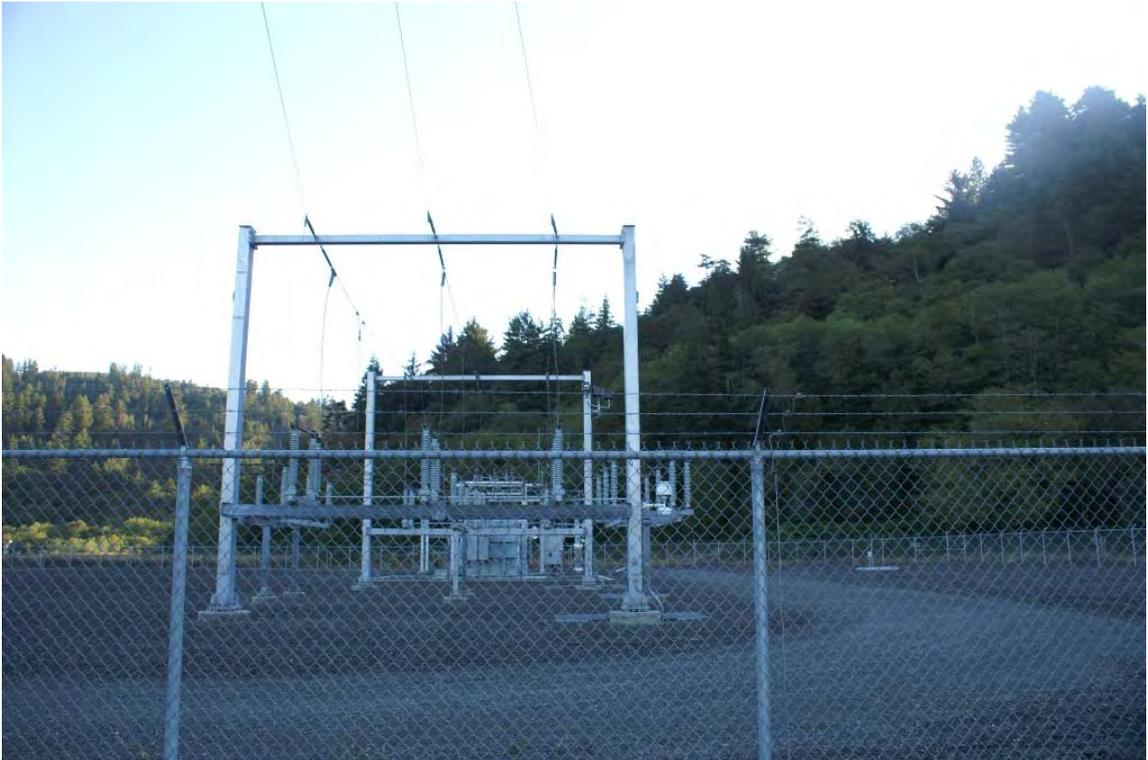
Pic0020

Pic 0020: Substation utilities from west side of substation looking east.

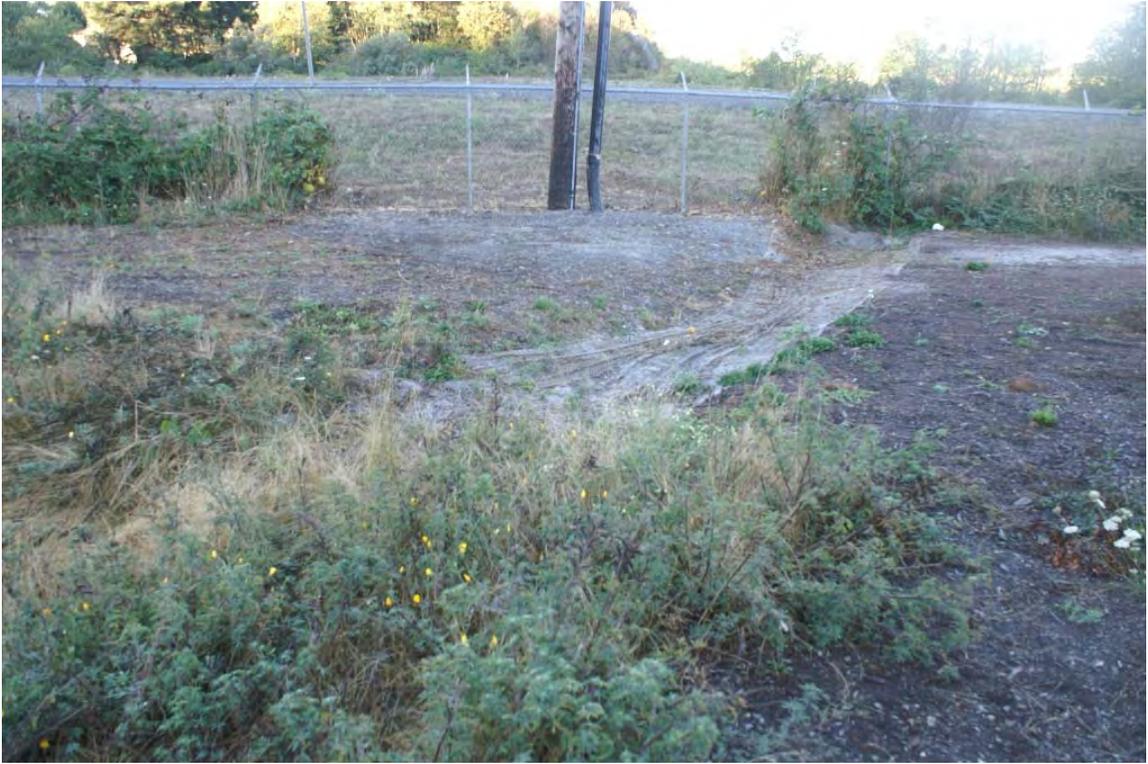
Pic0022

Pic 0022: Outlet of drainage channel to roadside culvert along Highway 101.

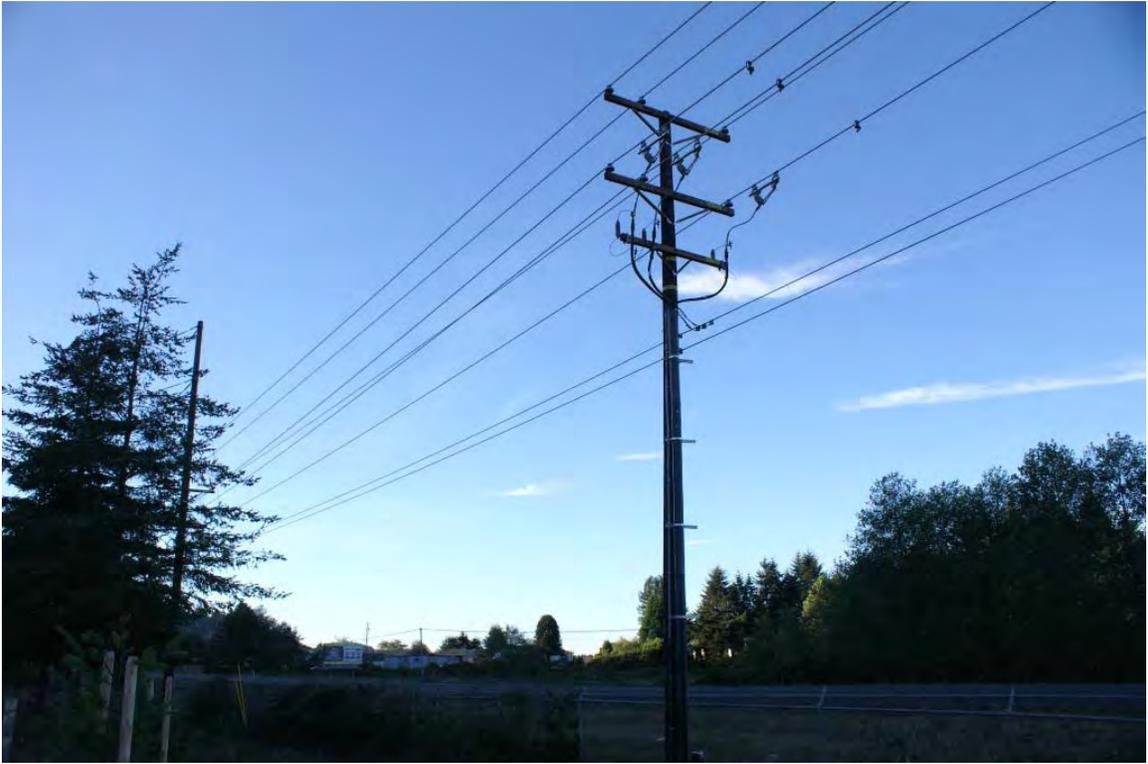
Pic0025

Pic 0025: New pole west of substation.

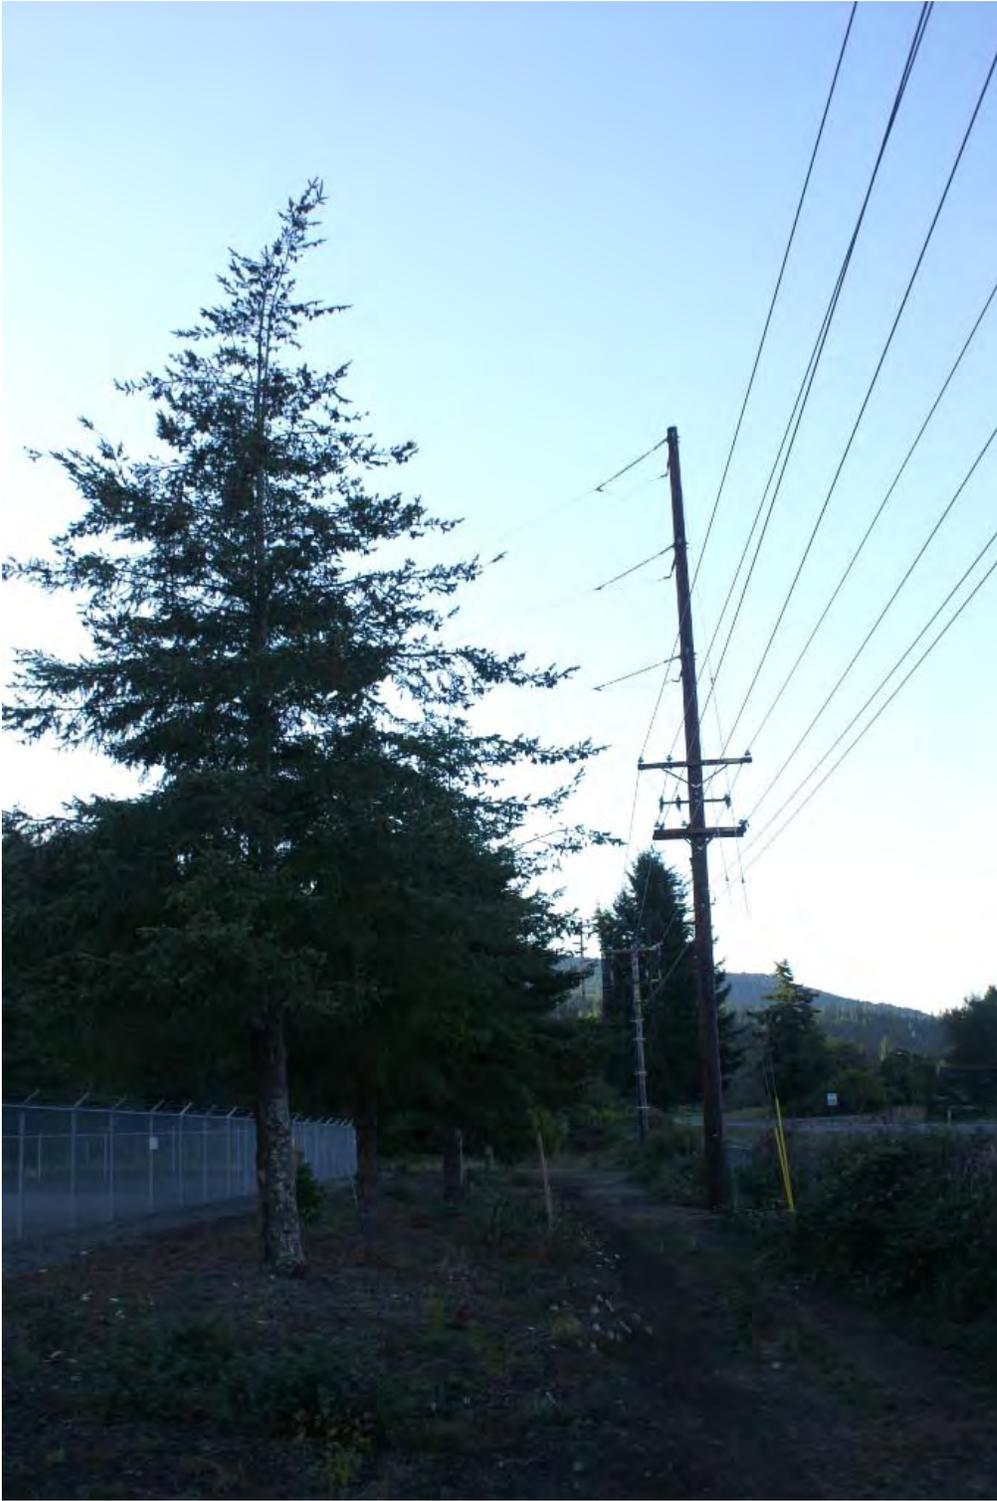
Pic0027

Pic 0027: New tapline connecting to substation, with previously existing tree in foreground.

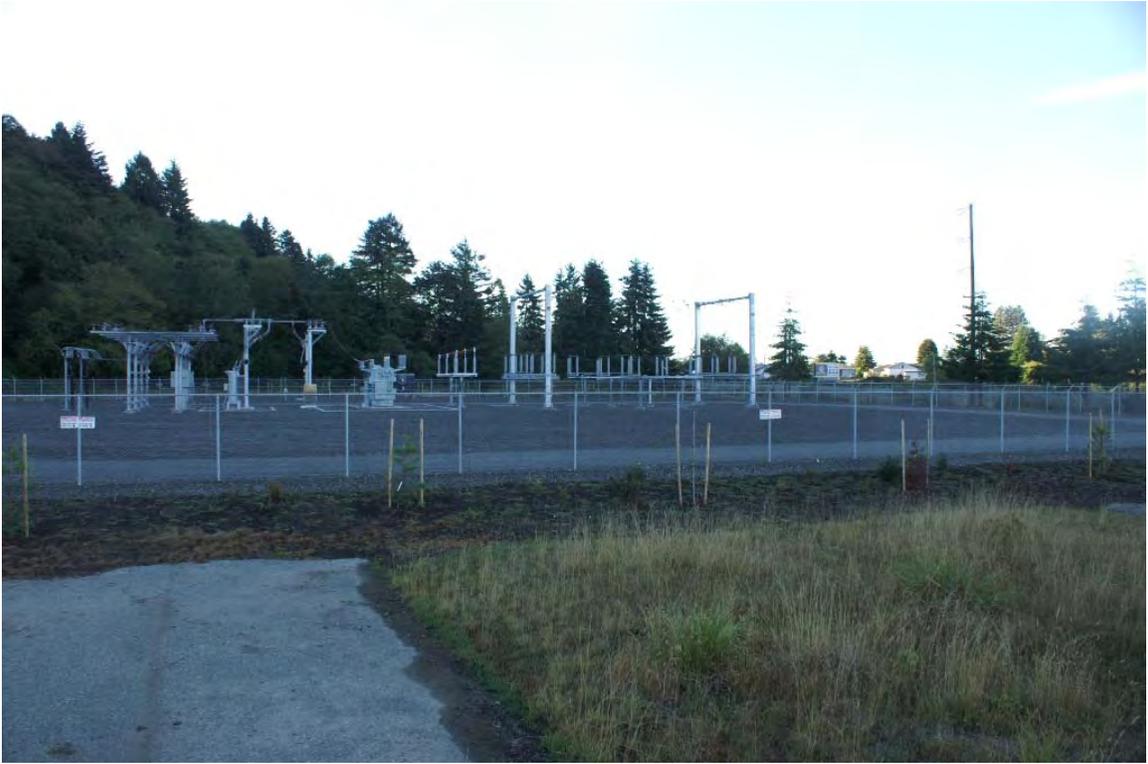
Pic0035

Pic 0035: Entire facility from the north side of the substation looking southwest.

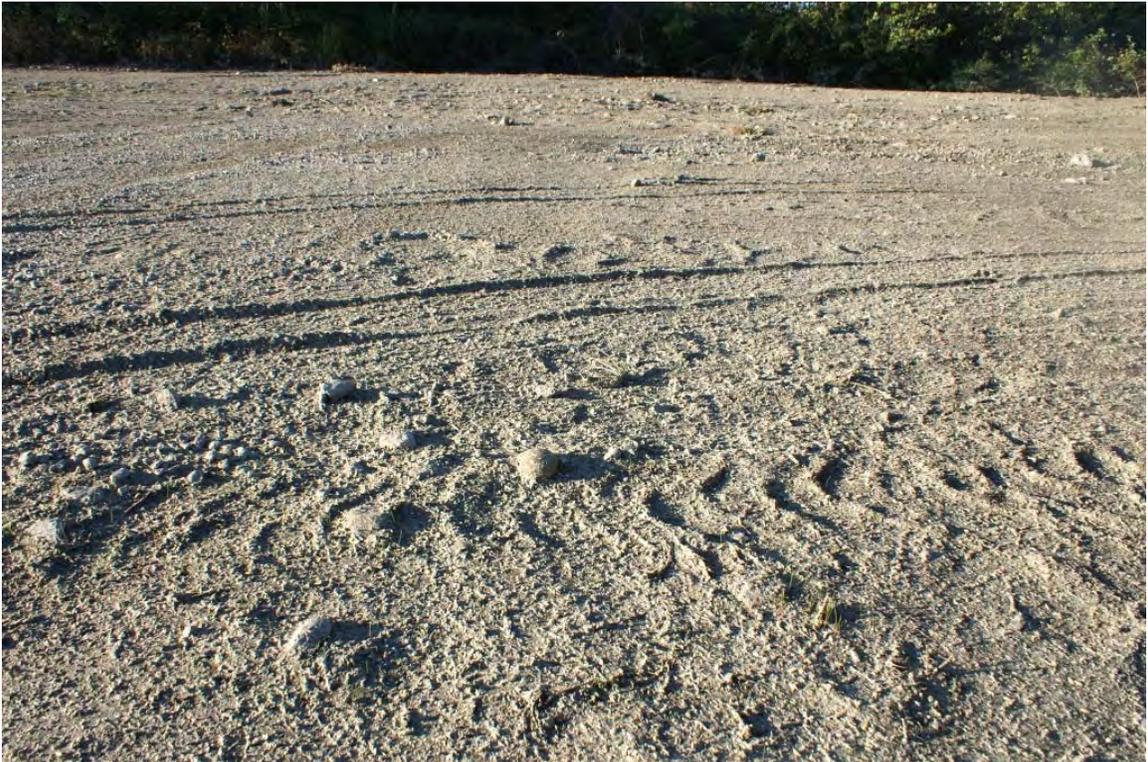
Pic0038

Pic 0038: Hydroseeding on previous site of Simonson Substation.

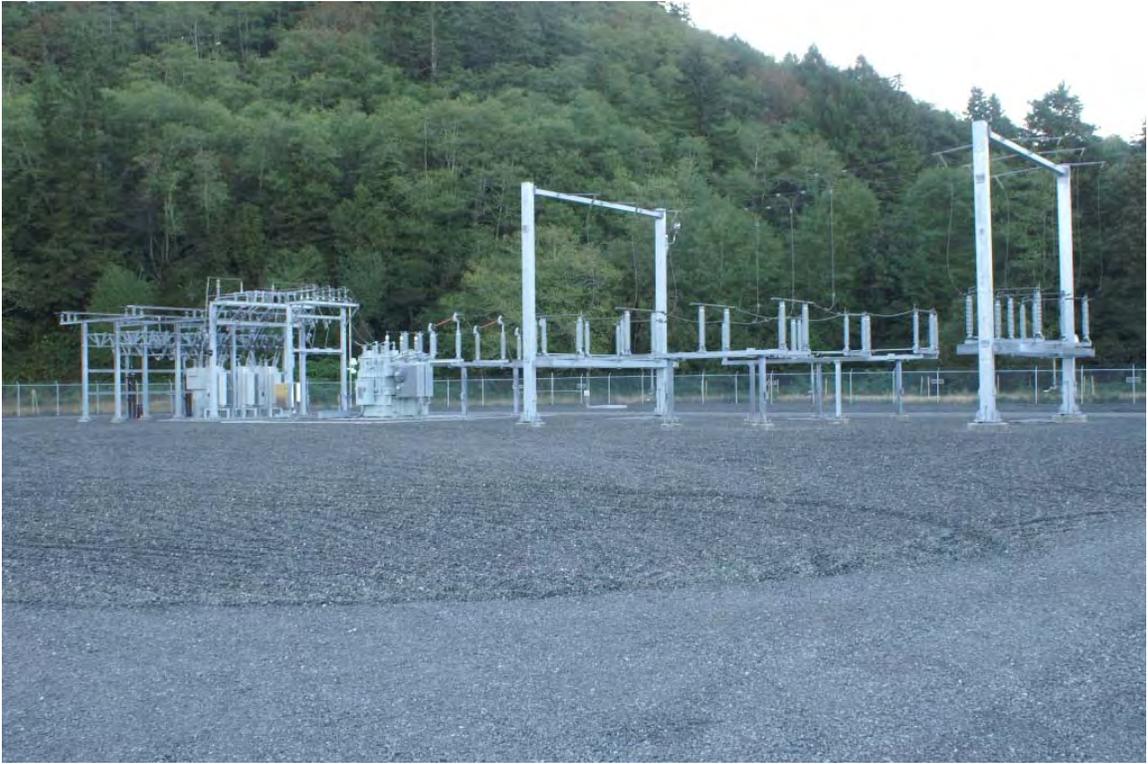
Pic0049

Pic 0049: Overall view of Morrison Creek Substation from inside gate, looking southeast.
