# **Accelerated Natural Gas Transmission System Aerial and Ground Leak Survey Trends Report**

**Pacific Gas and Electric Company**

February 1, 2011

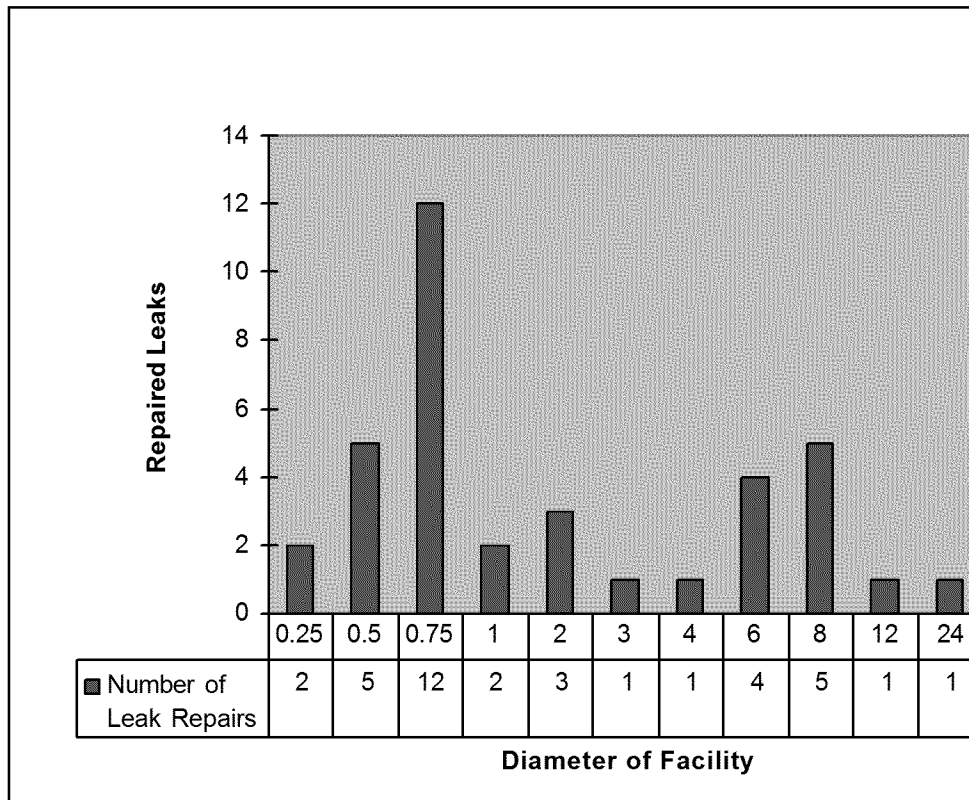
Figure 2 - Size of Facility

Reviewing the size of the facility where the leak occurs can provide insight on leaks where additional focus may be needed. Figure 2, below, includes all transmission/gathering leaks with the exception of leaks repaired by tightening, lubrication, or adjustment.

Note: Excludes the 16 leaks designated as leaks repaired by tightening, lubrication, or adjustment.

As shown by Figure 2 above, ninety-five percent of the leaks found and repaired (excluding the 16 leaks repaired by tightening, lubrication or adjustment) were on facilities less than 12 inches in diameter. Two leaks were found on facilities equal to or greater than 12 inches in diameter, as follows:
