Docket: : R.11-02-019
Exhibit Number : DRA-13
Commissioner : Florio
ALJ : Bushey
Witness : Rondinone

**DIVISION OF RATEPAYER ADVOCATES
CALIFORNIA PUBLIC UTILITIES COMMISSION**

**DRA REBUTTAL TESTIMONY
ON THE
PIPELINE SAFETY ENHANCEMENT PLAN OF
PACIFIC GAS AND ELECTRIC COMPANY**

Treatment of Electric Welded (EW) Pipe

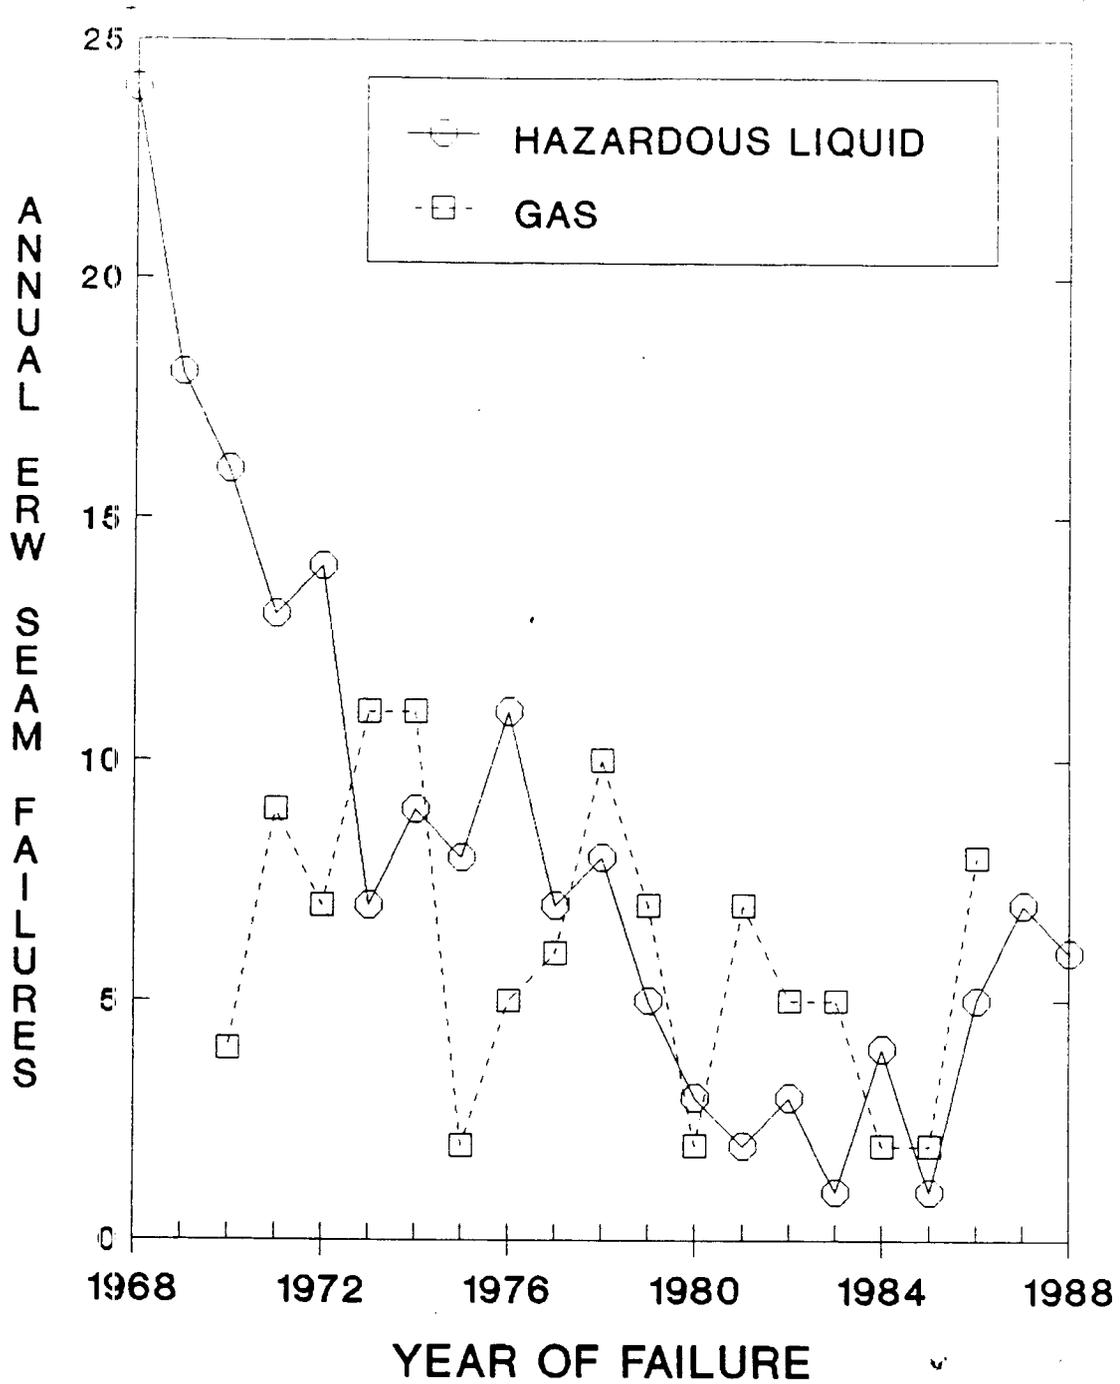
Figure 1. Annual Number of ERW Seam Failures in Hazardous Liquid Transmission Lines and Natural Gas Gathering and Transmission Lines During the Period 1968-1988 (15).

The data do not allow strict statistical analysis, but the values for HL, Table 4, indicate that the total number of failures per year was initially large and then decreased to an approximately constant value of about 5 failures per year. This trend is shown graphically in Figure 1. This effect is not evident for NG, Table 5 and Figure 1, where the total number of failures per year fluctuates about an average value of about 6 failures per year. The reason for the initially decreasing trend for HL pipelines over the period 1968 to 1978 is not known.

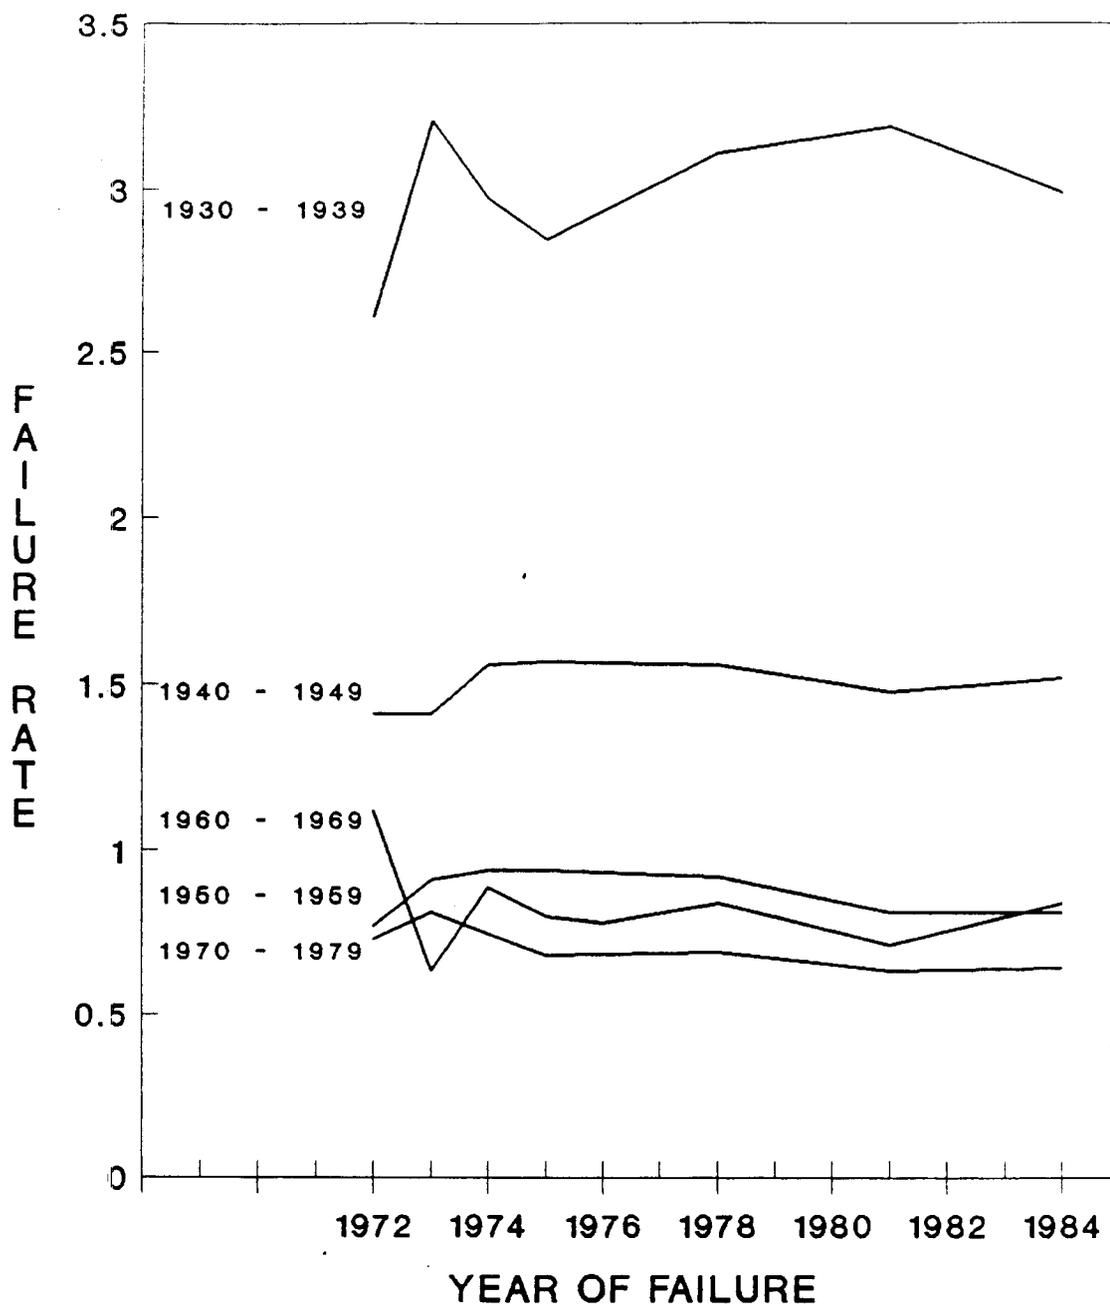
Figure 2. Annual Rates of Failure (number per year per 1000 miles of pipeline) in Natural Gas Gathering and Transmission Pipelines for the Period 1970-1984 Classified by Decade of Construction (16).

The Battelle report on NG pipelines (16) used mileage data similar to those of Table 3 to determine failure rate as a function of construction decade and incident year. Their findings, summarized graphically in Figure 2, show two important points:

- (1) Pipelines constructed in the 1930s and 1940s have significantly higher failure rates than those installed in the 1950s, 1960s and 1970s, the latter showing little differences. The fact that these older pipes show larger failure rates is worthy of attention, but is offset by the relatively small mileage installed in these decades, Table 3, and by the fact that many are being replaced (19).
- (2) As in the case of ERW seam failures, Section 4.2.3, it is somewhat surprising that the failure rate in the period 1970-1984 is essentially constant with incident year for each of the five decades represented in Figure 2. There is no evidence for an aging effect in these data.

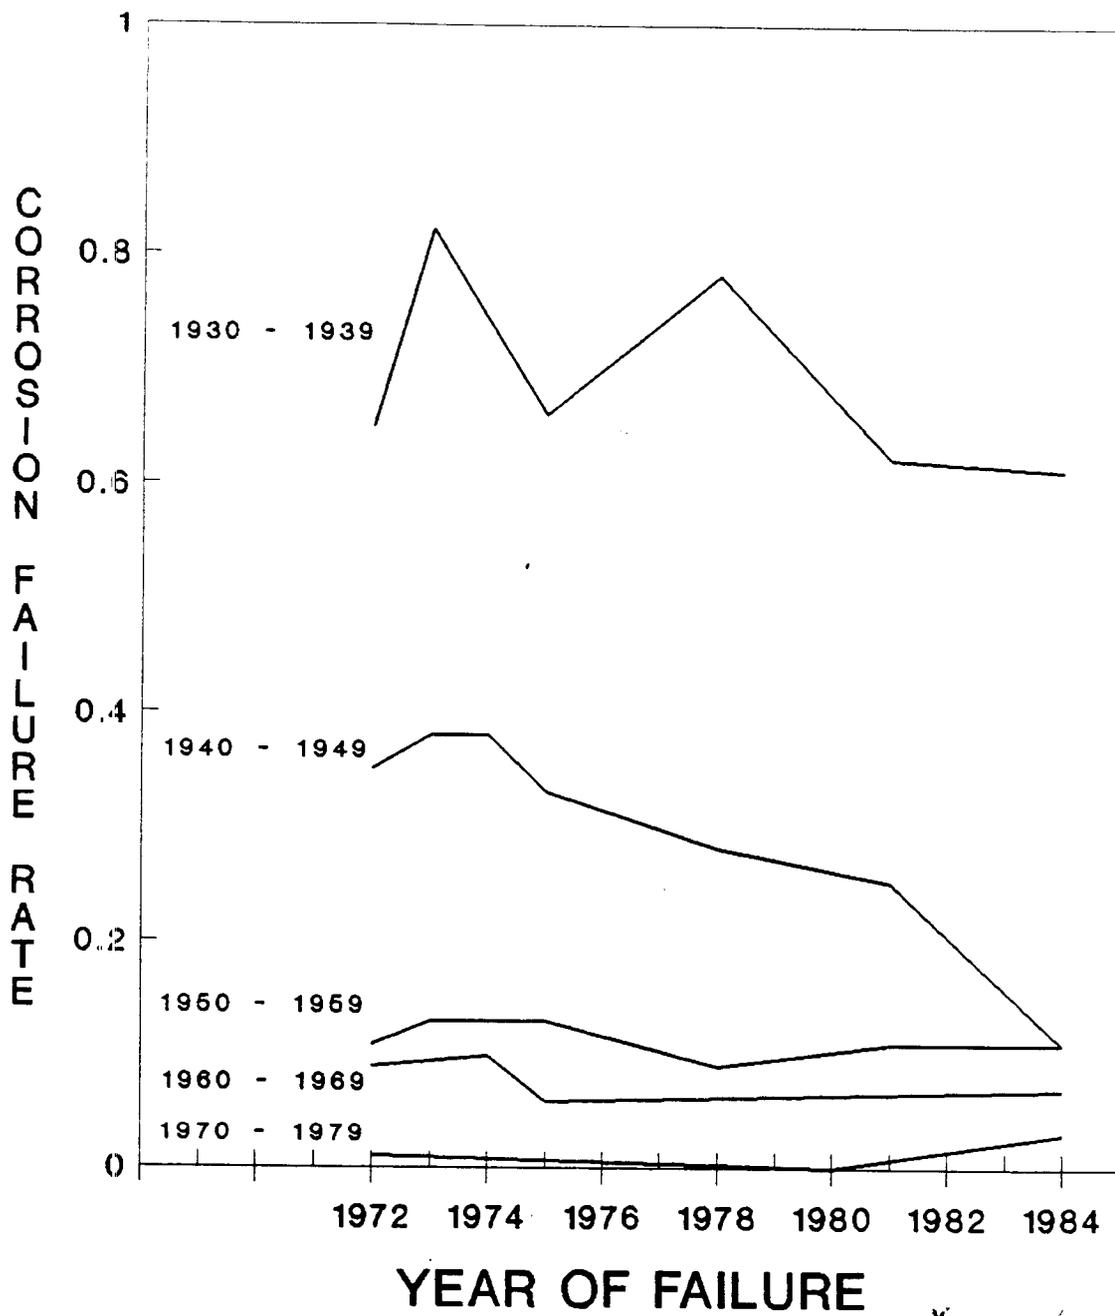
Figure 3. Annual Rates of Corrosion Failures (number per year per 1000 miles of pipeline) in Natural Gas Gathering and Transmission Lines for the Period 1970-1984 Classified by Decade of Construction (16).

Corrosion can be seen to have represented a major cause of failures in NG, Table 7, and HL, Table 8. In addition to the relatively small number of failures resulting from preferential attack at ERW seam welds, it is assumed that these failures stem from wall thinning due to uniform corrosion, and perforation due to localized forms such as pitting, stress corrosion cracking and hydrogen embrittlement (17). However, continued improvements have been made in corrosion protection over the past decade, including the mandatory use of coatings and cathodic protection, and there is evidence in the Battelle study (16) that these measures are having a major beneficial effect. Thus, Figure 3, taken from that report, demonstrates that the rates of failure due to corrosion have decreased markedly over the decades from 1930-1979, and that the rate for the 1970's is very small. Moreover, the failure rate for each decade shows no significant increase with time, again indicating that no aging effects are discernible.

These data suggest that the corrosion problem in pipelines, in general, is being effectively combatted. However, it can be seen in Figure 3 that, with the exception of the 1940s, there is no evidence that the failure rate in each decade is decreasing with time. This would suggest that the most current methods of protection and monitoring are not being effectively retrofitted, despite the regulatory requirements (20,21). Thus, as the Transportation Research Board report (18) emphasized, there is a need to sustain and extend our advances in corrosion control. This has particular relevance to older ERW pipe, as indicated in Section 5.0.
