Stipulations of Fact

San Bruno OII – I.12-01-007, Recordkeeping OII – I.11-02-016,
and Class Location OII – I.11-11-009

Pacific Gas and Electric Company (PG&E) stipulates that the following facts are true and accurate:

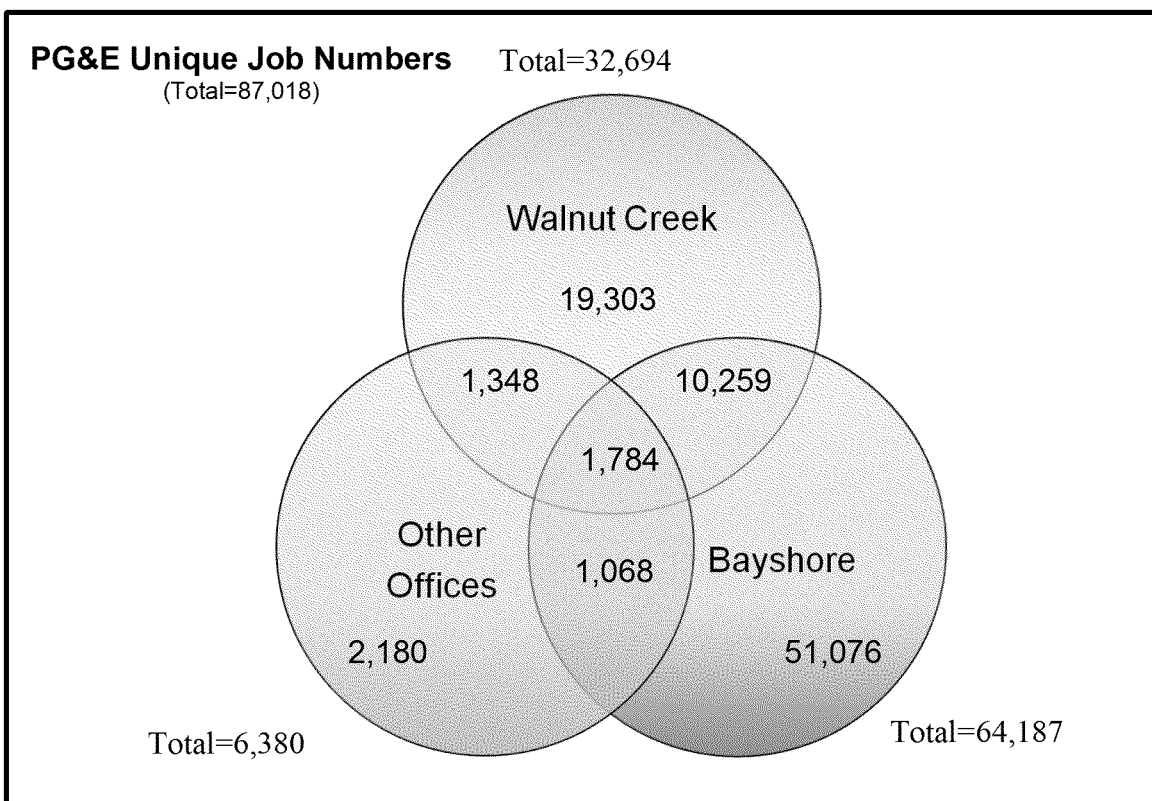
526. More than one year after PG&E began its MAOP Records Validation Project it still had approximately 875 boxes in Emeryville containing an unknown number of job folders to be processed and inventoried. (CPSD DR 25, A1)
527. In February 2012, PG&E's Emeryville data catalog showed 146,227 job folder records relating to 87,018 unique job numbers. (Ex. 6, p. 6-70)
528. As of February 2012, out of the 87,018 unique job numbers defined in PG&E's Emeryville Data Catalog, the following Venn Diagram shows where each of the job folders was originally stored.

- 51,076 (58.7%) jobs were stored in Bayshore only.
- 19,303 (22.2%) jobs were stored in Walnut Creek only.
- 10,259 (11.8%) jobs were stored in Walnut Creek and Bayshore.
- 2,180 (2.5%) jobs were stored in other offices only (not in Walnut Creek or Bayshore or both).
- 1,784 (2.1%) jobs were stored in Walnut Creek, Bayshore and at least one other office.

- f. 1348 (1.5%) jobs were stored in Walnut Creek and at least one other office (excluding Bayshore).
 - g. 1068 (1.2%) jobs were stored in Bayshore and at least one other office (excluding Walnut Creek).
(Exhibit 2, p. 6-63)
