Golden Gate Region Gas Department  
**Seismic Study of Gas Transmission Lines**  
**Project Review Meeting**  
**Phase 1 Results**

# Seismic Study of Gas Transmission Lines for Golden Gate Region Gas Department

**POTENTIAL GEOLOGIC HAZARDS FOR GAS PIPELINES  
ALONG THE SAN FRANCISCO PENINSULA CORRIDORS**

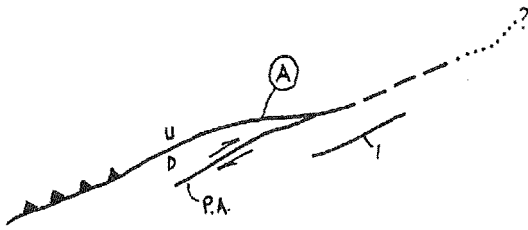
## FAULTS

Historically active fault, dashed where approximately located ( $\pm 100$  ft), dotted where covered or concealed, queried where existence uncertain. Paired arrows show sense of strike slip displacement; U = up, D = down; saw teeth of upper plate on thrust fault.
