*San Diego Gas & Electric Company
Performance Category Upgrade Request
for
Imperial Valley – Miguel 500 kV and
Imperial Valley – Central 500 kV*

<p>December 19, 2007</p>	<p>Performance Category Upgrade Request for Imperial Valley - Miguel 500 kV and Imperial Valley - Central 500 kV</p> <p>Double Line Outage Probability Analysis Seven Step Process Document</p> <p>Final Report</p> <p>Prepared By</p> <p>San Diego Gas & Electric Transmission Planning</p>
--------------------------	--

Appendix F

Alternative Path Analysis

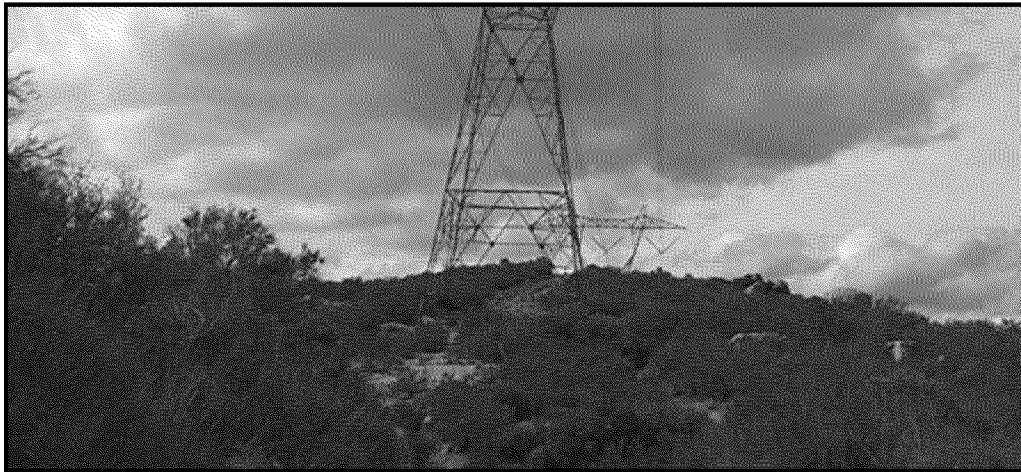
Land patrols are performed once every three years and aerial patrols are performed twice a year. The frequency of patrols would aid in the prevention of flashovers that could occur due to vegetation. An example of the typical vegetation through the alternative path is shown below.

Figure 19 - Chaparral Example

Tower 50095, as shown above, occurs in Segment 2 of the alternative path. The separation between this tower and the Imperial Valley – Miguel line is approximately 4 miles at this location. In extreme wind and fire situations, it is possible that the fire could spread to both lines causing an outage. Additional pictures of the towers as well as pictures of the surrounding area can be found in Appendix H.
