Subject: Root Cause Analysis of Fatal Injury at Kern Power Plant
2401 Coffee Road
Bakersfield, California

Bureau Veritas North America, Inc., Health Safety and Environmental Services, is pleased to provide you with a copy of the Root Cause Analysis of Fatal Injury report from the Kern Power Plant facility at 2401 Coffee Road, Bakersfield, California, 93301.

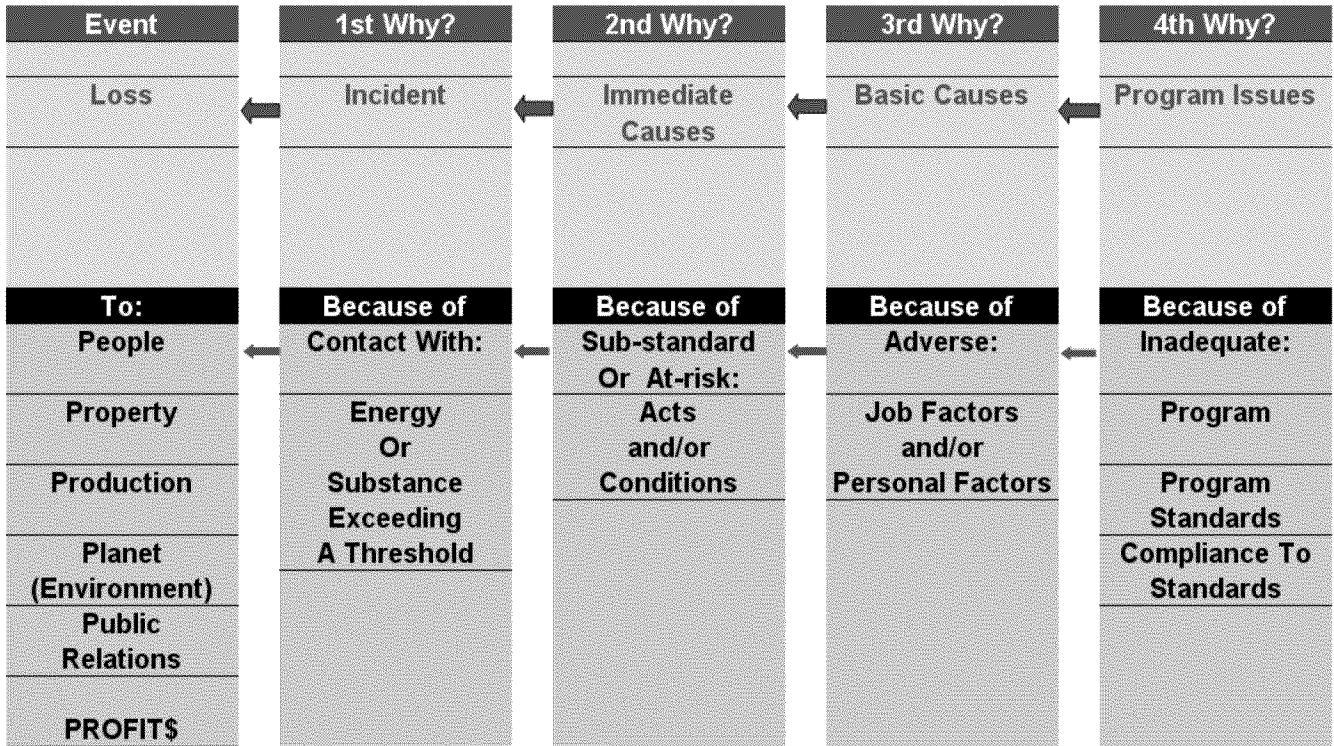
APPENDIX A
LOSS CAUSATION MODEL - USING “WHY?” ANALYSIS

LOSS CAUSATION MODEL* USING "WHY?" ANALYSIS

*Reference: Redacte Modified ILCI Loss Causation Model
