**Re: 2015 Annual Electric Distribution Reliability Report, D. 16-01-008**

Pursuant to the California Public Utilities Commission ("Commission") Decision ("D.") 16-01-008, "Updating the Annual Electric Reliability Reporting Requirements for California Electric Utilities," Bear Valley Electric Service (BVES) submits herewith its 2015 Annual Electric Distribution Reliability Report (Report).

BVES provides electric service to approximately 24,000 customers in the mountain resort community of Big Bear Lake, California. BVES owns and operates 34.25 miles of overhead 34.5 kilovolt sub-transmission miles, 1.4 miles of 34.5 kilovolt underground sub-transmission miles, 92 miles of overhead distribution circuit miles, 7.25 miles of underground distribution circuit miles, 13 sub-stations and a natural gas-fueled 8.4 MW peaking generation facility. The BVES service area is rural and mountainous and is served predominantly from overhead facilities.

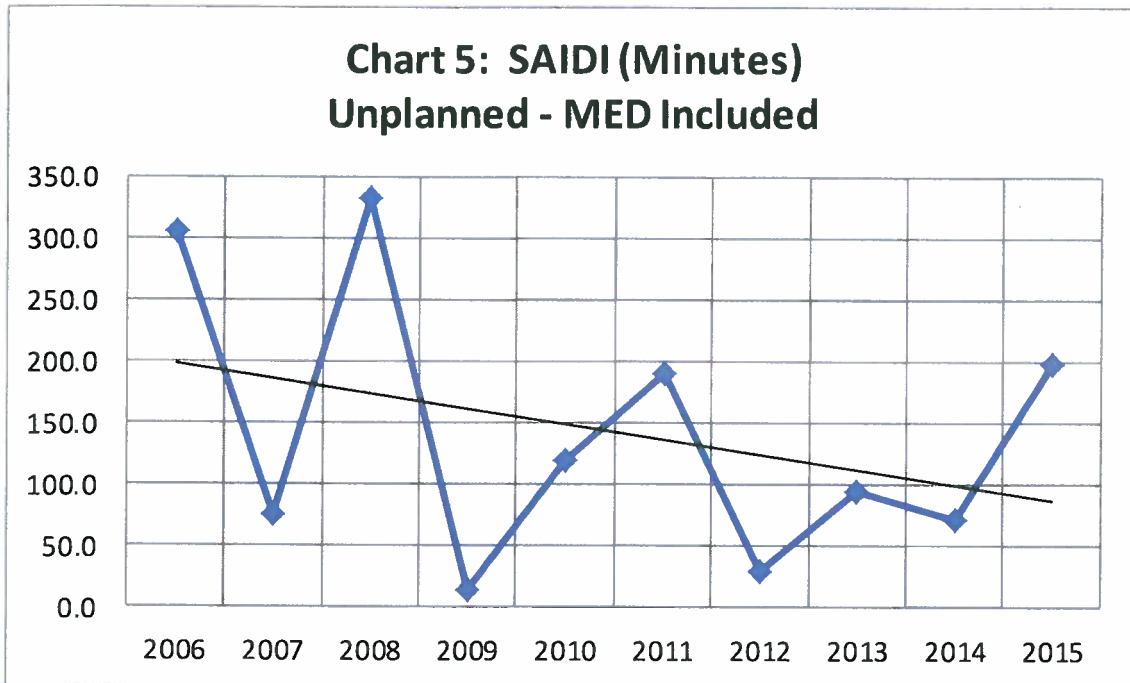
Charts 5 through 8 provide line graphs of SAIDI, SAIFI, MAIFI and CAIDI for the past 10 years with linear trend line (MED Included).
