Figure 3.14-18a
Existing Conditions
for KOP-Center-3
Mount Gleason Road
(Alternative 2, Segment 6)

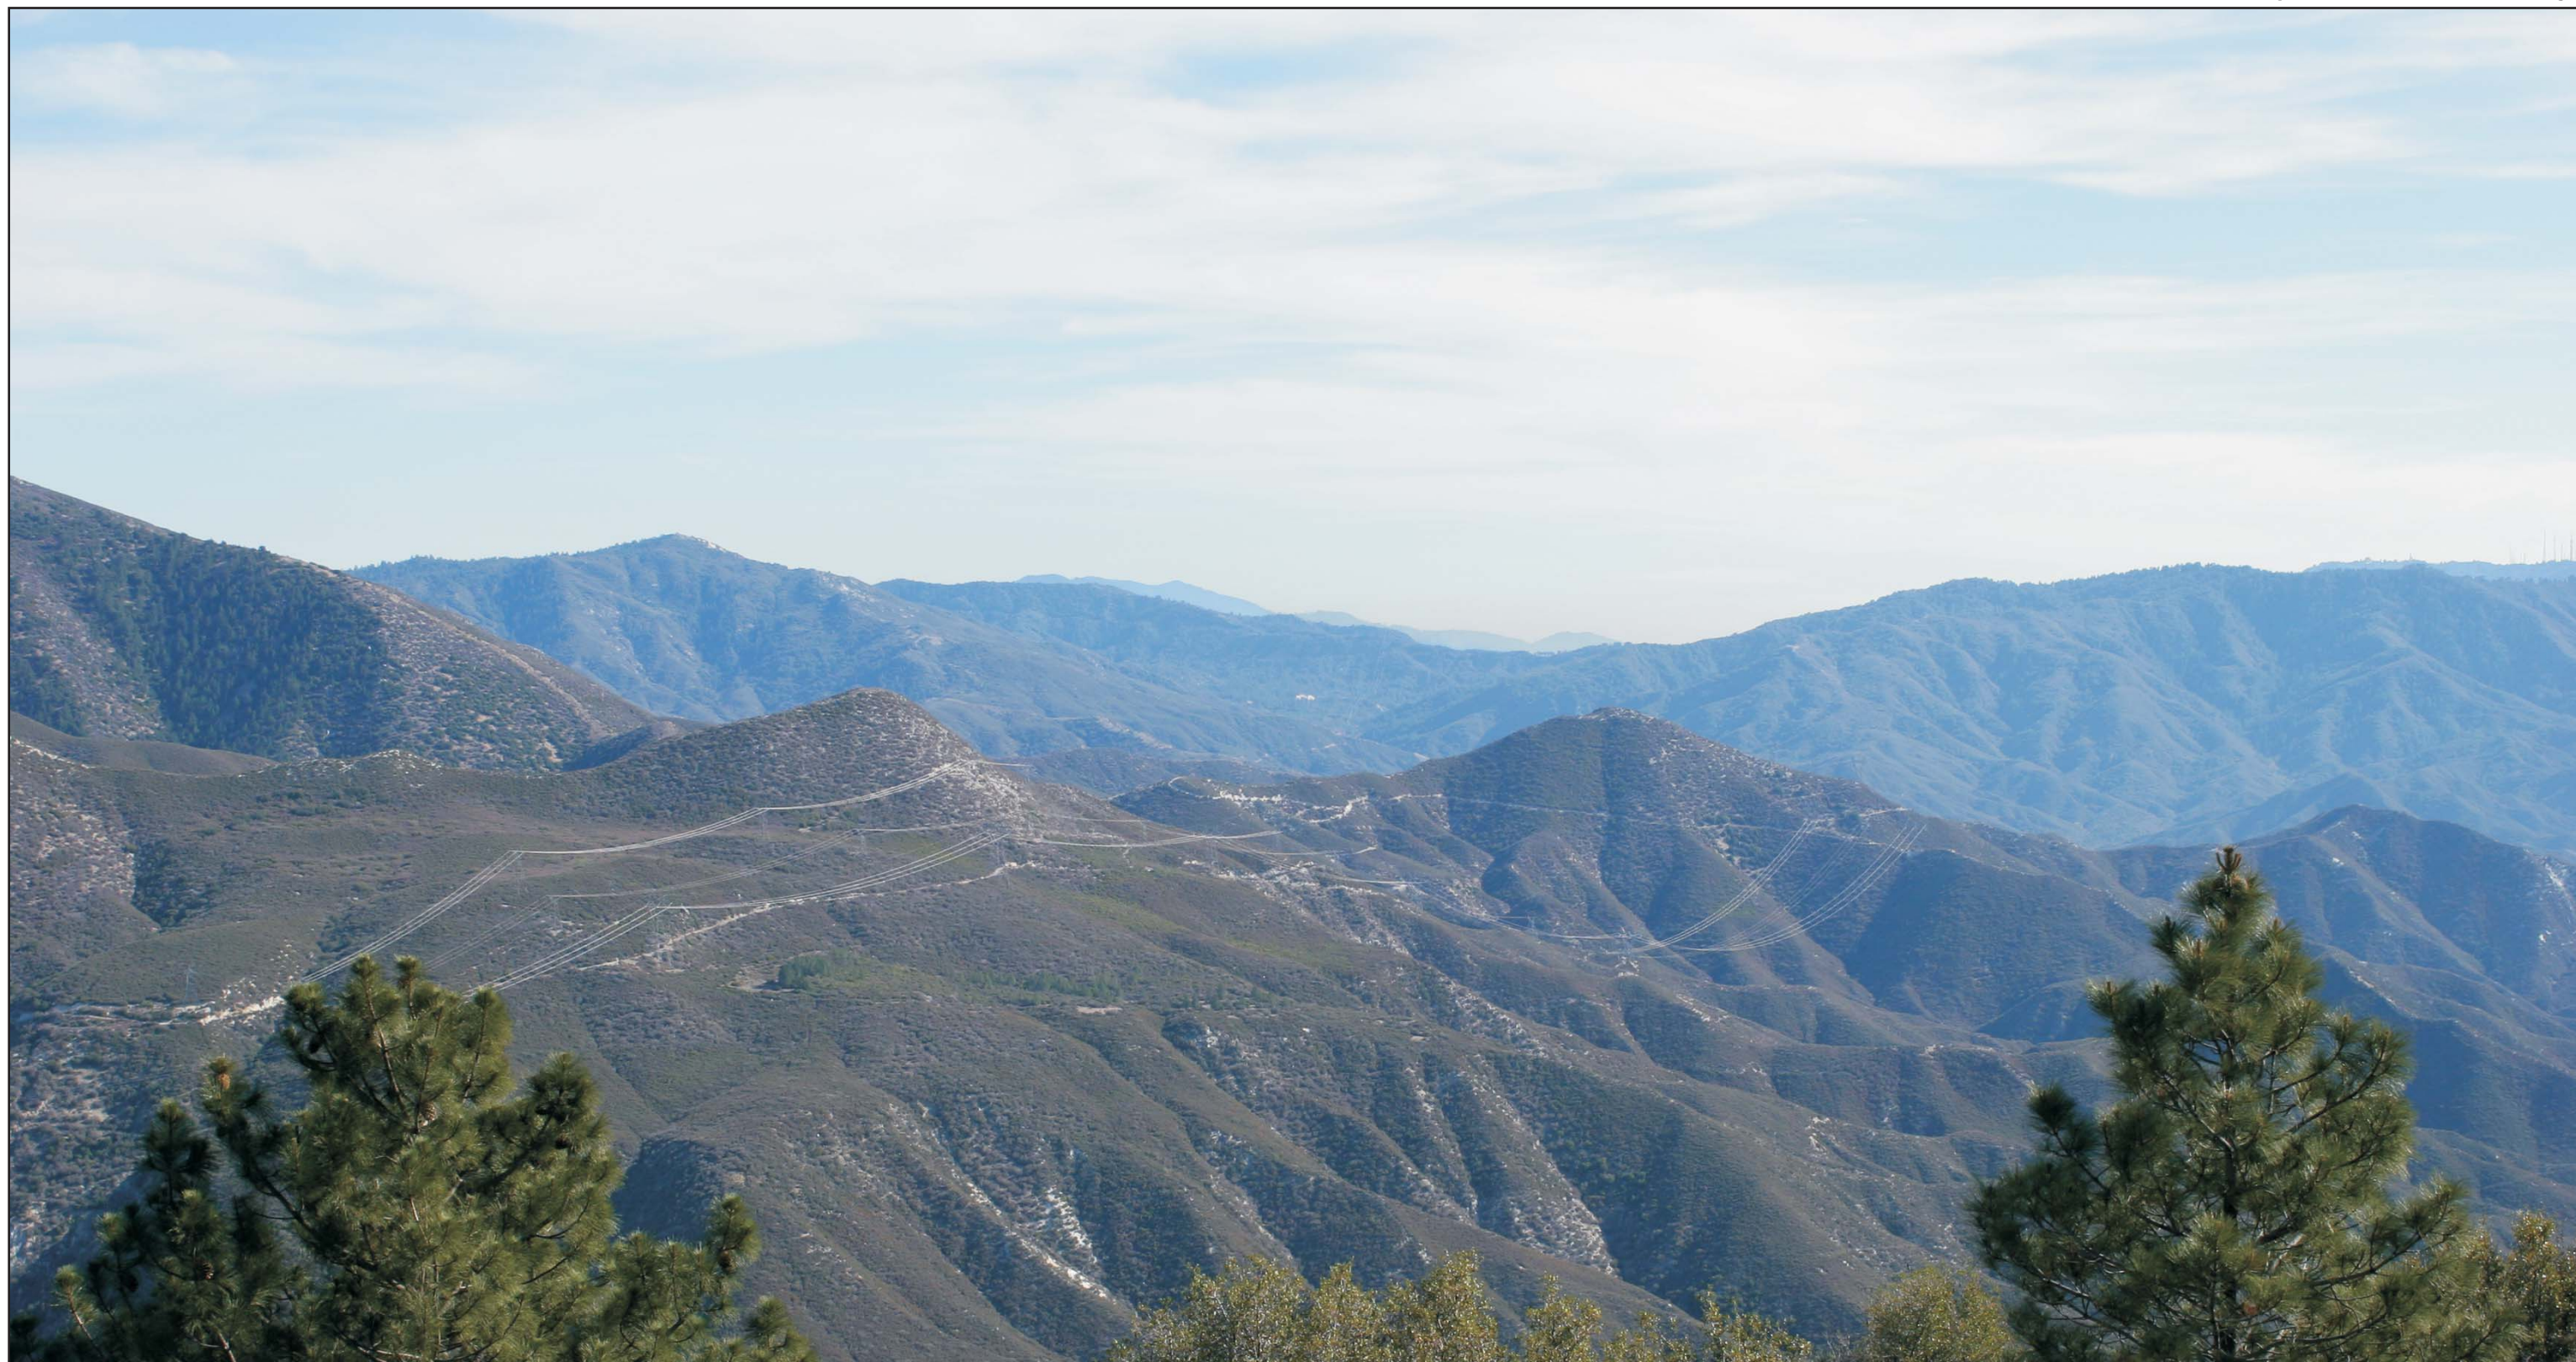
Existing Scenic Integrity: High, with Areas of Very Low. This existing landscape view is from the Mount Gleason Road, about three miles west of Mill Creek Summit, looking southeast down toward Segment 6. The PCT, west of Mill Creek Summit, shares much of this same viewshed. The landscape visible from Mount Gleason Road is predominantly natural-appearing, consisting of foreground, middleground, and background landscapes with dense, dark green chamise and chaparral covered mountainsides. There is very little vegetative pattern in this landscape and the sun angle and shadows emphasize the ruggedness of the steep slopes and broken terrain. The natural landscape has a coherent form and character with substantial visual variety created by the rugged, folded terrain. The natural landscape exhibits a high degree of intactness and scenic integrity, except for the highly discordant transmission line conductors that glow with reflected sunlight, leading the eye to the almost transparent, industrial-character steel lattice towers. Access and spur roads to the existing towers are visually evident and further emphasize the reflectivity of the conductors, causing the valued landscape character to appear heavily altered. This leads to a rating of very low scenic integrity for the utility corridor.

Scenic Integrity Objective: High. In the 2005 Forest Plan, the entire landscape in this vicinity is mapped as High SIO, where the management direction states that human activities should not be visually evident. Human-caused deviations may be present but must repeat the form, line, color, texture, and pattern common to the natural landscape character so completely and at such a scale that they are not evident.
