Figure 3.14-19a
Existing Conditions
for KOP-Center-4
Southbound Angeles
Forest Highway
(Alternative 2, Segment 6)

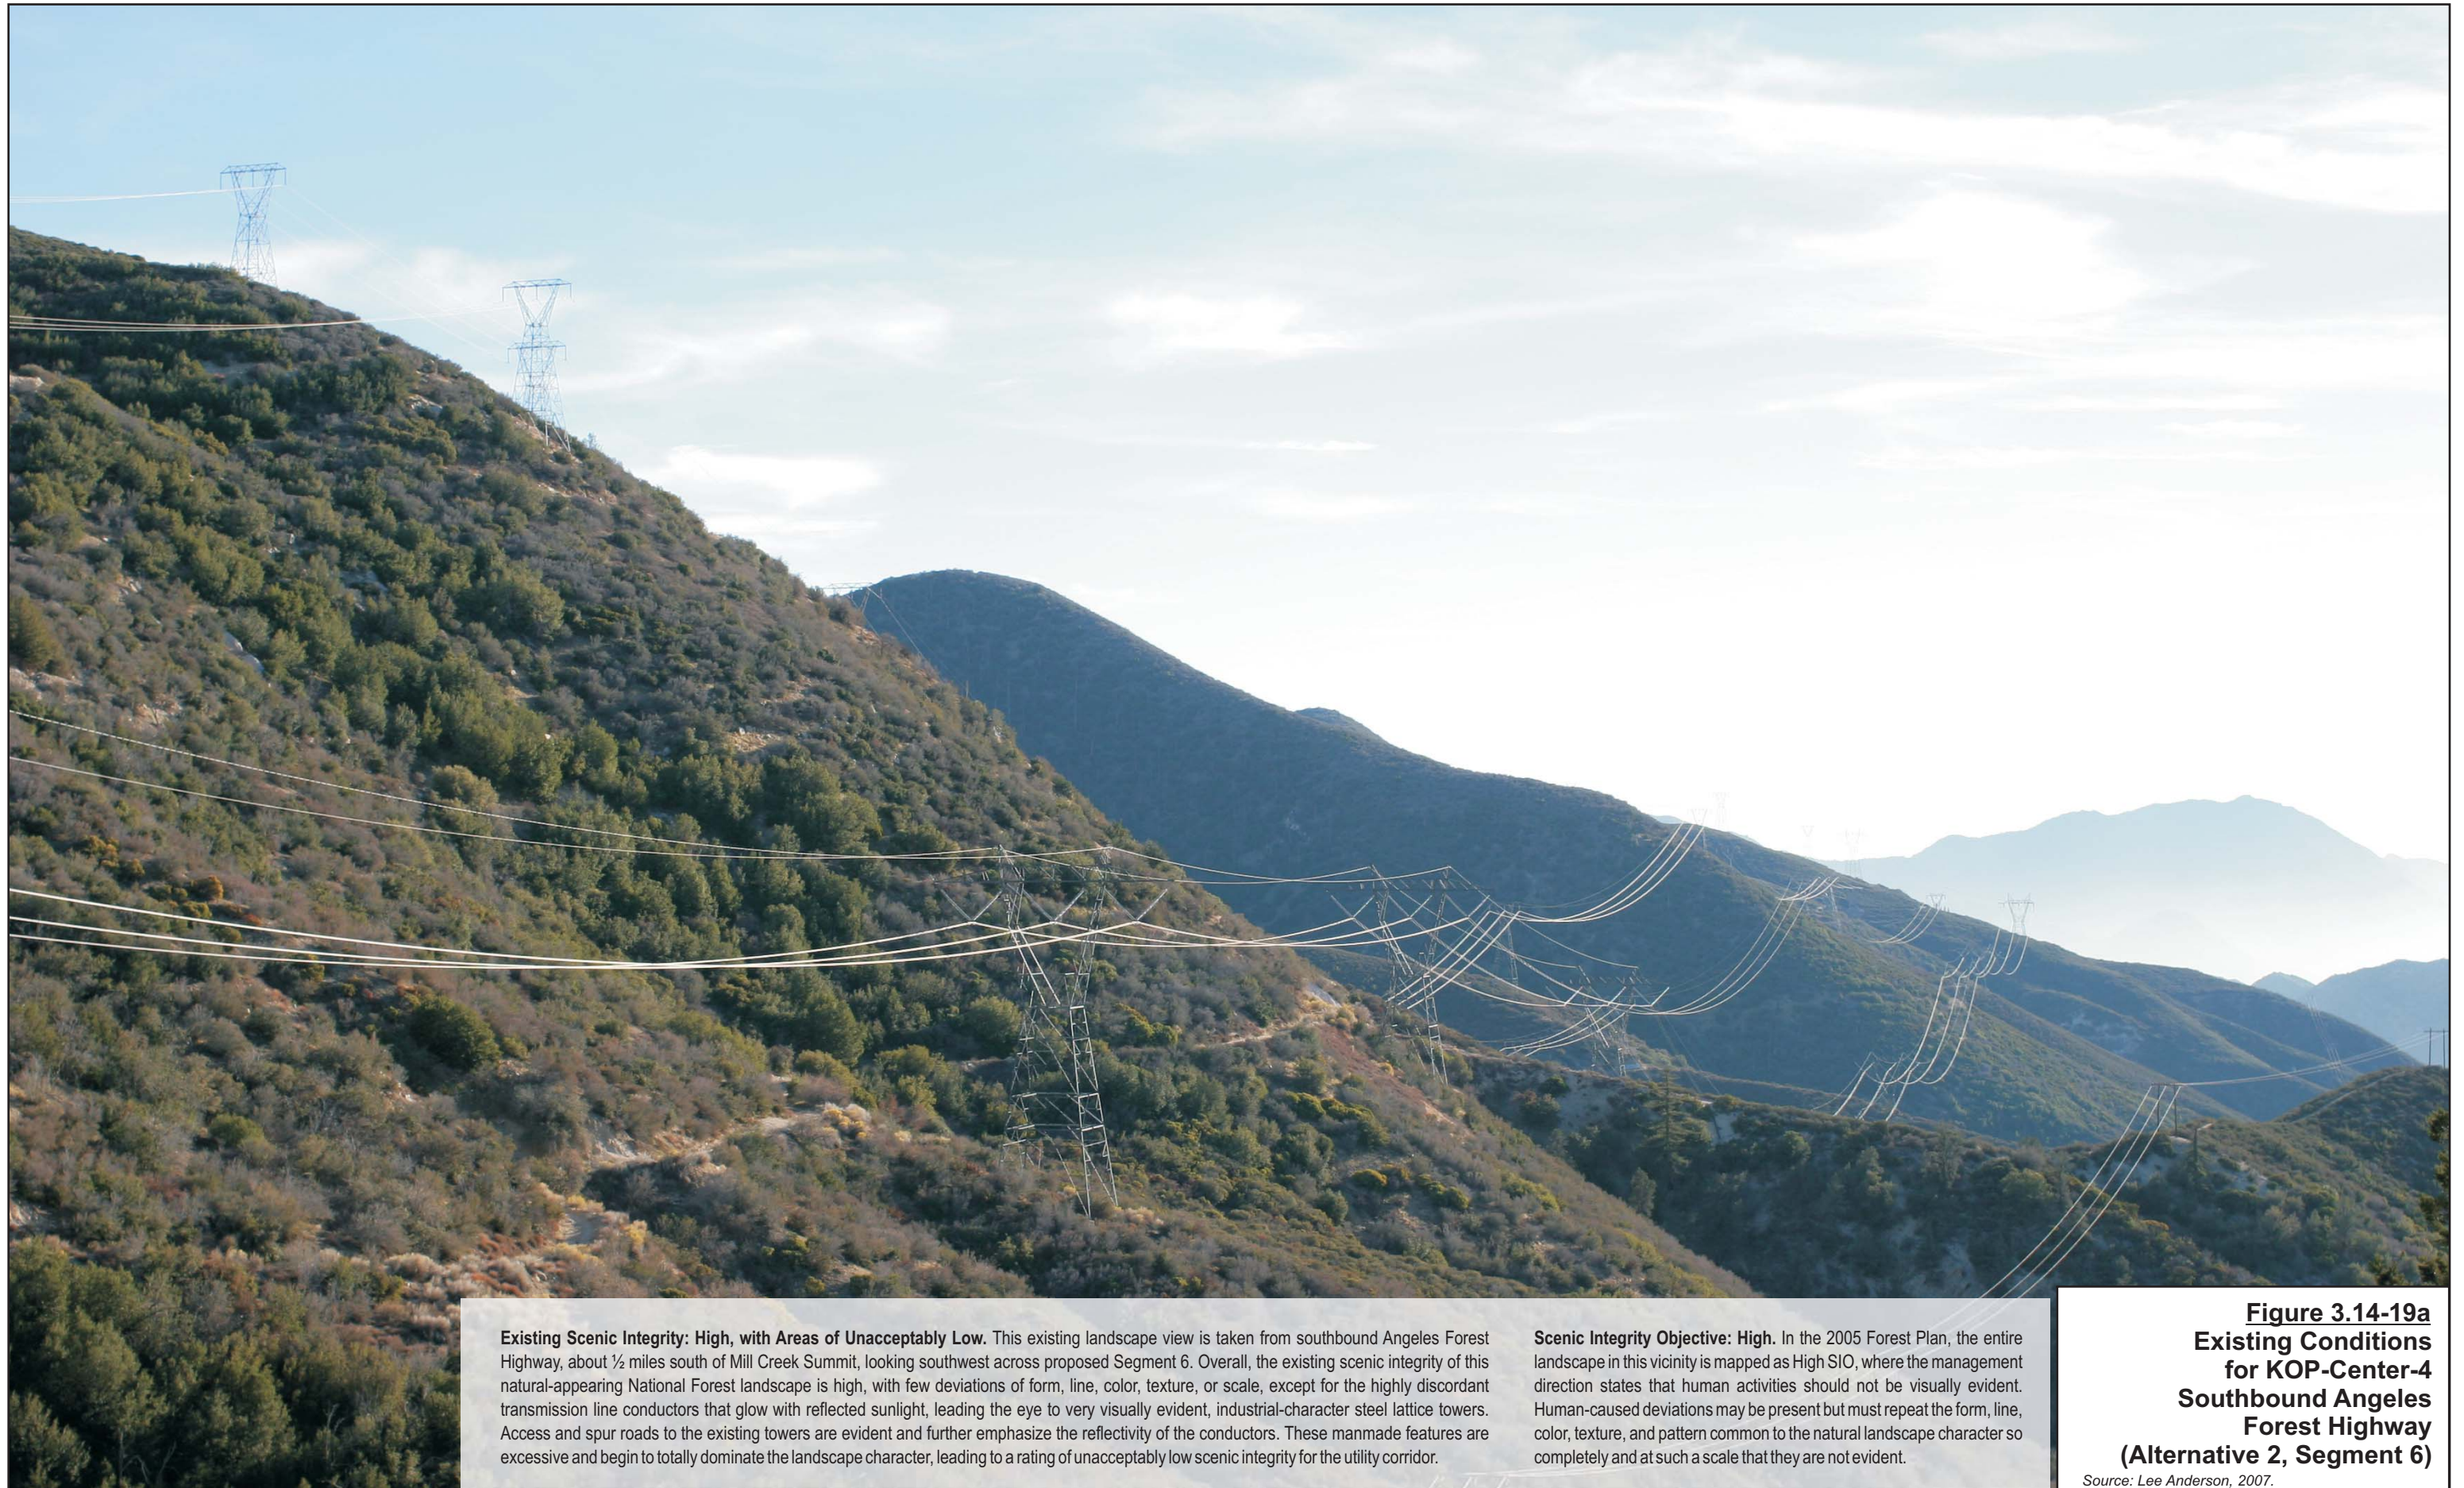
Existing Scenic Integrity: High, with Areas of Unacceptably Low. This existing landscape view is taken from southbound Angeles Forest Highway, about ½ miles south of Mill Creek Summit, looking southwest across proposed Segment 6. Overall, the existing scenic integrity of this natural-appearing National Forest landscape is high, with few deviations of form, line, color, texture, or scale, except for the highly discordant transmission line conductors that glow with reflected sunlight, leading the eye to very visually evident, industrial-character steel lattice towers. Access and spur roads to the existing towers are evident and further emphasize the reflectivity of the conductors. These manmade features are excessive and begin to totally dominate the landscape character, leading to a rating of unacceptably low scenic integrity for the utility corridor.

Scenic Integrity Objective: High. In the 2005 Forest Plan, the entire landscape in this vicinity is mapped as High SIO, where the management direction states that human activities should not be visually evident. Human-caused deviations may be present but must repeat the form, line, color, texture, and pattern common to the natural landscape character so completely and at such a scale that they are not evident.
