**Figure 3.14-66a**  
**Existing Conditions**  
**for KOP-Center-3**  
**Mount Gleason Road**  
**(Alternative 6, Segment 6)**

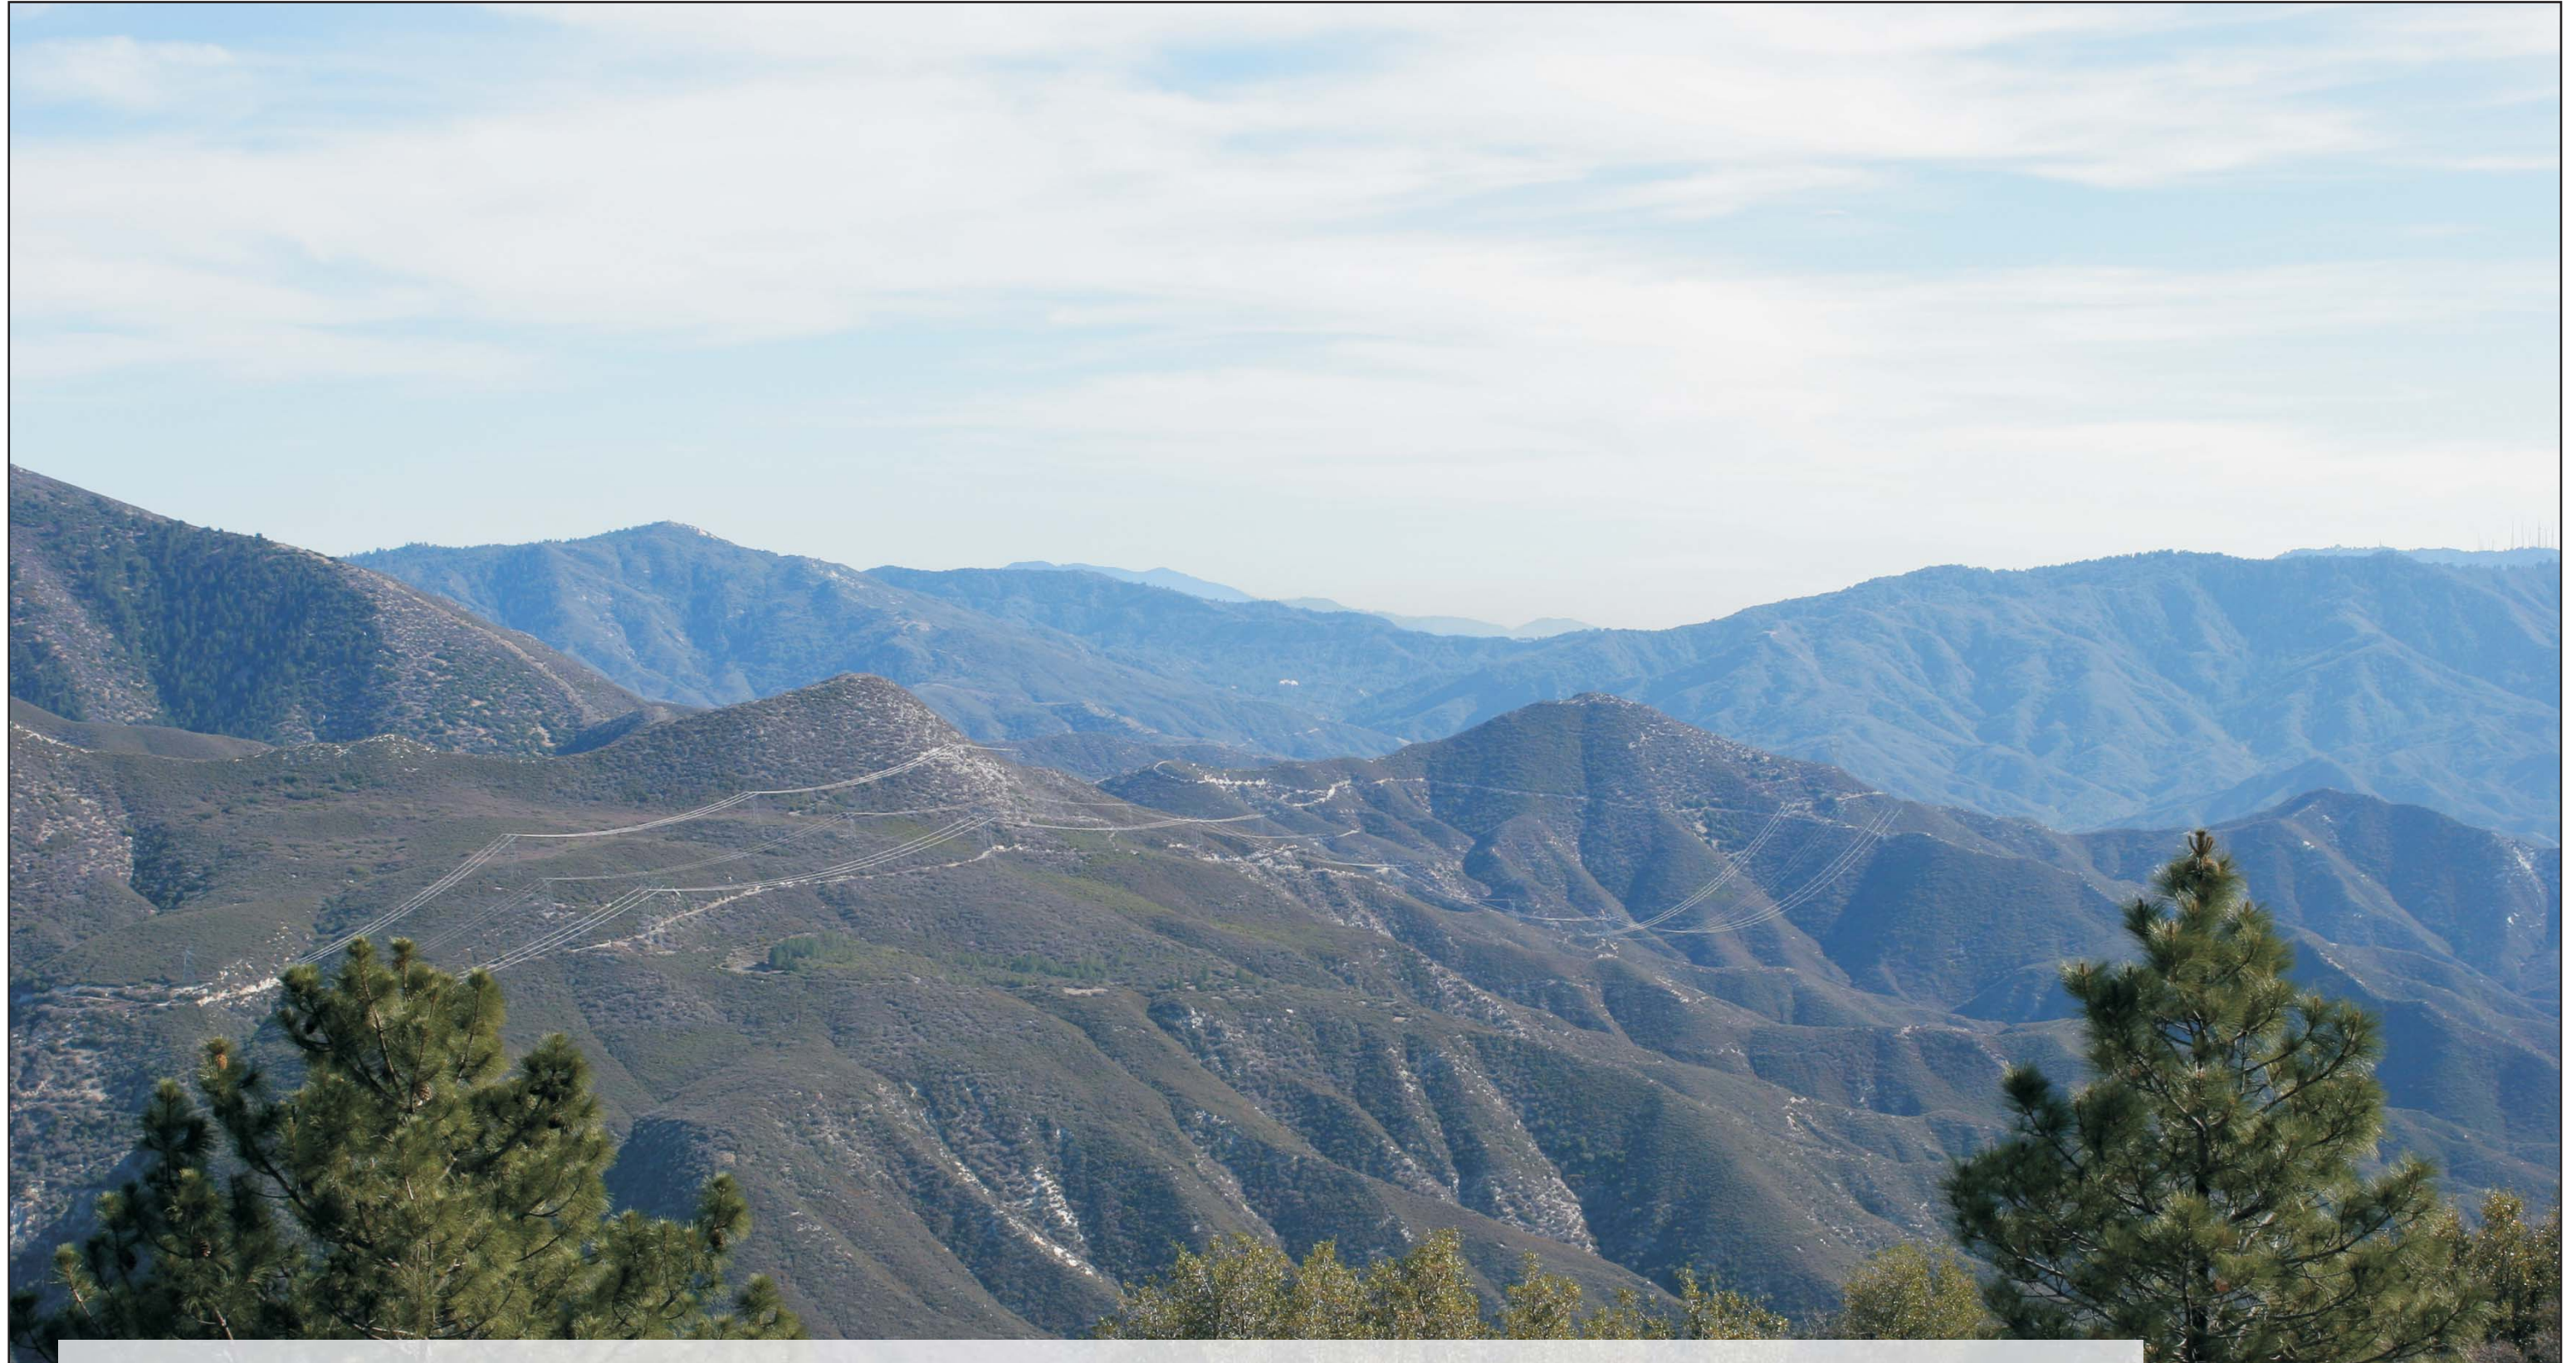
**Existing Scenic Integrity: High, with Areas of Very Low.** This existing landscape view is from the Mount Gleason Road, about three miles west of Mill Creek Summit, looking southeast down toward Segment 6. The PCT, west of Mill Creek Summit, shares much of this same viewshed. The landscape visible from Mount Gleason Road is predominantly natural-appearing, consisting of foreground, midground, and background landscapes with dense, dark green chamise and chaparral covered mountainsides. There is very little vegetative pattern in this landscape and the sun angle and shadows emphasize the ruggedness of the steep slopes and broken terrain. The natural landscape has a coherent form and character with substantial visual variety created by the rugged, folded terrain. The natural landscape exhibits a high degree of intactness and scenic integrity, except for the highly discordant transmission line conductors that glow with reflected sunlight, leading the eye to the almost transparent, industrial-character steel lattice towers. Access and spur roads to the existing towers are visually evident and further emphasize the reflectivity of the conductors, causing the valued landscape character to appear heavily altered. This leads to a rating of very low scenic integrity for the utility corridor.

**Scenic Integrity Objective: High.** In the 2005 Forest Plan, the entire landscape in this vicinity is mapped as High SIO, where the management direction states that human activities should not be visually evident. Human-caused deviations may be present but must repeat the form, line, color, texture, and pattern common to the natural landscape character so completely and at such a scale that they are not evident.
