**Figure A-19a**  
**Existing Conditions**  
**for KOP-Center-4**  
**Southbound Angeles**  
**Forest Highway**  
**(Alternative 2, Segment 6)**

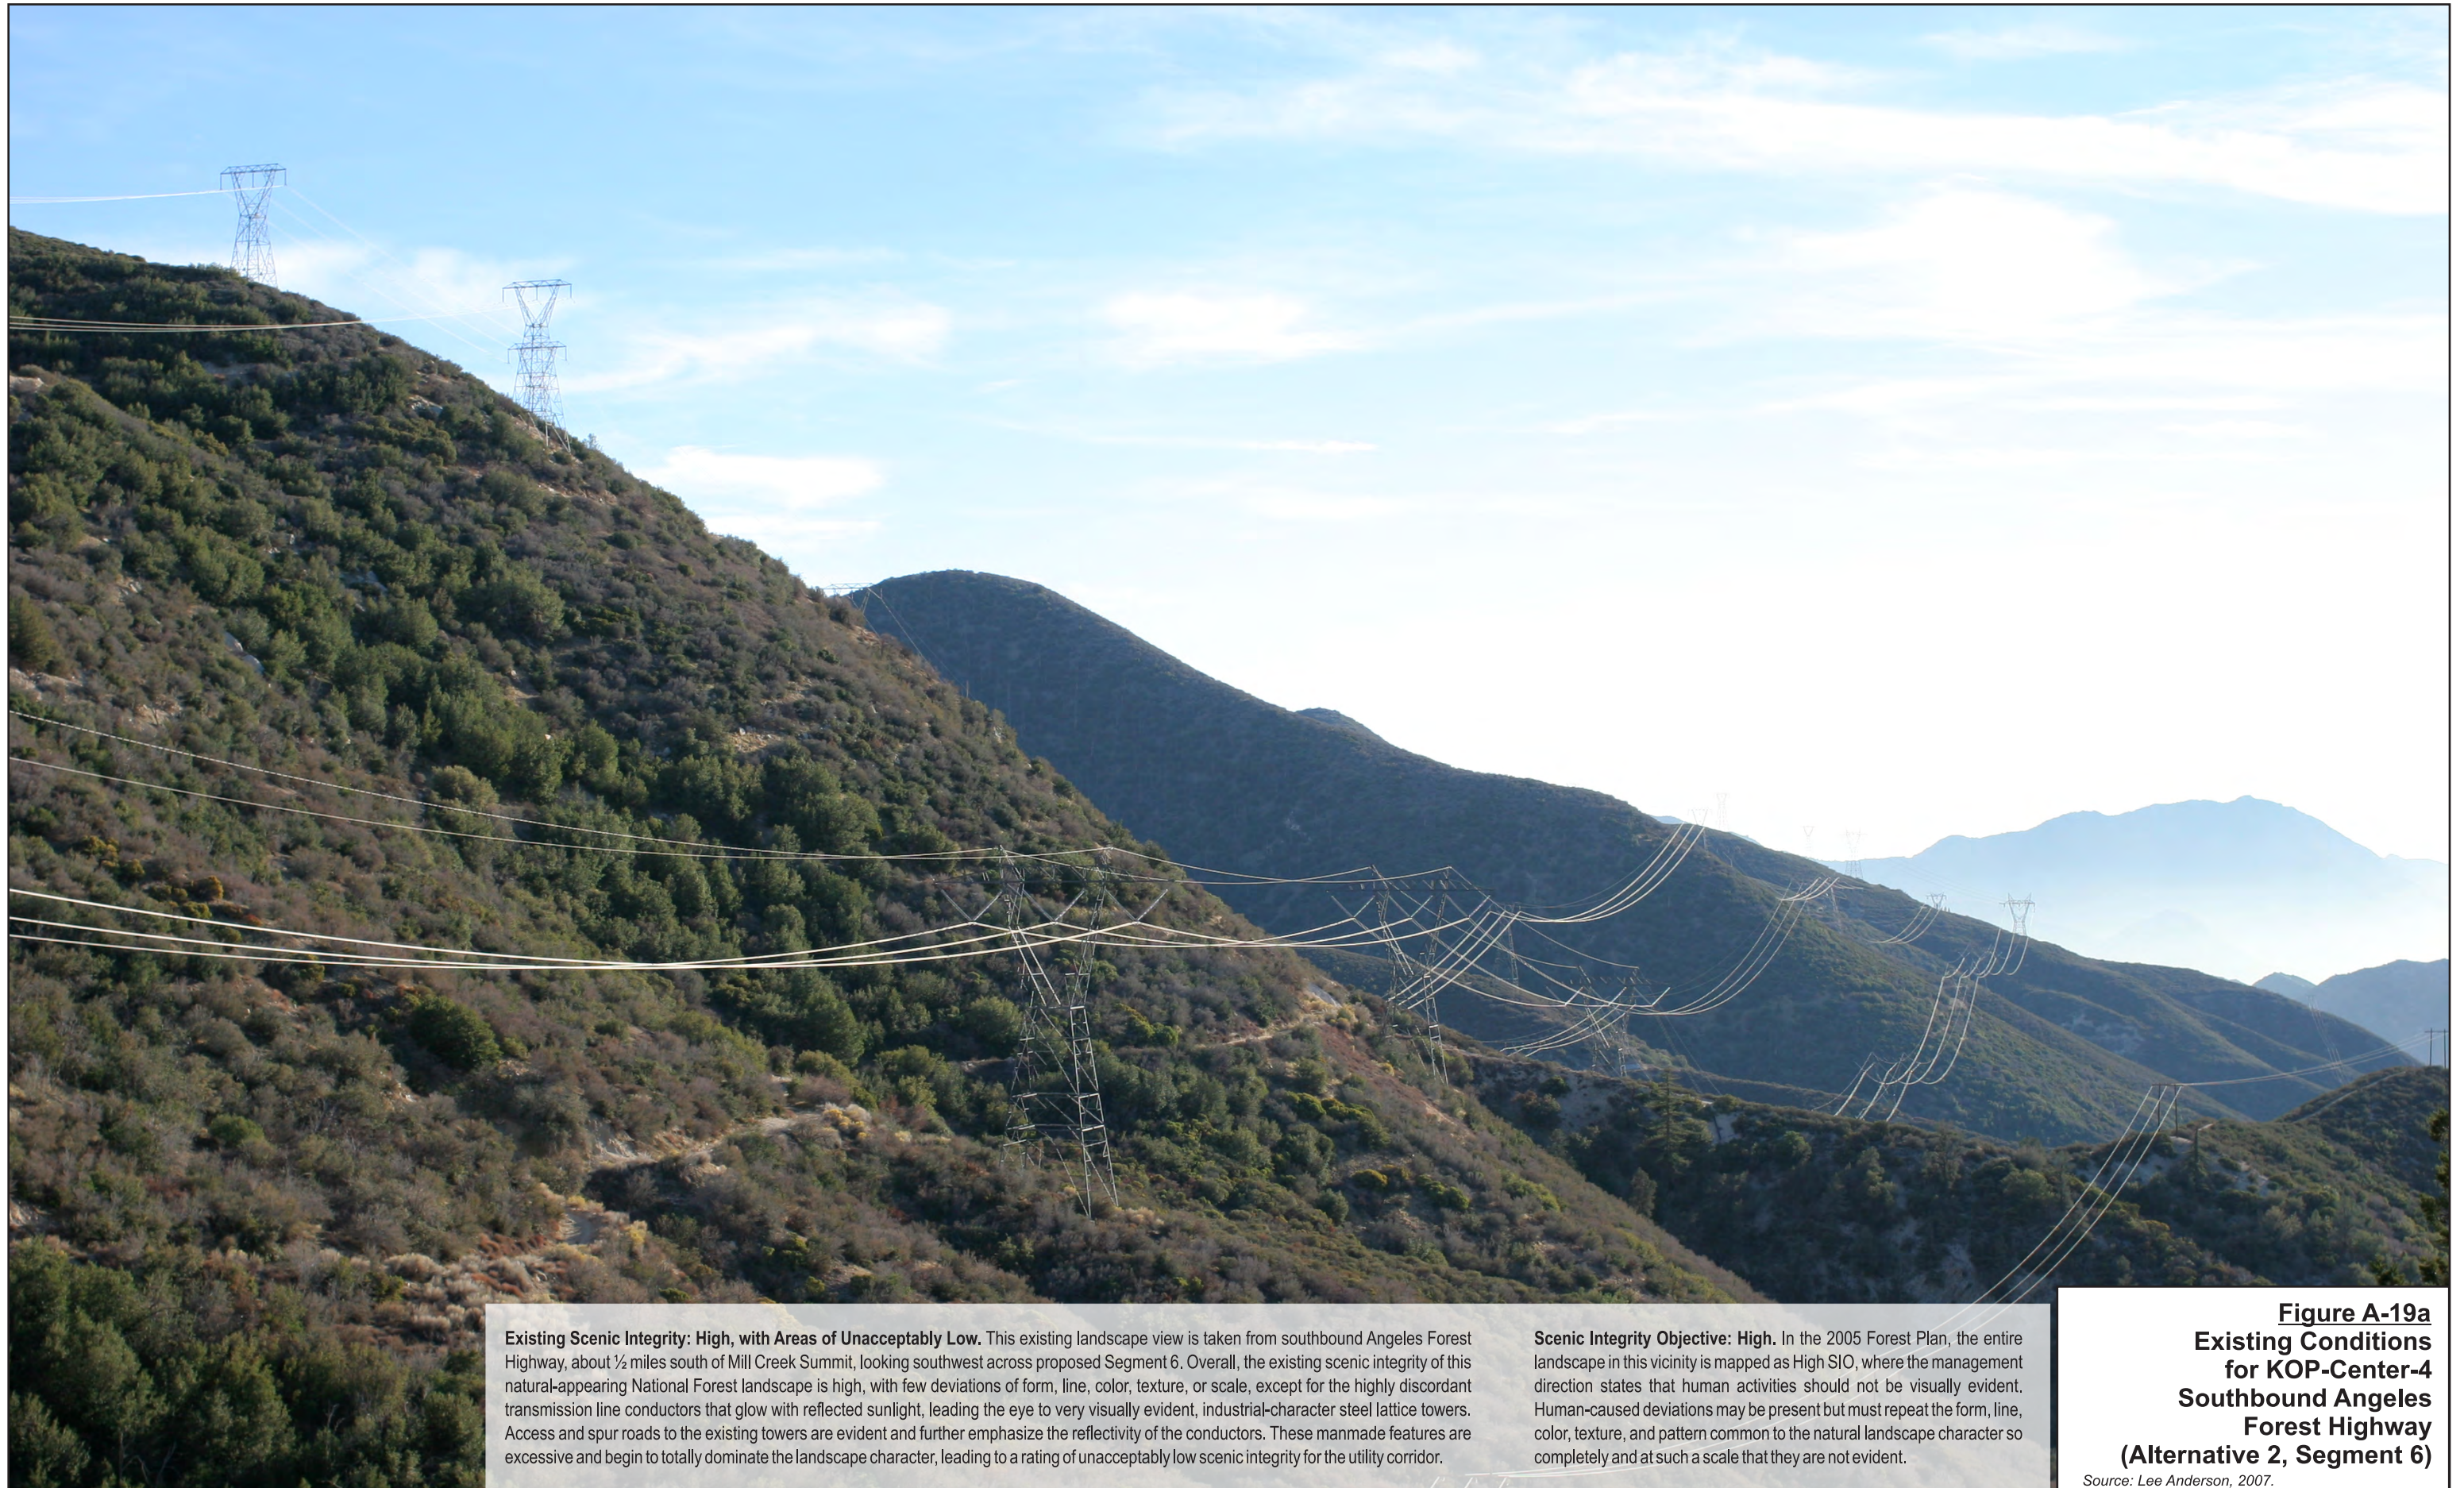
**Existing Scenic Integrity: High, with Areas of Unacceptably Low.** This existing landscape view is taken from southbound Angeles Forest Highway, about ½ miles south of Mill Creek Summit, looking southwest across proposed Segment 6. Overall, the existing scenic integrity of this natural-appearing National Forest landscape is high, with few deviations of form, line, color, texture, or scale, except for the highly discordant transmission line conductors that glow with reflected sunlight, leading the eye to very visually evident, industrial-character steel lattice towers. Access and spur roads to the existing towers are evident and further emphasize the reflectivity of the conductors. These manmade features are excessive and begin to totally dominate the landscape character, leading to a rating of unacceptably low scenic integrity for the utility corridor.

**Scenic Integrity Objective: High.** In the 2005 Forest Plan, the entire landscape in this vicinity is mapped as High SIO, where the management direction states that human activities should not be visually evident. Human-caused deviations may be present but must repeat the form, line, color, texture, and pattern common to the natural landscape character so completely and at such a scale that they are not evident.
