Figure A-20a
Existing Conditions
for KOP-Center-5
Northbound Angeles
Forest Highway
(Alternative 2, Segment 6)

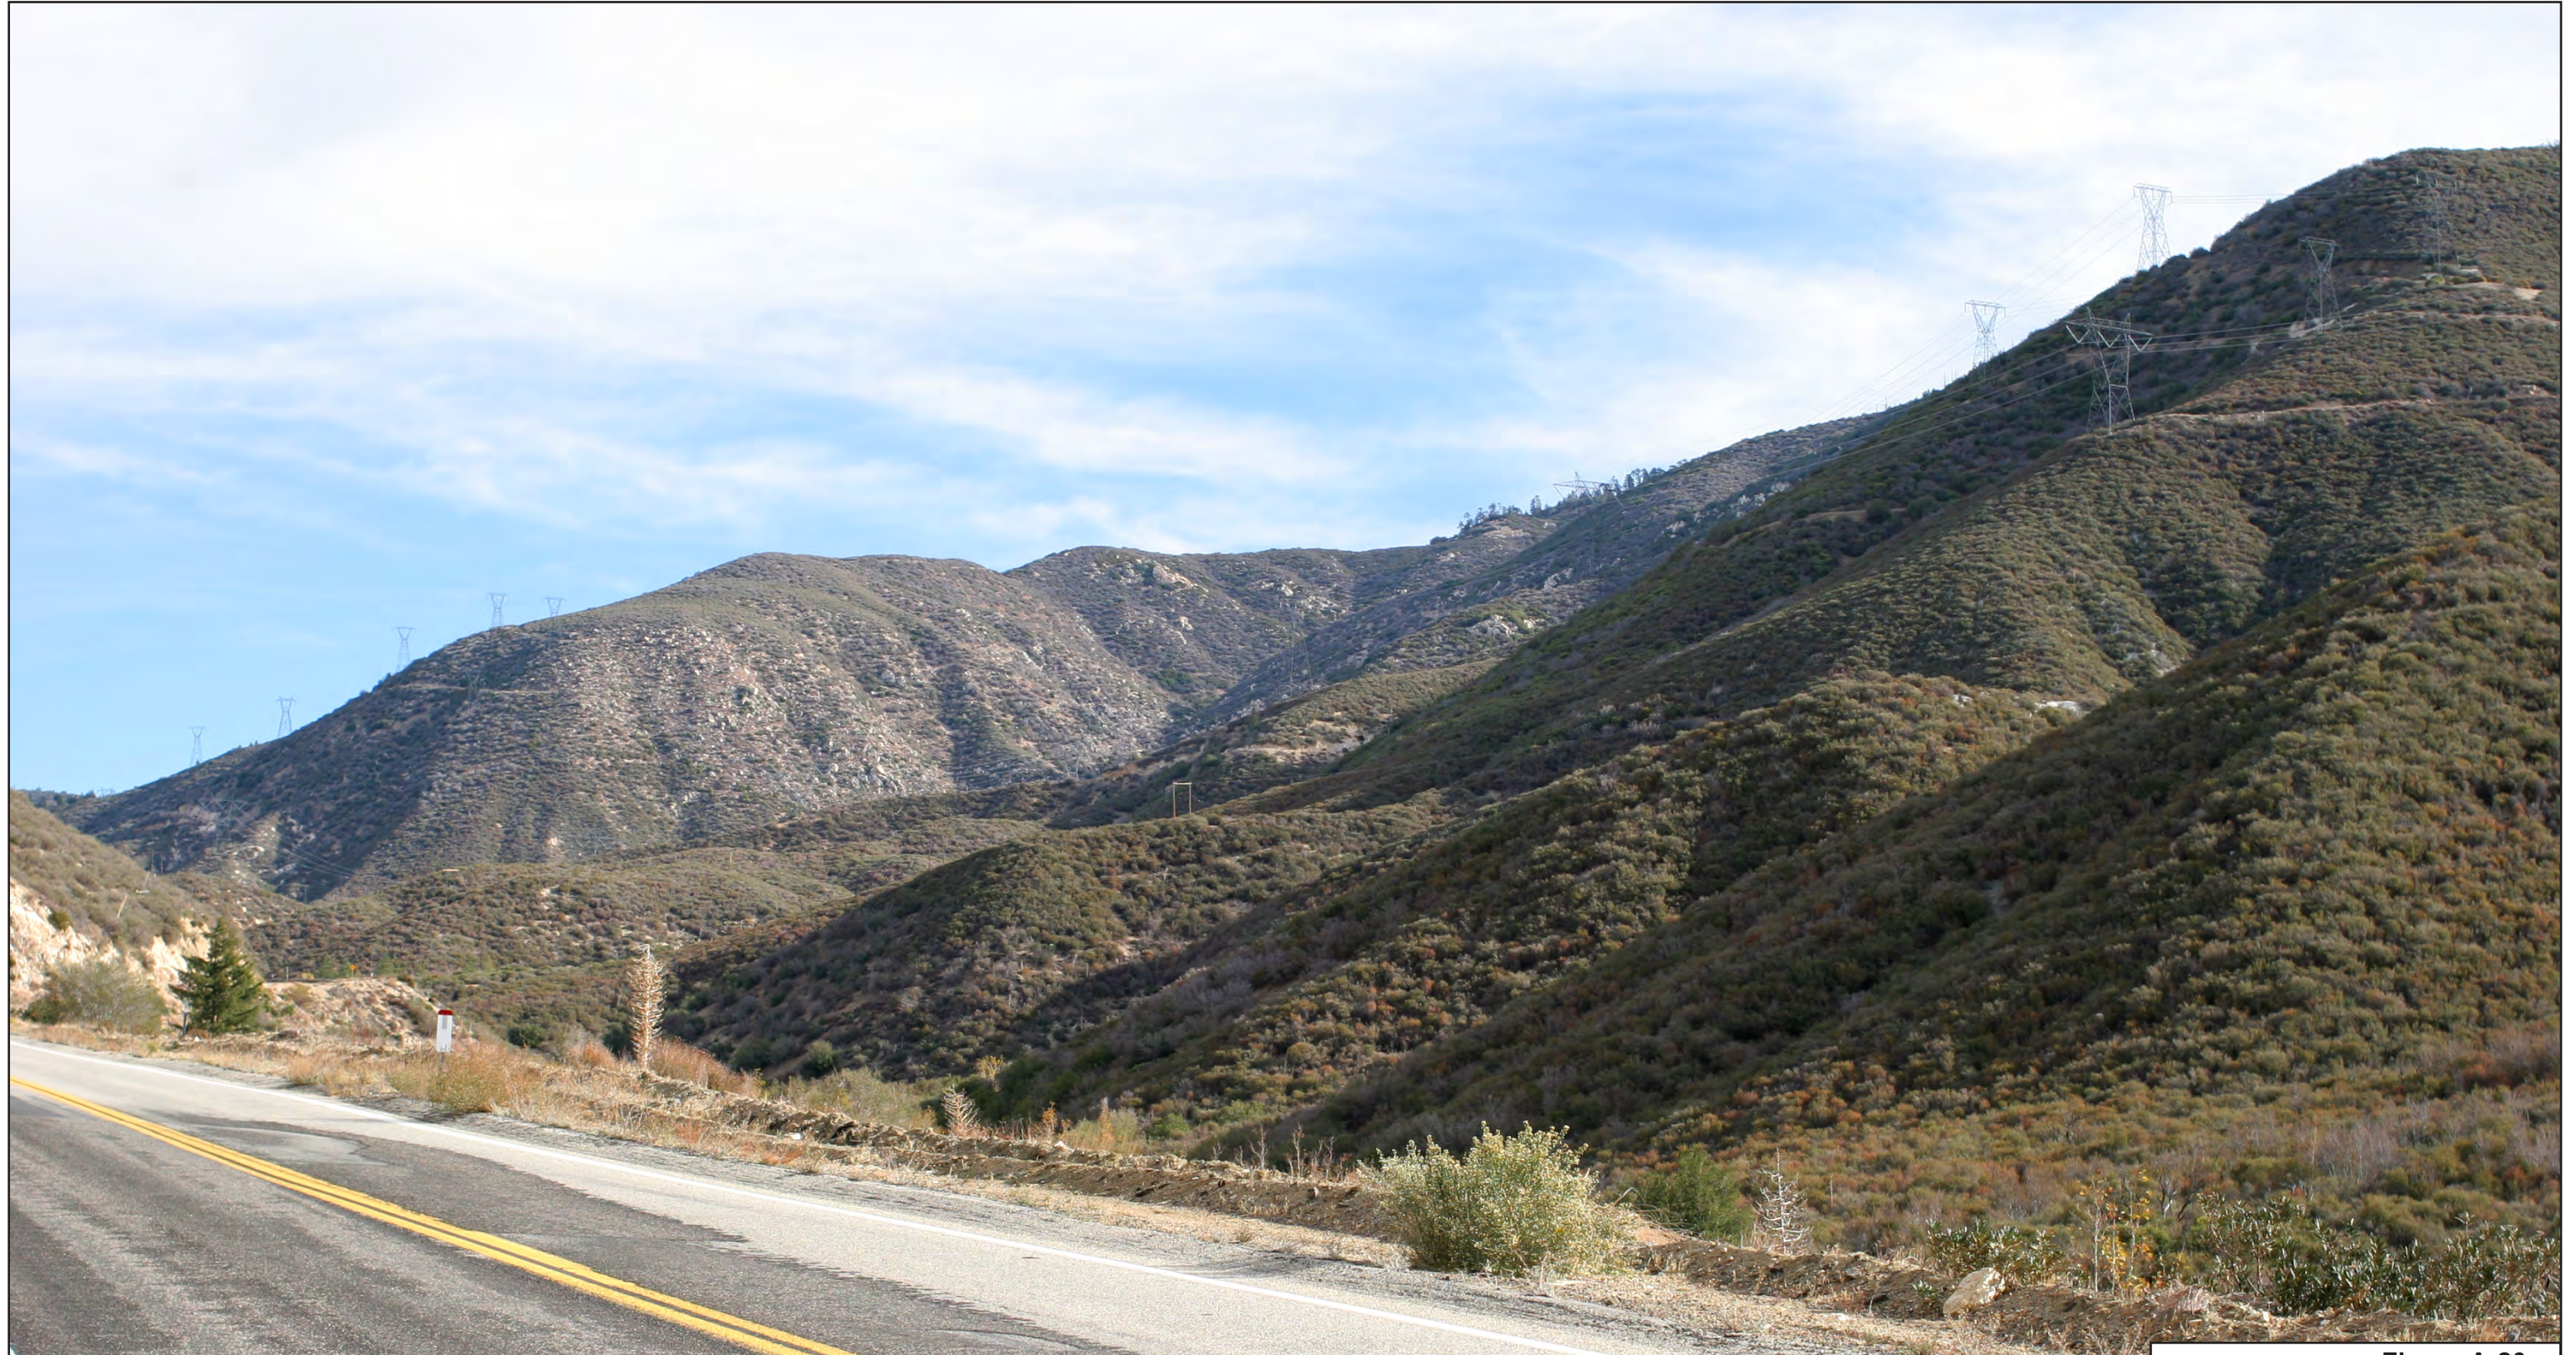
Existing Scenic Integrity: High, with Areas of Low. This existing landscape view is taken from northbound Angeles Forest Highway, about three miles south of KOP-North-4, looking north toward Mill Creek Summit and northeast toward proposed Segment 6. The landscape visible from the Angeles Forest Highway in general, and KOP-Center-5 specifically, is predominantly natural-appearing, consisting of foreground, middleground, and background landscapes with dense, dark green chemise and chaparral covered mountainsides. There is very little vegetative pattern in this landscape view. The sun angle and shadows emphasize the ruggedness of the steep slopes and broken terrain. The natural landscape has a coherent form and character with substantial visual variety created by the rugged, folded terrain. The natural landscape exhibits a high degree of intactness and scenic integrity, but the highly discordant transmission line structures and the access and spur roads leading to those towers are visually evident and moderately alter the valued landscape character, leading to a rating of low scenic integrity for the utility corridor.

Scenic Integrity Objective: High. In the 2005 Forest Plan, the entire landscape in this vicinity is mapped as High SIO, where the management direction states that human activities should not be visually evident. Human-caused deviations may be present but must repeat the form, line, color, texture, and pattern common to the natural landscape character so completely and at such a scale that they are not evident.
