Figure A-43b
Visual Simulation
for KOP- South-8
Colima Road,
Hacienda Heights
(Alternative 2, Segment 8)

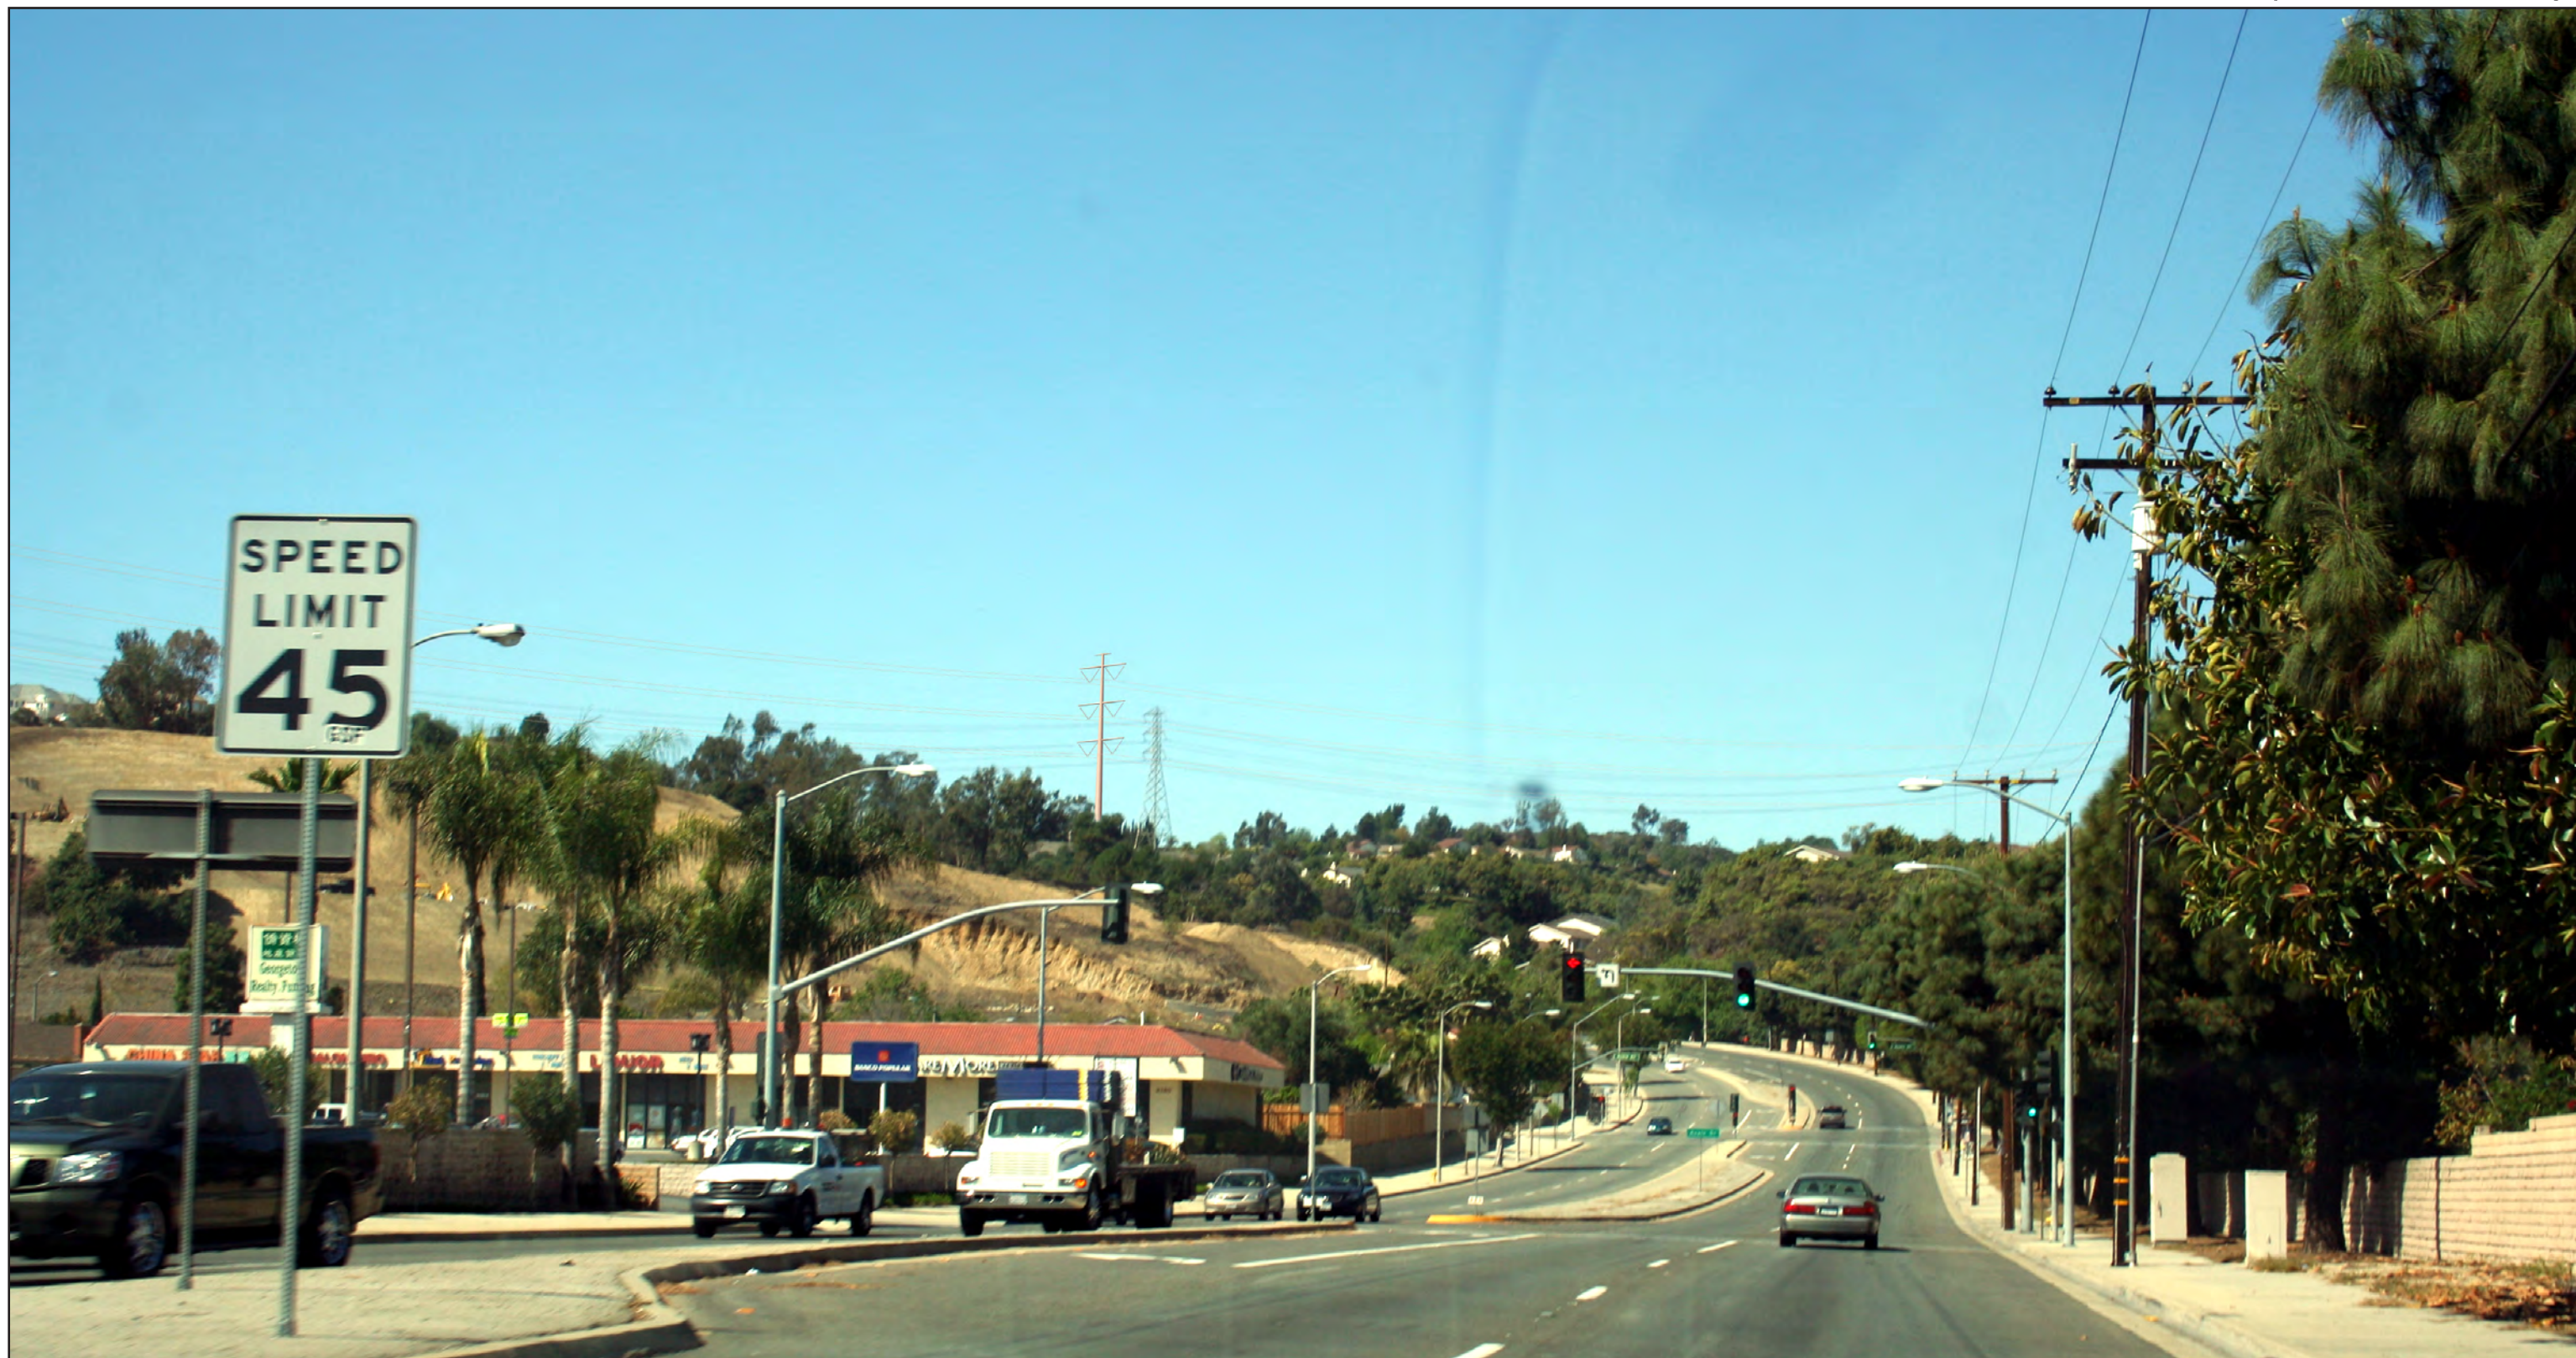
Overall Visual Change: low-to-moderate. With ratings of moderate visual contrast, low-to-moderate dominance, and low-to-moderate view blockage/impairment, the overall visual change would be low-to-moderate; and combined with the moderate-to-high overall visual sensitivity of the visual setting and viewing characteristics, visual impacts would be **Adverse But Not Significant**, as indicated in Table 2-2.

Adverse Visual Impacts. In the vicinity of KOP-South-8, implementation of the Project would result in adverse but not significant visual impacts V-1, V-3, and V-5, as detailed in Table 6-1.

Mitigation Measures. Implementation of Mitigation Measures (MMs) would reduce these adverse but not significant visual impacts (**Class III**) and would improve the visual environment. MMs would include V-1a – Clean up staging areas, storage areas, marshalling yards, access and spur roads, and structure locations on a regular periodic basis; V-2 – Use tubular steel poles instead of lattice steel towers in designated areas (same as APM AES-2 - TSPs Near Existing Residential Development); V-2b – Treat surfaces with appropriate colors, textures, and finishes; and V-3a – Match spans of existing transmission structures.
