Figure A-67a
Existing Conditions
for KOP-Center-4
Southbound Angeles
Forest Highway
(Alternative 6, Segment 6)
Source: Lee Anderson, 2007.

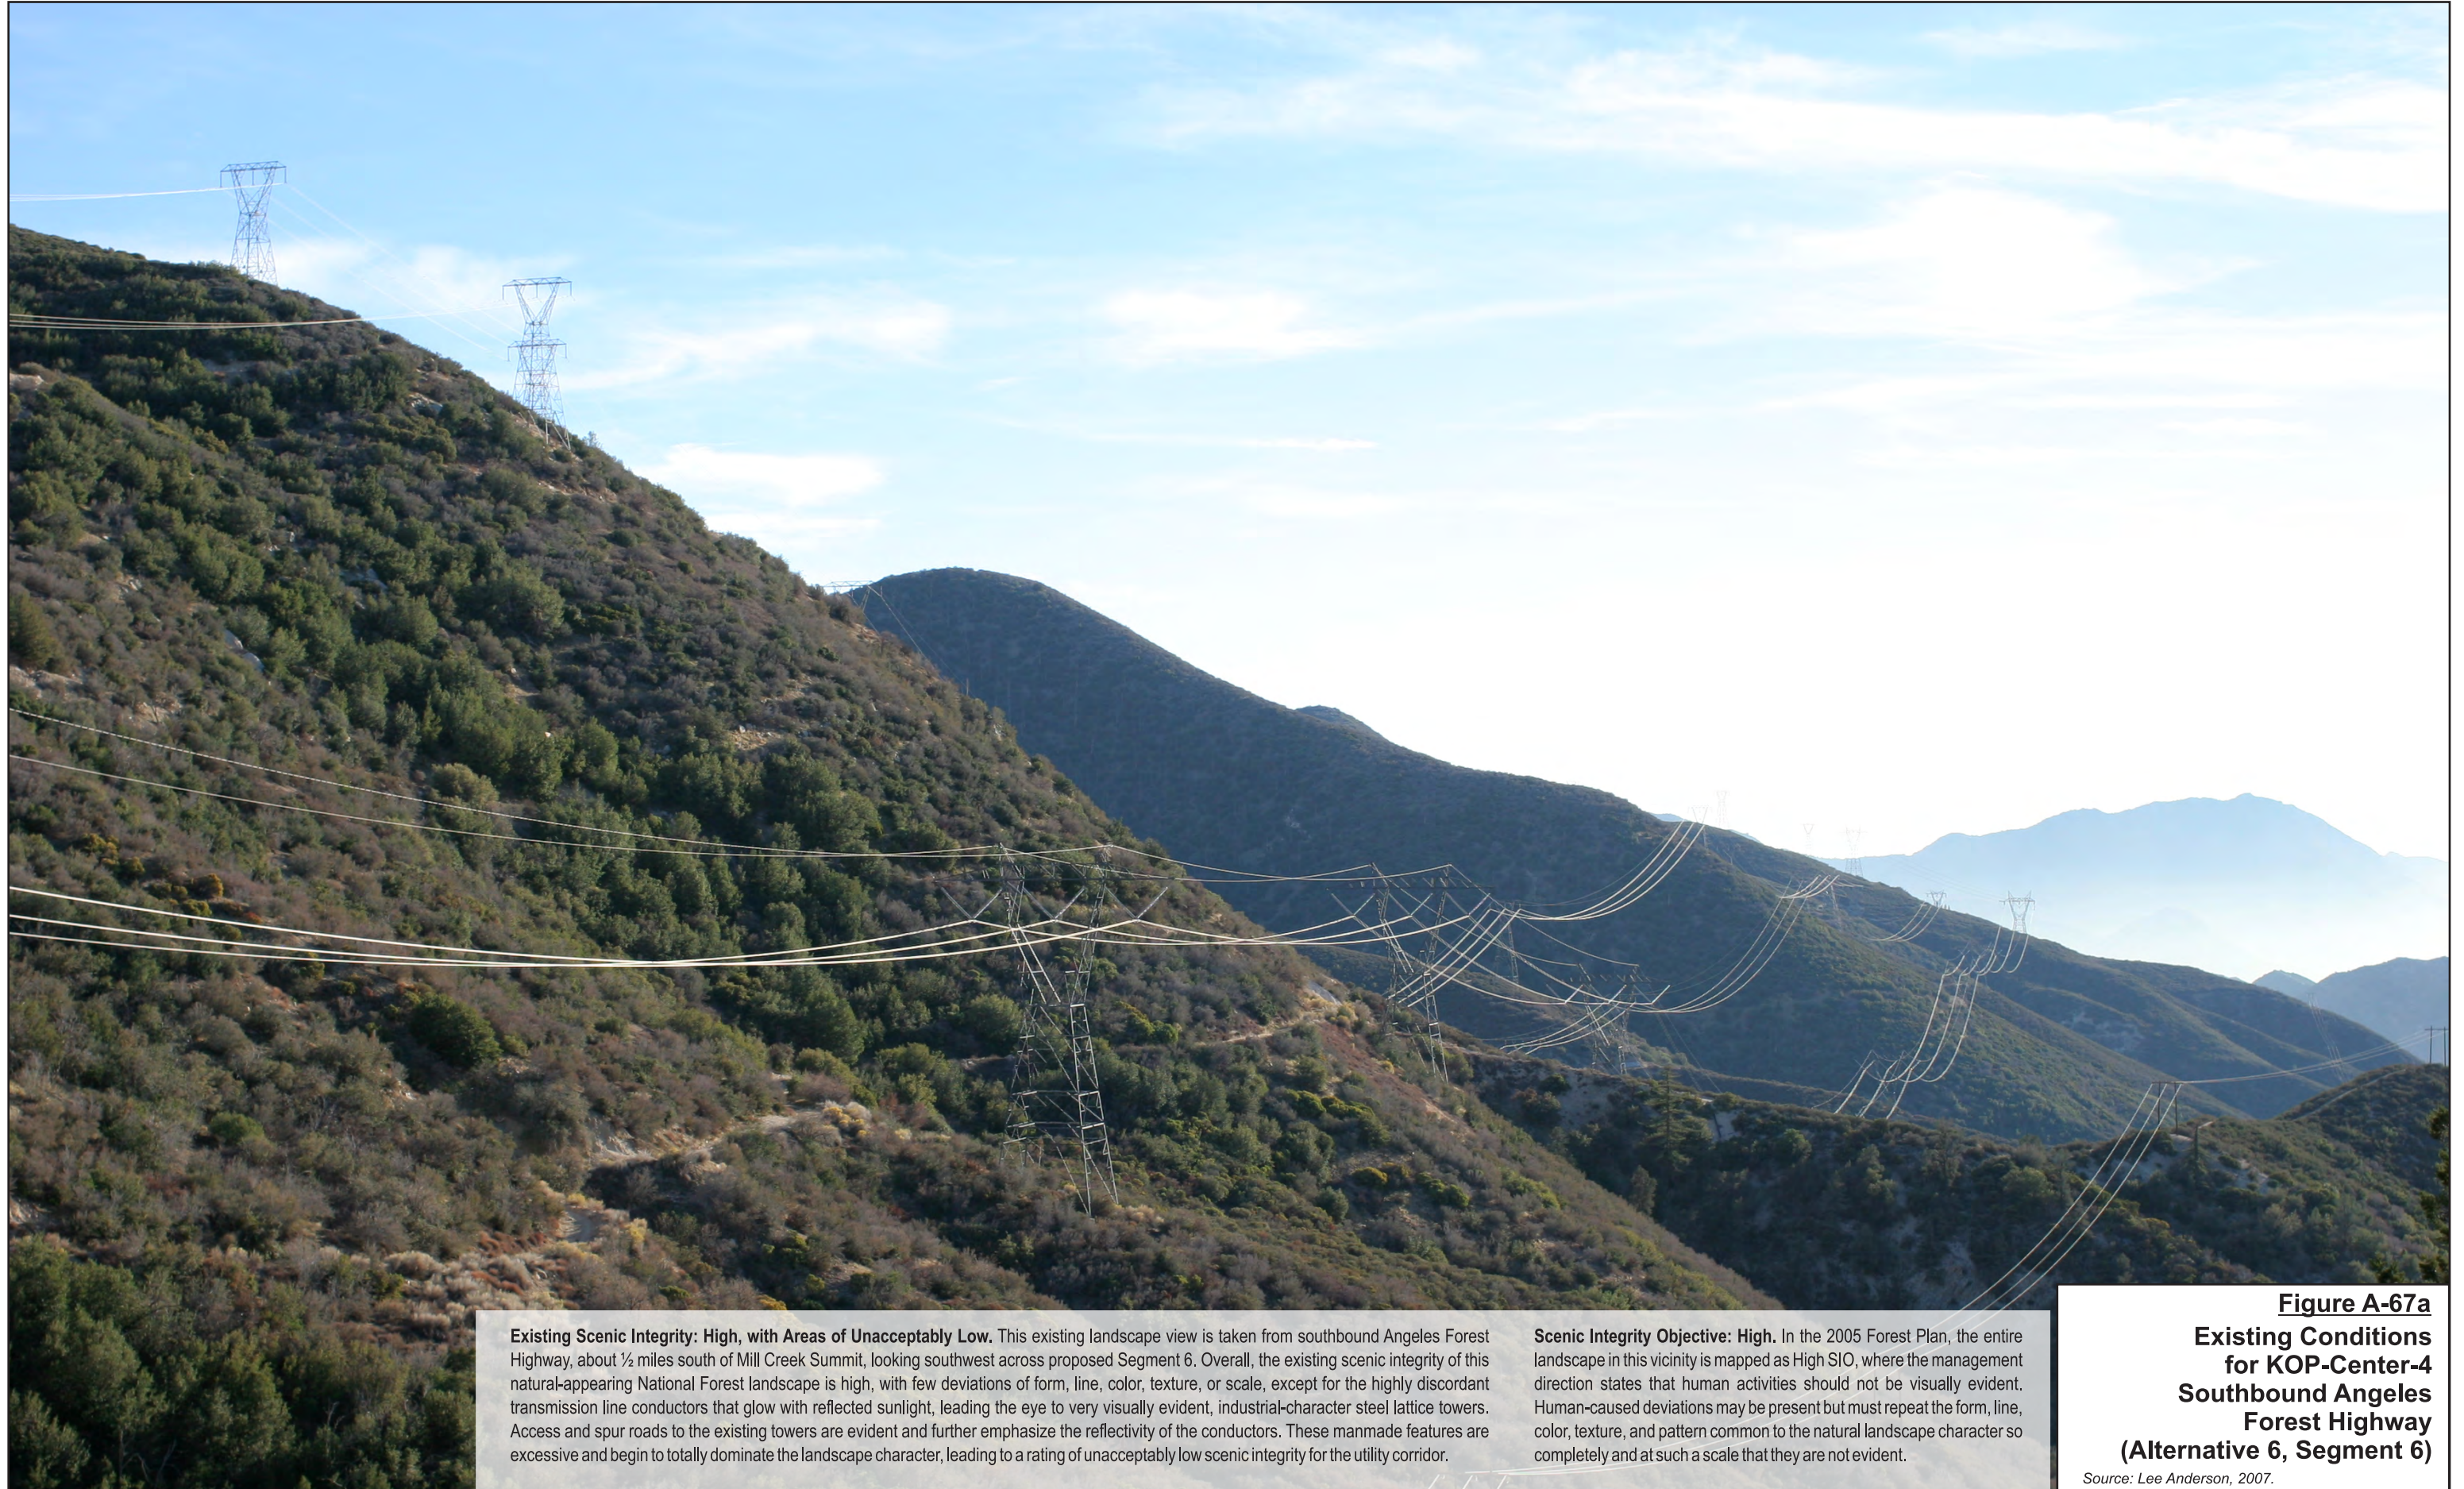
Existing Scenic Integrity: High, with Areas of Unacceptably Low. This existing landscape view is taken from southbound Angeles Forest Highway, about ½ miles south of Mill Creek Summit, looking southwest across proposed Segment 6. Overall, the existing scenic integrity of this natural-appearing National Forest landscape is high, with few deviations of form, line, color, texture, or scale, except for the highly discordant transmission line conductors that glow with reflected sunlight, leading the eye to very visually evident, industrial-character steel lattice towers. Access and spur roads to the existing towers are evident and further emphasize the reflectivity of the conductors. These manmade features are excessive and begin to totally dominate the landscape character, leading to a rating of unacceptably low scenic integrity for the utility corridor.

Scenic Integrity Objective: High. In the 2005 Forest Plan, the entire landscape in this vicinity is mapped as High SIO, where the management direction states that human activities should not be visually evident. Human-caused deviations may be present but must repeat the form, line, color, texture, and pattern common to the natural landscape character so completely and at such a scale that they are not evident.
