**Figure A-78a (Revised)**  
**Existing Conditions**  
**for KOP-Center-15**  
**Eastbound Mount Gleason Road**  
**(Alternative 6, Segment 11)**

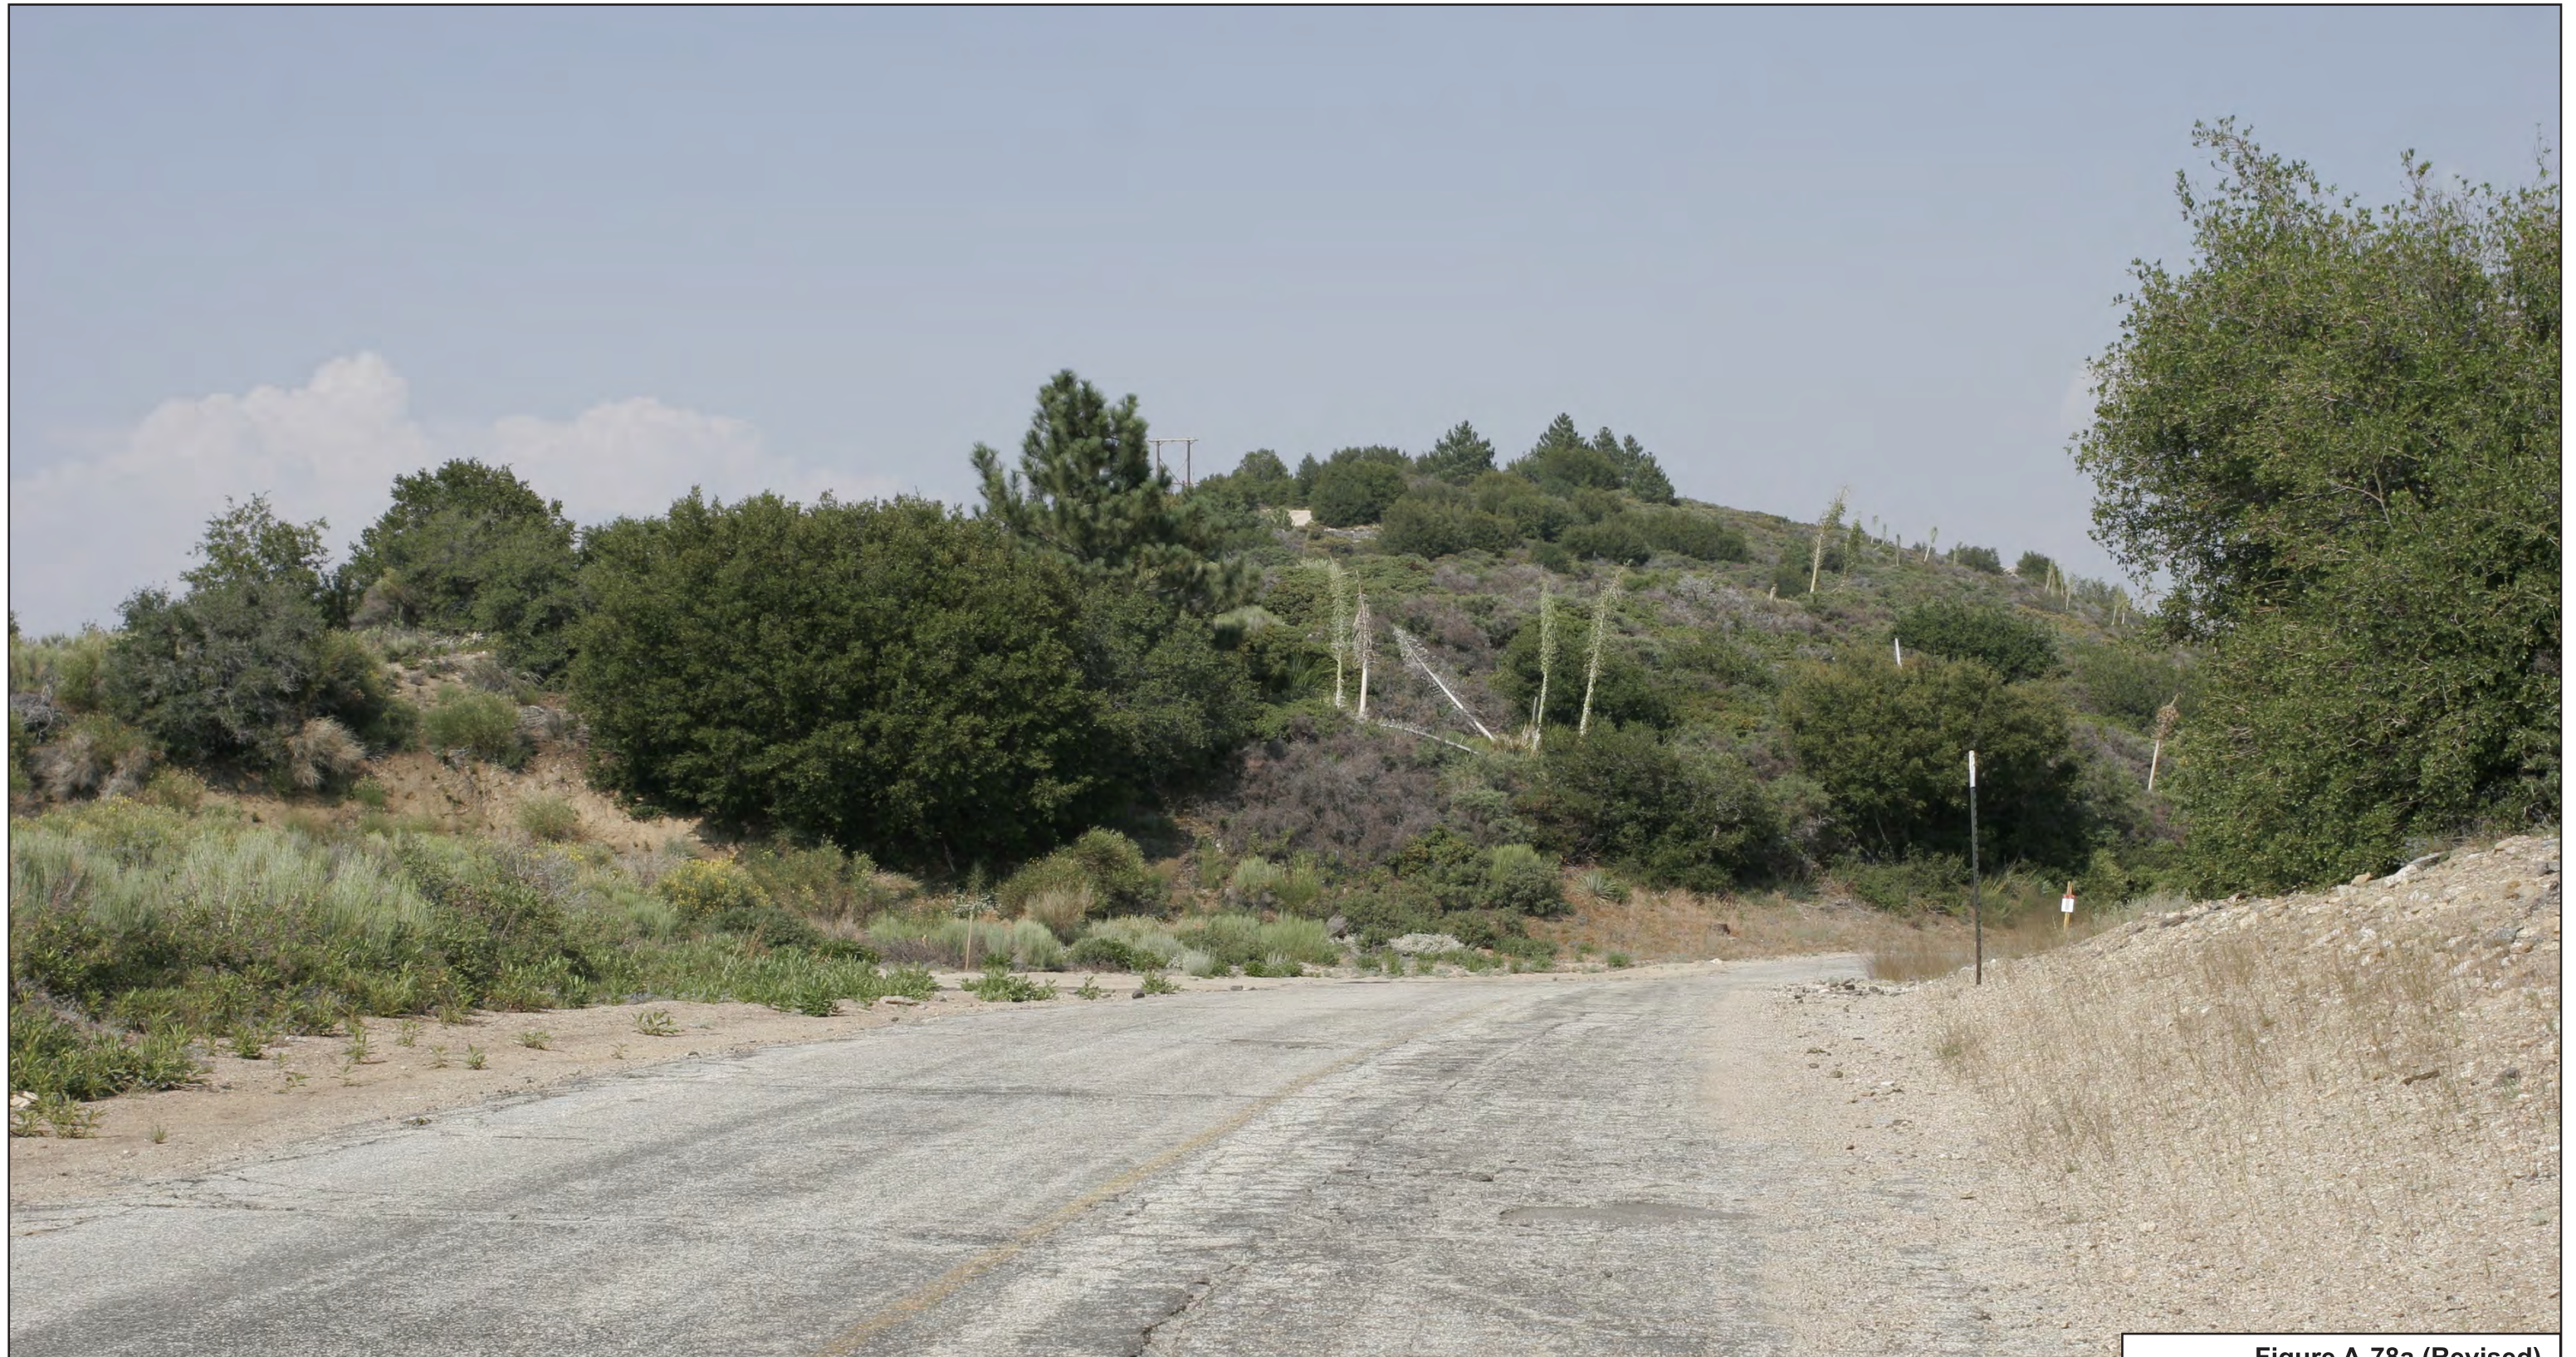
**Existing Scenic Integrity: High, with Areas of Borderline Moderate to Low.** The landscape visible from the Mount Gleason Road is predominantly natural-appearing, consisting of large-scale, panoramic views to middleground and background landscape, such as shown at KOP-Center-3. However, this is a foreground view toward the proposed Project's (Alternative 2) helicopter staging area and it does not show panoramic views; rather, it shows details in the landscape that are somewhat discordant. The dense, dark green brushfields are interrupted by cut and fill slopes of the road itself, and by an access road that follows along the ridgeline and powerline with wooden poles that interrupt the skyline. The natural landscape exhibits a moderate degree of intactness, or scenic integrity, except for the distinct manmade features: the power line with its H-frame wooden poles, and the cut and fill slopes with bare earth. These discordant features distract from the harmony of the natural form and character of the landscape and do not borrow form, line, color or texture from the natural-appearing landscape; therefore, this scene is on the borderline between moderate and low inherent scenic integrity.
