Figure A-83b
Visual Simulation
for KOP-Center-20
Forest Road to
Millard Campground
(Alternative 6, Segment 11)

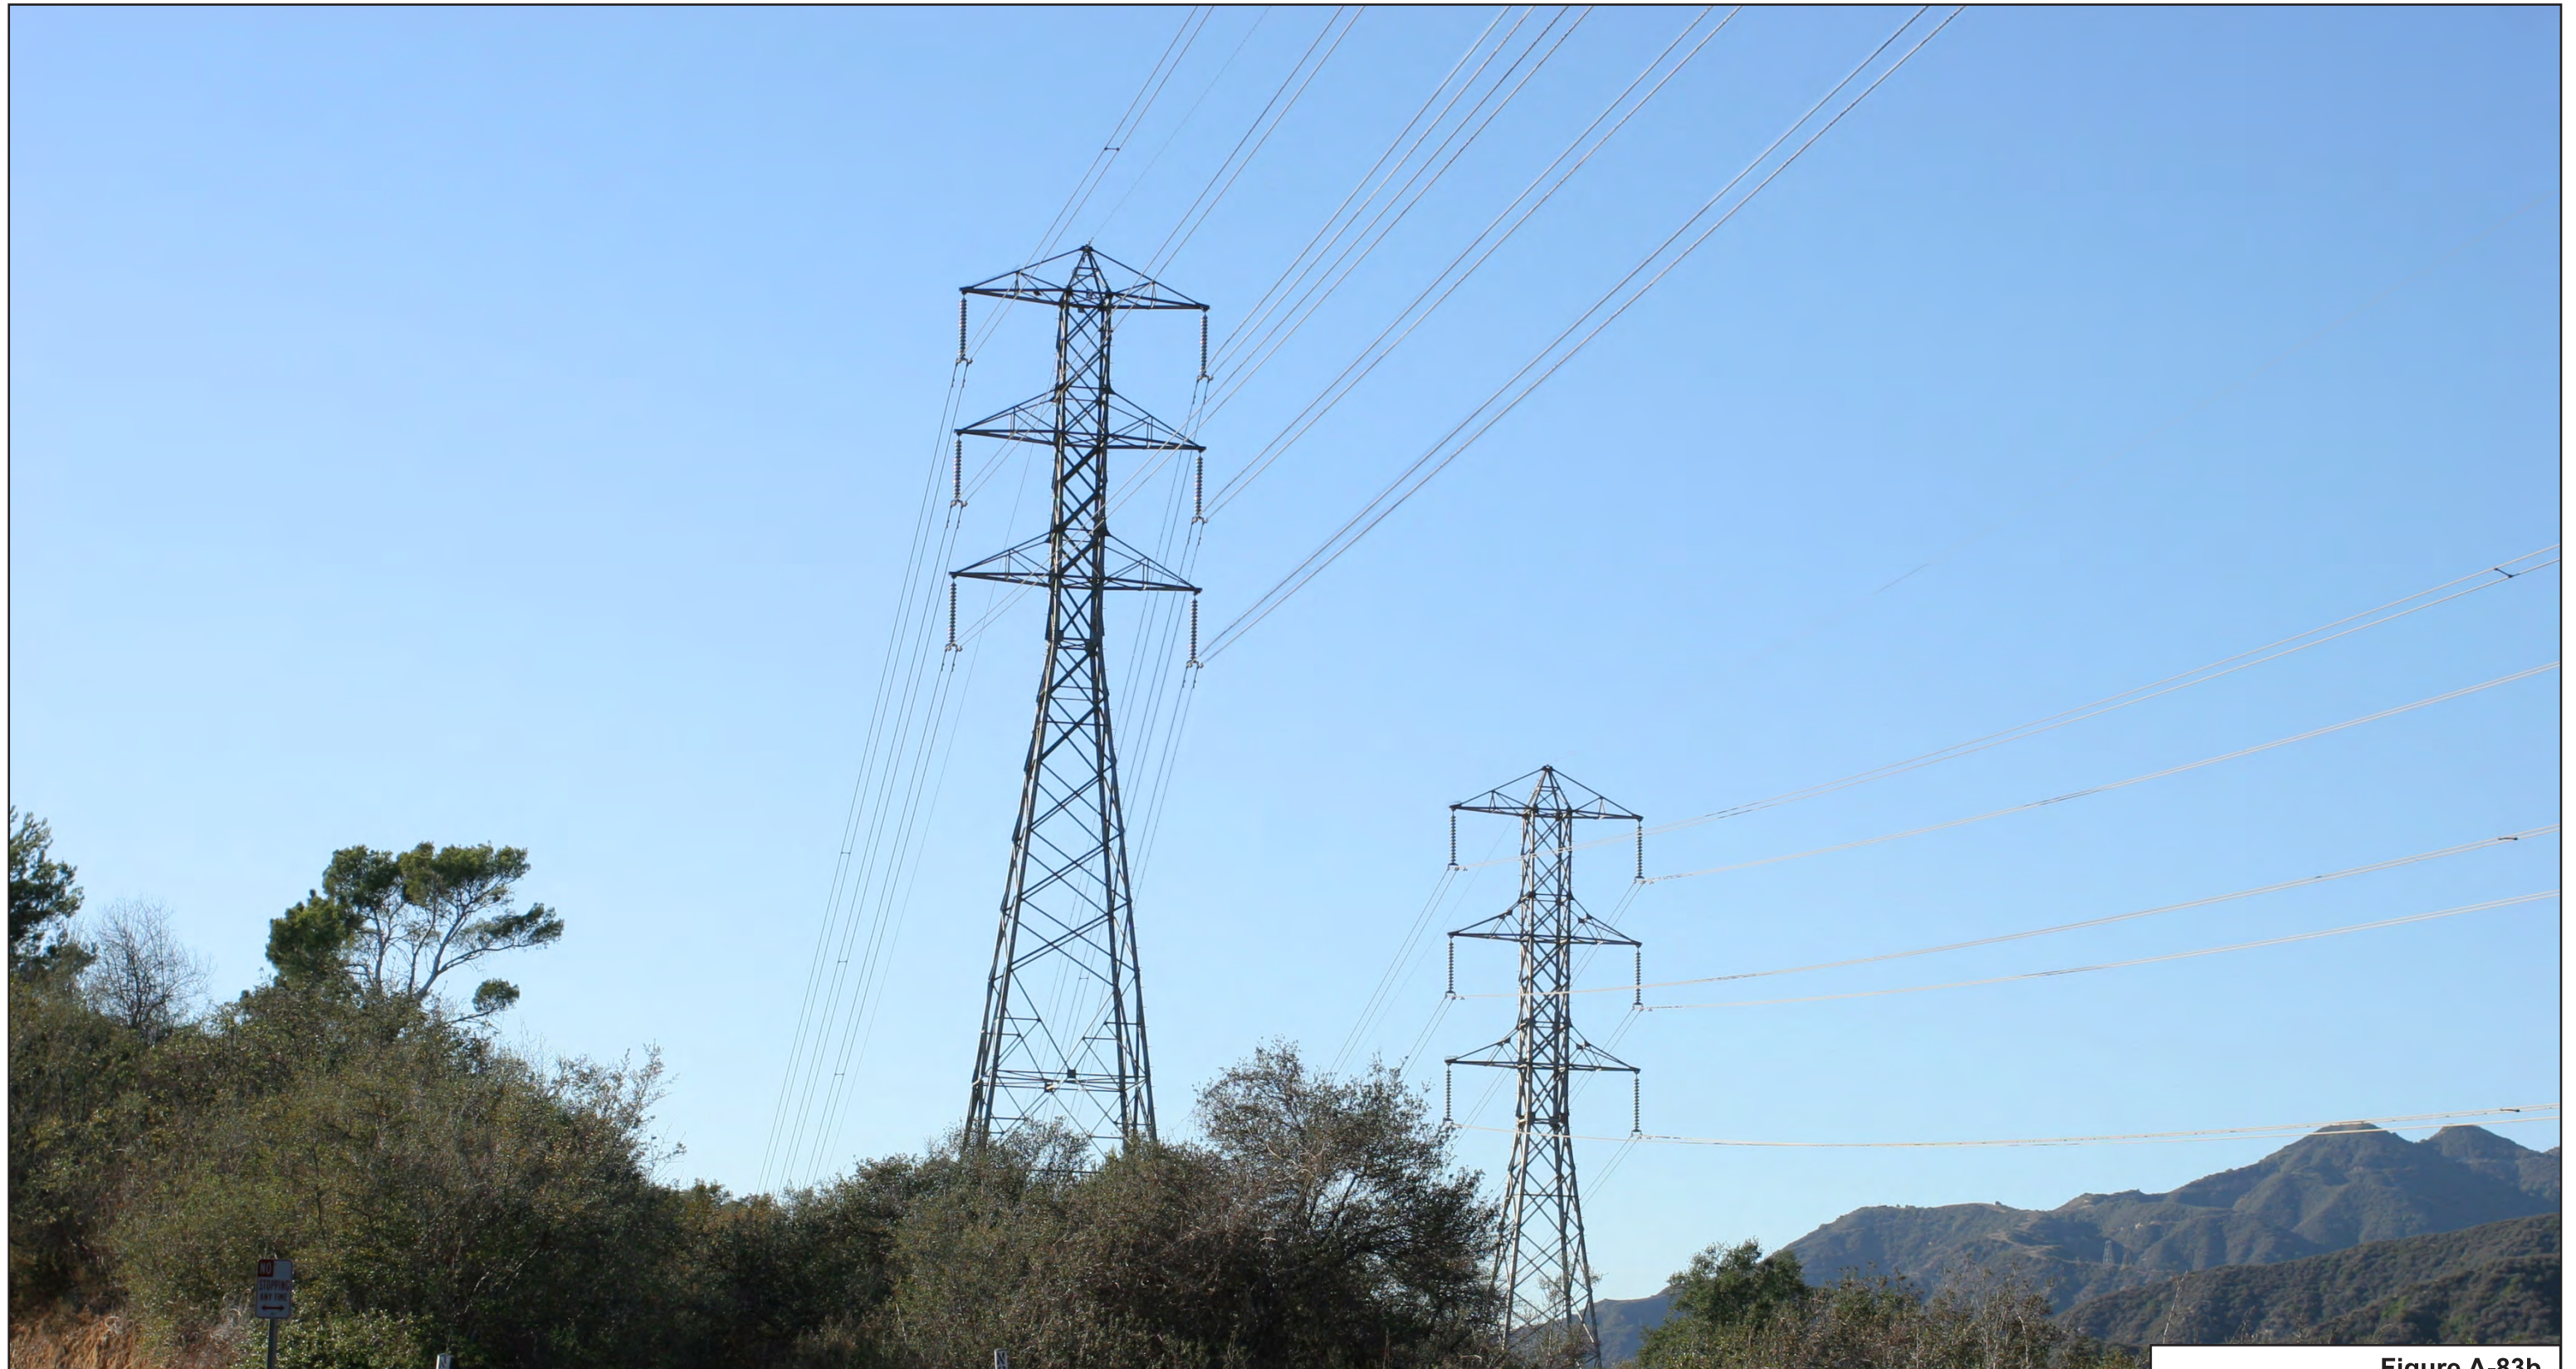
Future Scenic Integrity: High, with Areas of Unacceptably Low. In this portion of Segment 11, and for all areas from the Gould Substation to the Mesa Substation, new insulators would be hung on the vacant positions of these existing 220-kV double circuit towers and new conductors would be strung. The only visible change would be new insulators and conductors on existing LSTs. Access and spur roads are not visible from this vantage point.
