PROJECT MEMORANDUMPG&E - TRI-VALLEY 2002 CAPACITY INCREASE PROJECTTo:Roosevelt Grant, CPUCFrom:Vida Strong, Aspen Project ManagerDate:July 10, 2003Subject:Weekly Report #42: June 30, 2003 – July 6, 2003CPUC Environmental Monitor (EM): Anne Sweet

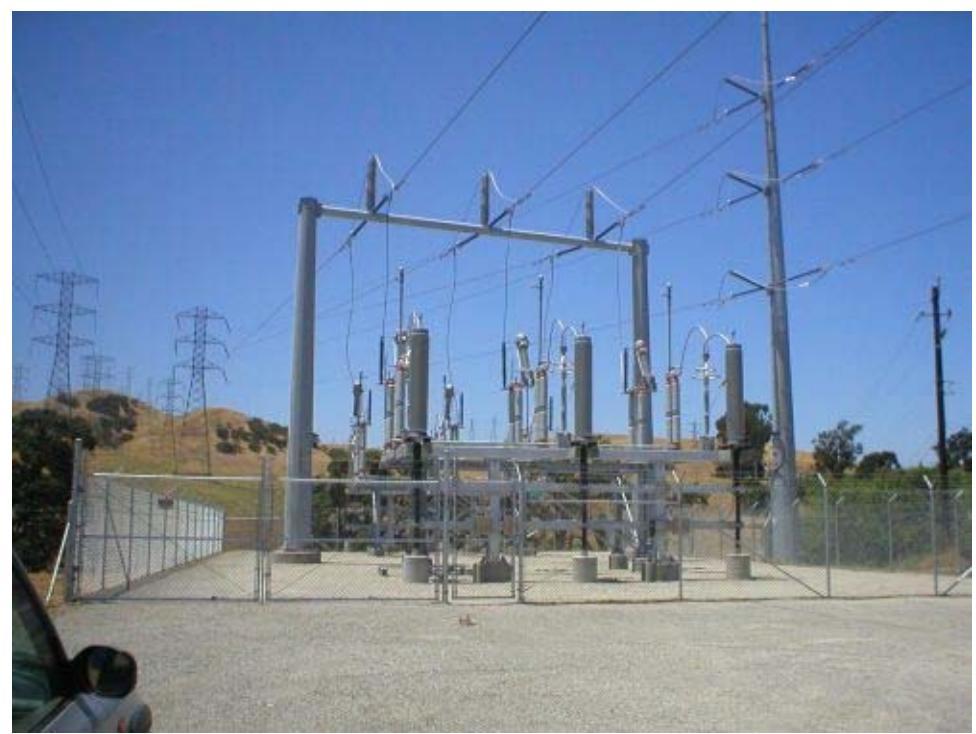
Figure 1 – Transition Station, Phase One.

Crews have finished the Transition Station work (see Figure 1). Crews continue to water the area that was previously seeded and mulched.
