PROJECT MEMORANDUM

ANTELOPE PARDEE PROJECT, SEGMENT 1

To: John Boccio, Project Manager, CPUC
Marina Kadota, Project Manager, ANF
From: Vida Strong, Aspen Project Manager
Date: February 26, 2008
Subject: Weekly Report #5 February 10-16, 2008

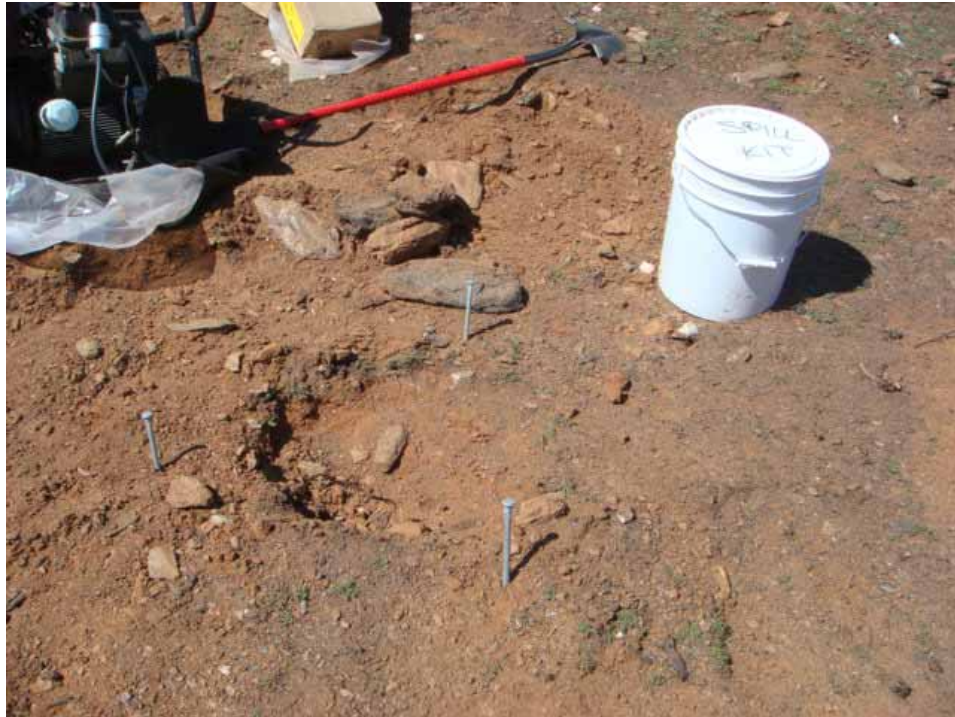
3. On February 13th, Dan Pearson (Burns and McDonald) contacted Marian Kadota (ANF) and notified her that a small gasoline spill was reported at Tower 50 during drilling operations. Reportedly, the spill (approximately 2-cups) was fully contained and removed from the site (see Figure 1). The drilling crew was shut down until the materials in the Spill Kit were replenished. Apparently, the drafts from the helicopter blew over the gas can and secondary containment, resulting in the spill.

Figure 1: Removal of gasoline spill and contaminated soils at Tower Site 50.

The ANF reported a Non-Compliance for the hazmat spill reporting procedures on February 13th. By not contacting ANF dispatch, PAR did not comply with the emergency response portion of the plan by contacting Marian Kadota instead. In addition, the ANF hazmat coordinator never got a final version of the spill plan with signatures. The ANF Ranger recommended that a Non-Compliance letter be drafted and that SCE provide ANF with the final signed plan by the end of the day. In addition, the contact and notification protocol information, as well as the complete Spill Plan, are to be included in each project spill kit.

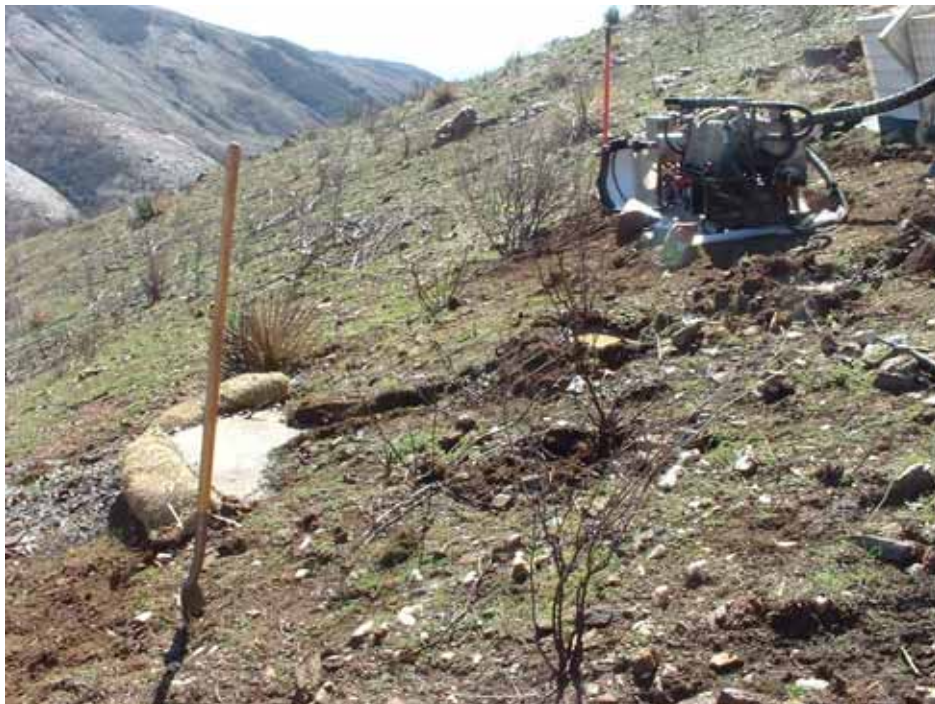
5. On February 14th, the site of the gasoline spill at Tower 50 was inspected by George Geer (ANF) and Jenny Slaughter (CPUC EM). The location of the spilled gas was flagged and the contaminated soil had been excavated. A covered 5-gallon bucket containing the contaminated soil was left on site and crews had left for the day due to high winds creating a hazard for helicopter work. The straw wattle was in place down slope from the drill site and some muddy material was observed to have flowed out from either side of the wattle. During the February 16 inspection, ANF representative M. Kadota had stated that as long as the water draining out from the wattle was not channeling or creating erosion, that it was acceptable (see Figure 2).

Figure 2: Straw wattles and catchment basins used to contain drilling mud at geo-tech sites at Tower site 53.

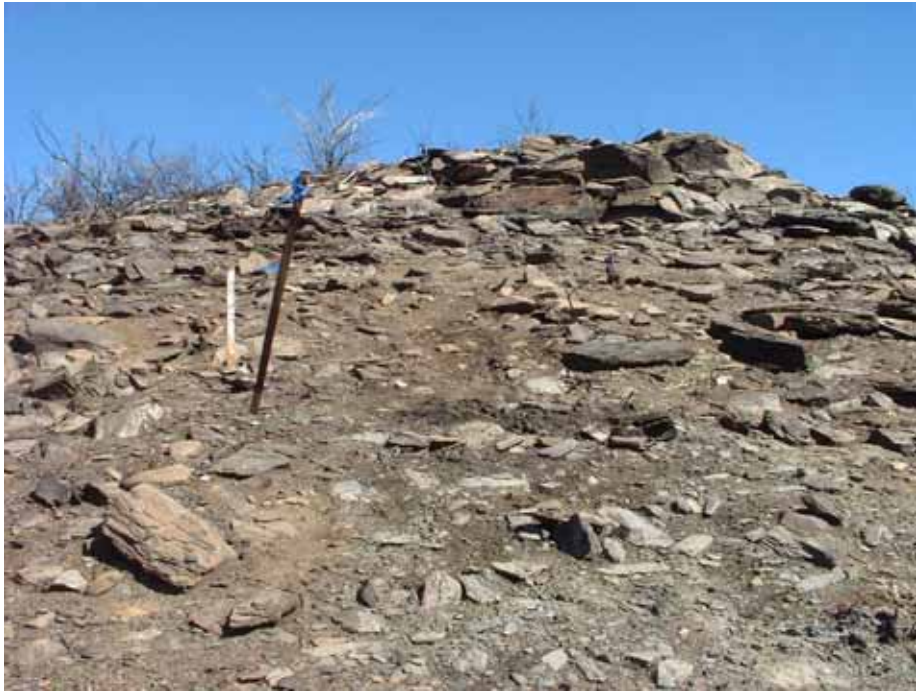
It was noted and reported that clean up of drilling sites was acceptable (see Figure 3) and that geo-tech fabric for weed control was under equipment at drilling locations.

Figure 3: Tower site 51 after drilling.
