**PROJECT MEMORANDUM  
SCE TRANSMISSION PROJECTS, SEGMENTS 1 - 11**

**To:** John Boccio, Project Manager, CPUC  
**From:** Vida Strong, Aspen Project Manager  
**Date:** November 10, 2011  
**Subject:** Weekly Report 196, October 23 to October 29, 2011

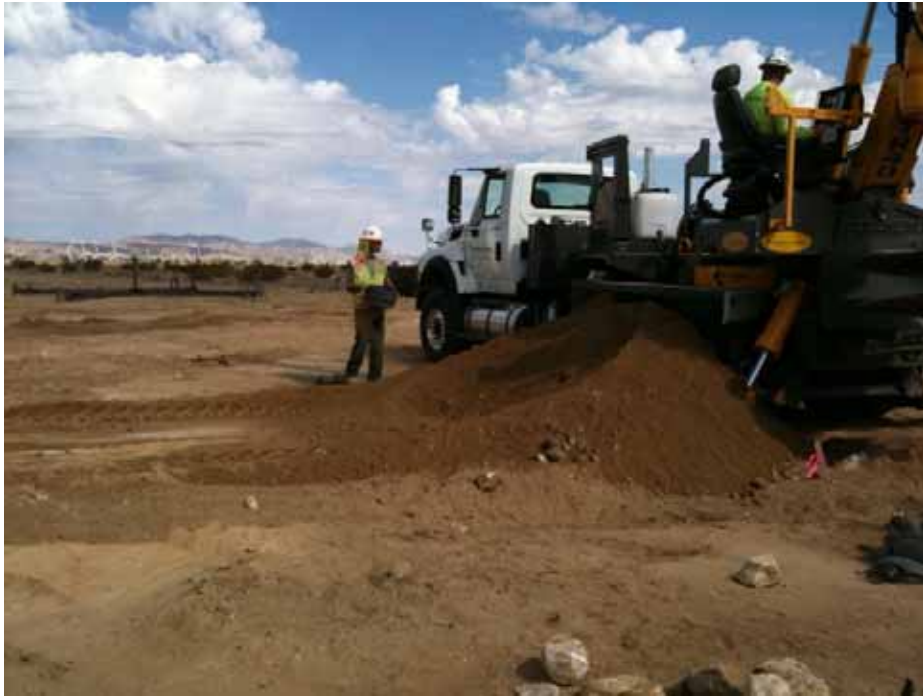
**Figure 1:** Paleontological monitor onsite during foundation drilling of Tower 29, Segment 10.

4. Segment 10: KV Structures (drilling contractor) continued drilling, setting rebar cages using a spider jig for stub angle placement, concrete pouring at Tower 29 (see Figure 1). H&M steel crews continued tower assembly and erection at Towers 8 thru 10, 12 thru 14, 27, 36, and 41. Moore Fence Company installed tortoise fence at the wire sleeve site between Towers 36 and 37 and at Tower 39. Fencing crews continued removing the temporary fence, conducted permanent fence maintenance,

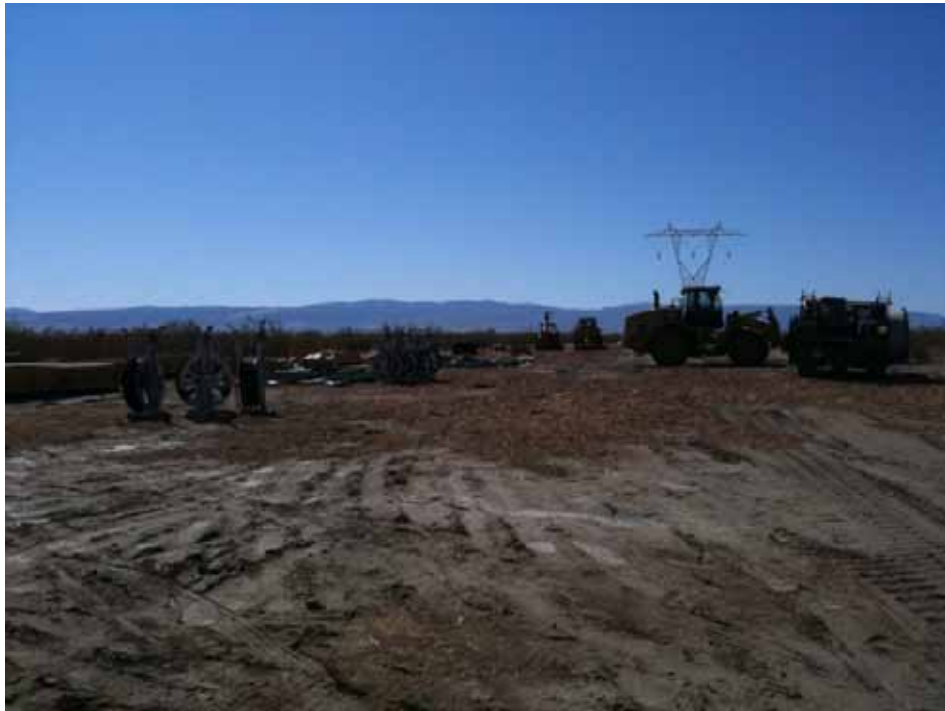
**Figure 2:** Wire stringing materials being hauled to wire set-up site between Towers 83 and 84, Segment 10 in preparation for wire stringing.

and sand bag replacement. H&H Grading completed mulching Joshua trees at Tower 1 and the Tower 3 wire set-up site. They also cleared and grubbed the five wire sleeve sites throughout the segment. Wire stringing preparation which consisted of hauling materials into the wire pull site between Towers 83 and 84 was conducted (see Figure 2).

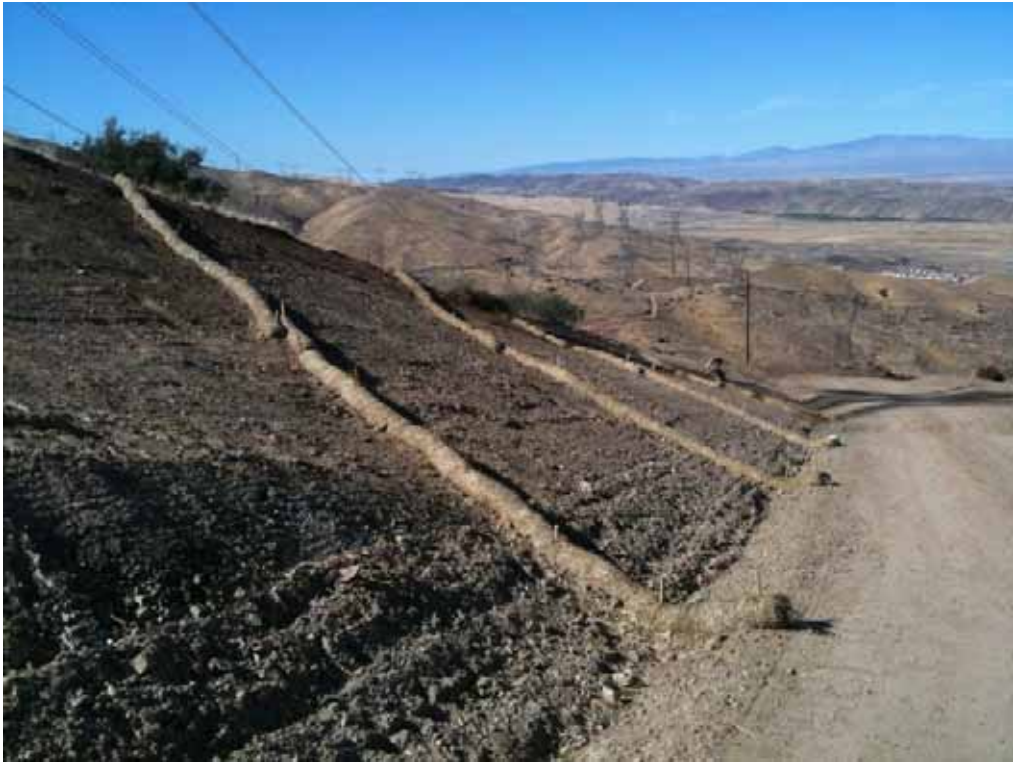
**Figure 3:** Fiber rolls installed in the disturbance area near Tower 49, Segment 5.

3. The CPUC EM provided the SCE Environmental Coordinator with photo documentation concerning potential erosion of disturbance areas that are adjacent to access roads which would cause sedimentation to leave the site. BMP's were recently installed (see Figure 3).

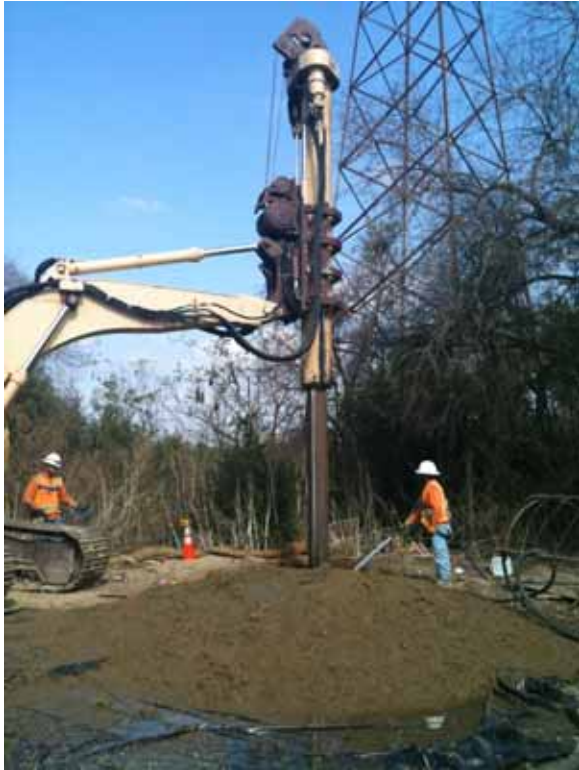
**Figure 4:** Foundation drilling along Siphon Road in Whittier Narrows with spill pile, Segment 8 66 kV.

5. The CPUC EM noted trackout and concrete containment concerns during a site visit on October 26<sup>th</sup> to 66 kV foundation drilling along Siphon Road on the Walnut-Hilgen-Industry-Mesa-Reno line. The following day, the trackout had been hand-swept. The concrete had been contained on plastic tarps but had spilled off of the plastic. The spilled concrete was immediately cleaned by the contractor. An SCE Level 1 non-compliance was issued for the incident.

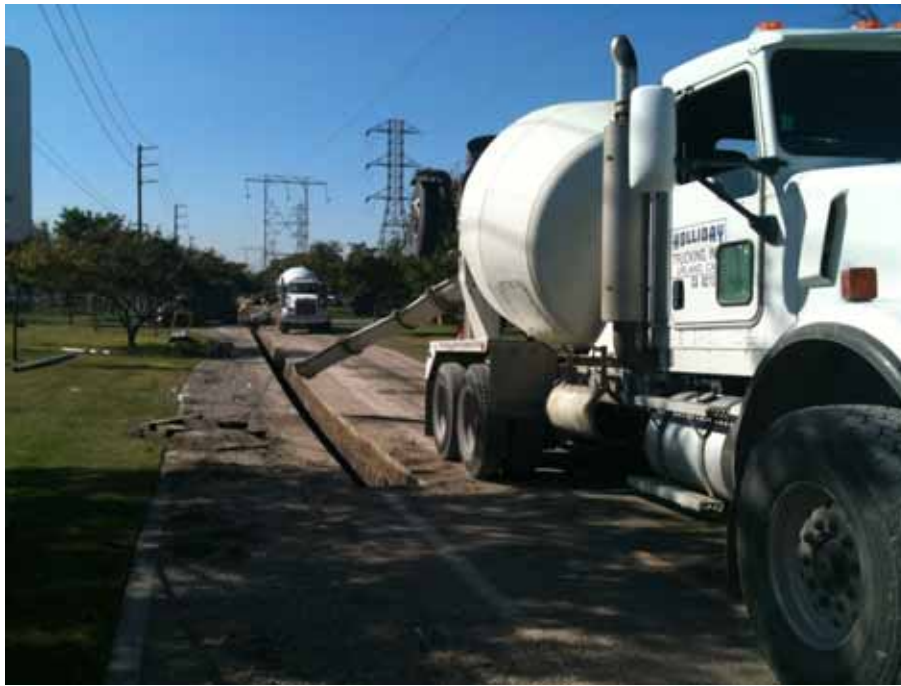
**Figure 5:** Concrete pour in a distribution trench in Ayala Park, Segment 8 66 kV underground.

2. Segments 7 & 8, 66 kV: During the subject period, Wilson crews continued work on foundations within the Whittier Narrows recreation area on the Rio Hondo–Amador-Jose-Mesa line and continued work along San Gabriel Boulevard on the Walnut-Hilgen-Mesa-Industry-Reno line (see Figure 4). Henkels and McCoy continued work on the overhead portion on both lines. Work included foundation drilling as well as pole setting. PAR crews continued digging vaults and distribution trench lines within Ayala Park in the City of Chino as part of the 66 kV underground/Chino substation relocation (see Figure 5).

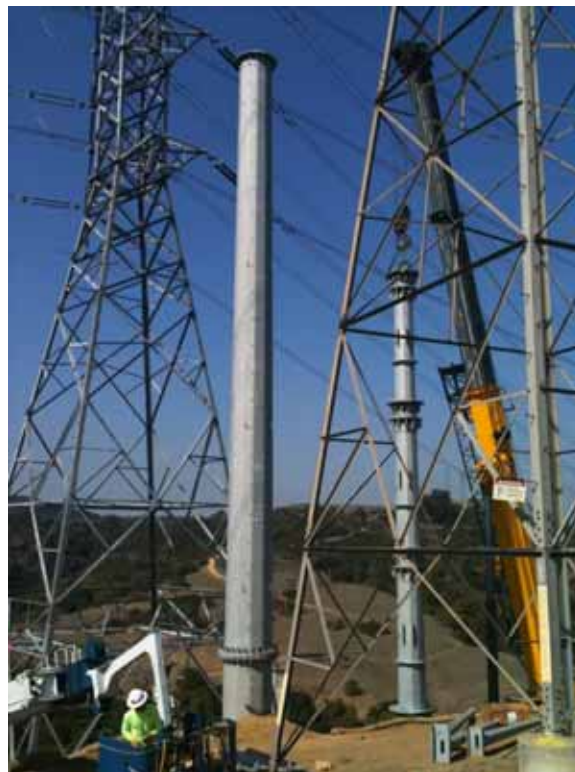
**Figure 6:** Crews dismantle a shoofly pole, Segment 8.

Fullerton shoo-fly, sagging, clipping and hanging jumpers and removing shoo-fly poles (see Figure 6). DCX continued drilling at three tower locations. Tri-State continued drilling one foundation at the Interstate 605 (I-605) Shoofly. Foundations are now 24% complete on Phase 4. To date, 100% of the conductor and 95% of the structures on the existing 220 kV Chino-Mesa line have been removed. In total, foundations are 28% complete, one structure on the new double circuit 500 kV Mira Loma-Vincent line has been erected, and three structures on the 220 kV Chino-Mesa line have been erected.

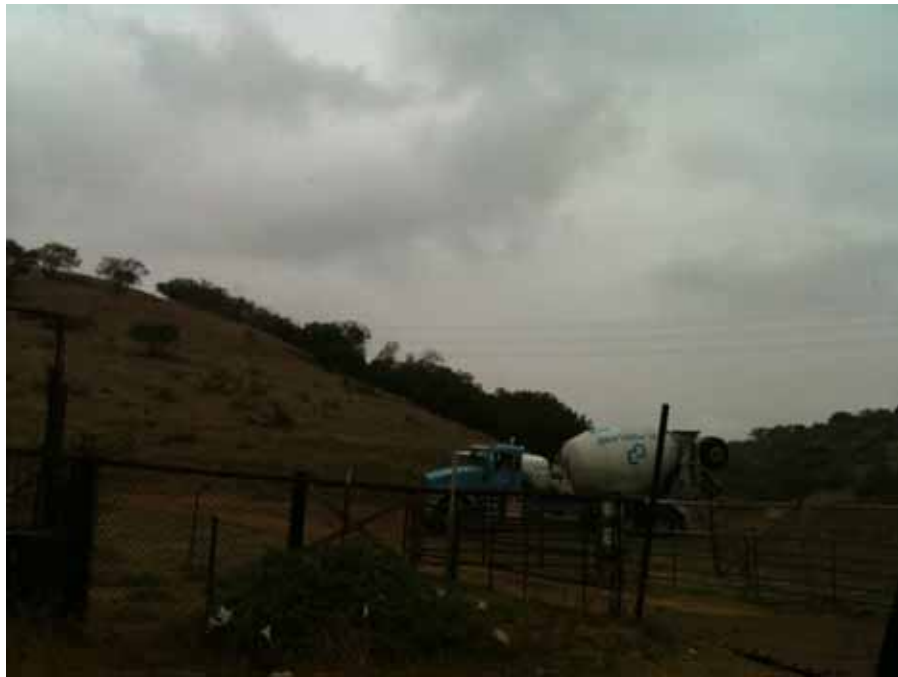
3. The CPUC EM observed a concrete truck parked beyond the limits of an approved access road near the entrance to M54-T3 on October 25<sup>th</sup> (see Figure 7). The CPUC EM notified the ICF Segment 8 Lead Biologist. An SCE Level 1 non-compliance was issued for the incident.

**Figure 7:** A concrete truck parked outside of an approved access road, Segment 8.

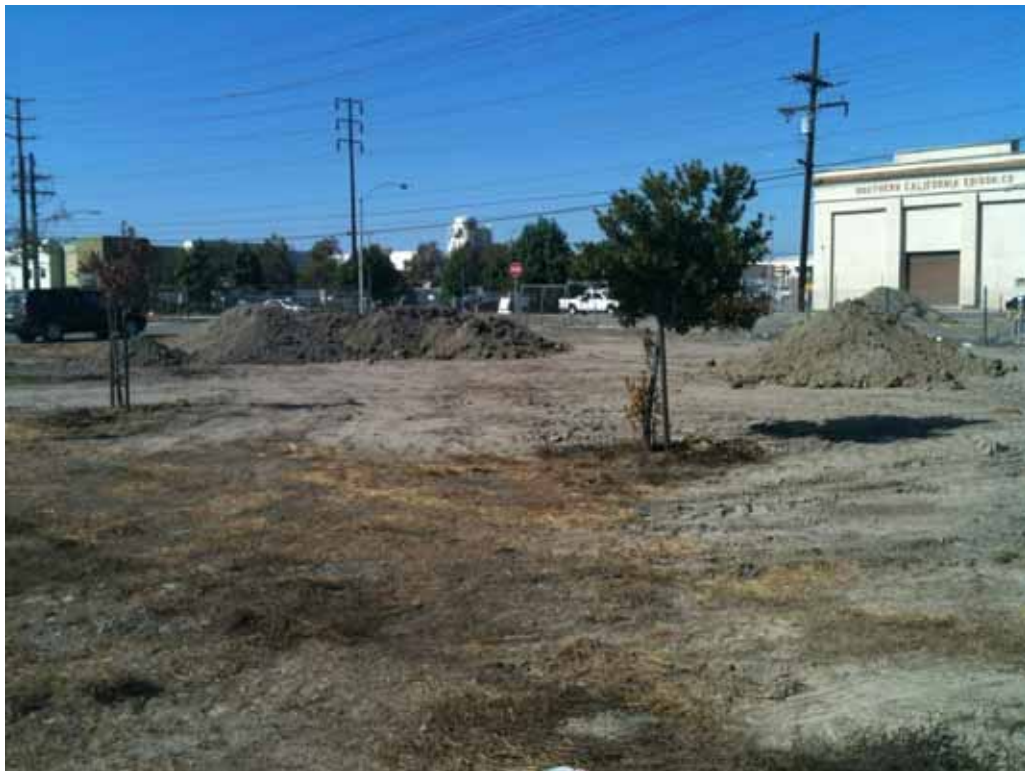
4. On October 26<sup>th</sup> a PAR crew member working within Ayala Park hit a distribution line with an excavator. The line fell to the ground and started a small vegetation fire (see Figure 8). The fire was extinguished and did not impact any resources. The CPUC EM was informed of the incident by personnel in the field and requested that SCE provide notifications of incidents of this nature in the future.

**Figure 8:** Burn area within Ayala Park, Segment 8 66 kV.
