**PROJECT MEMORANDUM  
SCE TRANSMISSION PROJECTS, SEGMENTS 1 - 11**

**To:** John Boccio, Project Manager, CPUC  
**From:** Vida Strong, Aspen Project Manager  
**Date:** December 22, 2011  
**Subject:** Weekly Report 201, November 27 to December 03, 2011

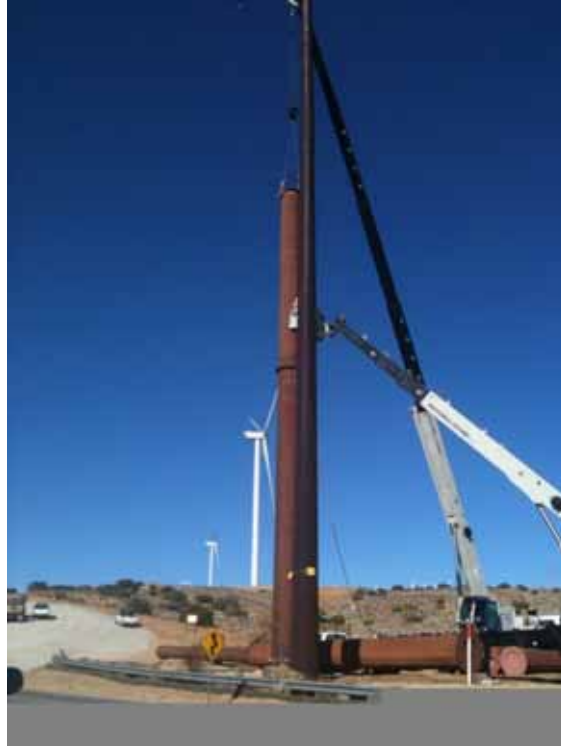
3. The Wilderness Line work, associated with Segment 3B, occurred along Oak Creek Road. Three tubular steel pole (TSP) foundations were completed (see Figure 1). Partial erection of one TSP occurred (see Figure 2). The remaining work is on hold until Segment 3B work begins in this area.

**Figure 2:** TSP erection along Oak Creek Road, Wilderness Line, Antelope Transmission Segment.

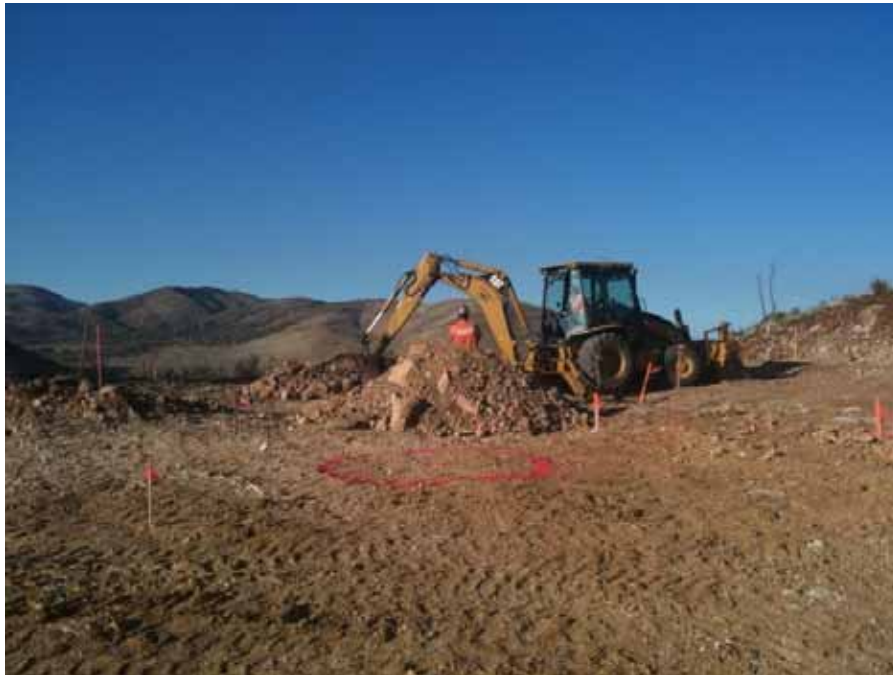
3. Segment 5: Woodward Brothers (drilling contractor) continued drilling, setting rebar cages, and concrete pouring at Tower 55A. H&M steel crews continued tower assembly and erection of the Midway-Vincent upgrade Towers M90-T1X, M91-T2X, and M92-T1X. H&H Grading conducted BMP (i.e. fiber roll) maintenance throughout the segment. Cattracts continued hauling rock (from Tower 68 excavation) to an approved off-site landfill in Lancaster. They also mobilized to Tower 25 to conduct slope stabilization work. Crux partially mobilized to Tower 68 to prepare for micro-pile foundation work (see Figure 3).

**Figure 3:** Crux conducting preliminary digging at Tower 68, Segment 5.

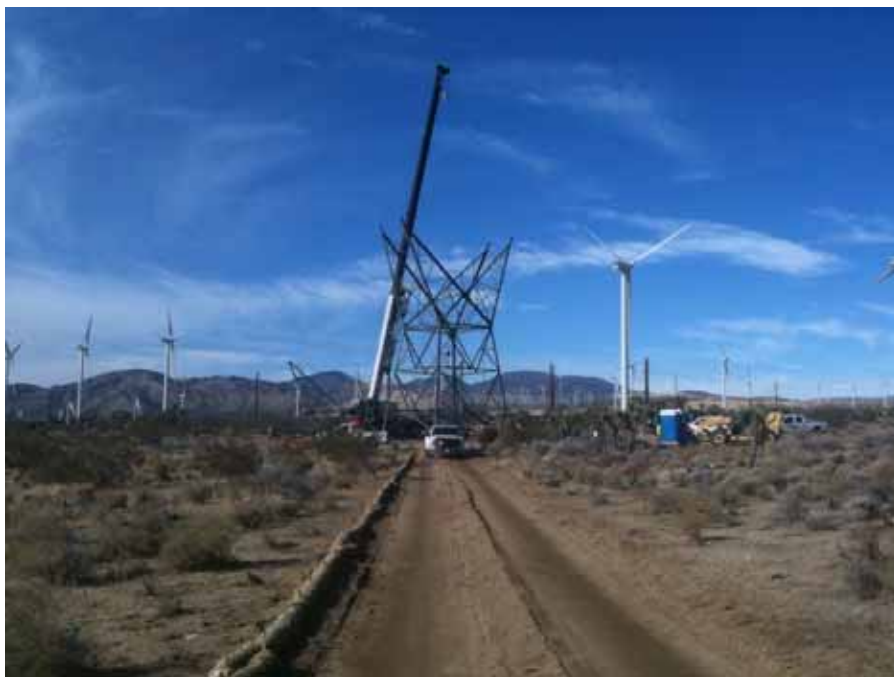
**Figure 4:** H&M steel crew erecting Tower 3, Segment 10.

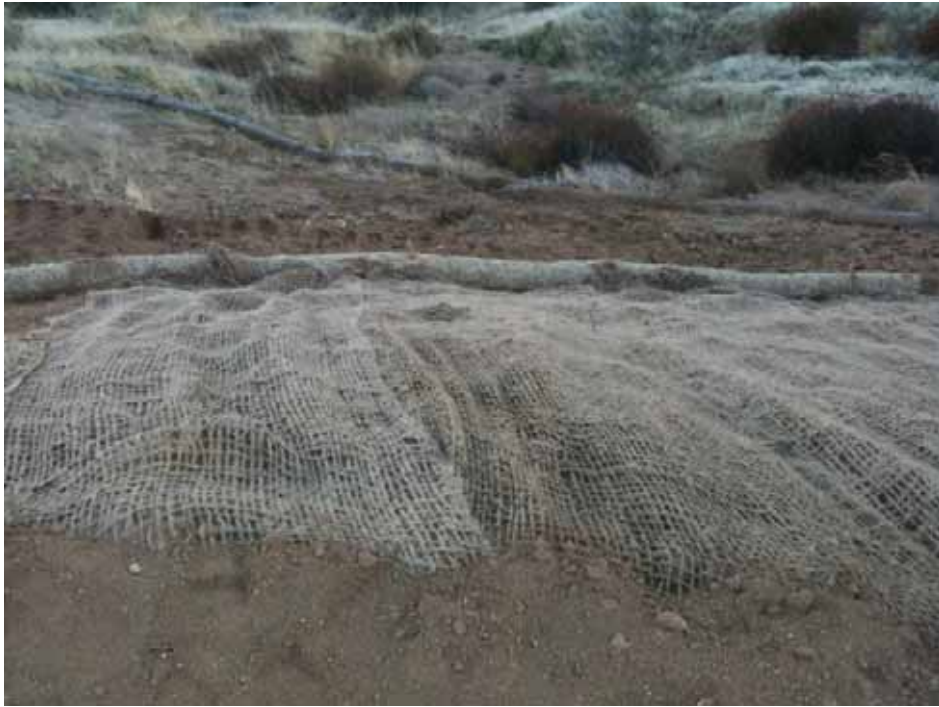
5. Jute netting was installed on a slope at Tower 50 disturbance area on Segment 5 (see Figure 5).
6. The CPUC received a memorandum from SCE on April 11<sup>th</sup> in regards to topsoil salvage from temporary disturbance sites for restoration and visual requirements for Segments 4, 5 and 10. So far, there has been no salvaging of topsoil in project areas. In response to the memorandum, CPUC has requested that SCE document their topsoil salvaging plans by Project segment. In addition, in response to a May 26th site visit on Segments 7 & 8 regarding top soil salvaging, the HMMP for Segments 4, 5 & 10 will be revised to reflect the top soil salvaging protocols discussed during the site visit. The revised Segment 7 & 8 HMMP was submitted on November 23rd.

**Figure 5:** BMP repair at Tower 50 (jute netting was installed), Segment 5.

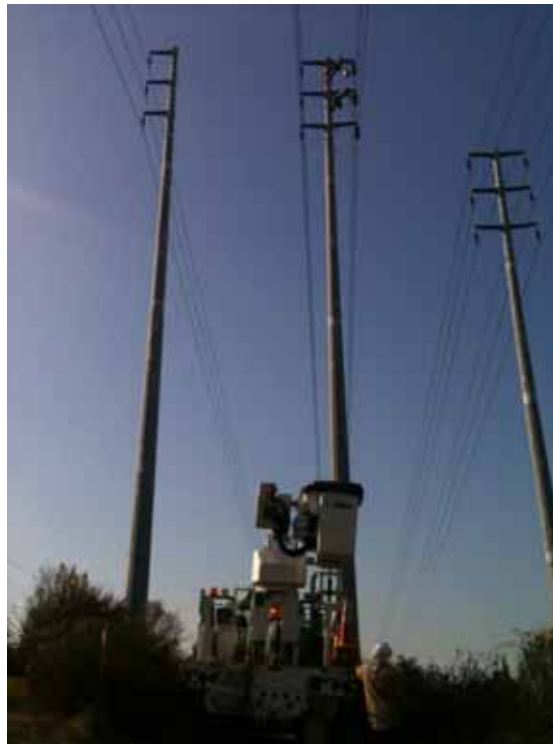
3. Segments 7 & 8, 66 kV: During the subject period, PAR crews continued digging vaults, and distribution and telecom trench lines within Ayala Park and across Edison Avenue (into Chino Substation) in the City of Chino as part of the 66 kV underground/Chino Substation relocation. Additionally, SCE crews framed poles within Chino Substation and replaced insulators within Montebello Hills (see Figure 6).

**Figure 6:** SCE crews install new insulators within Montebello Hills.

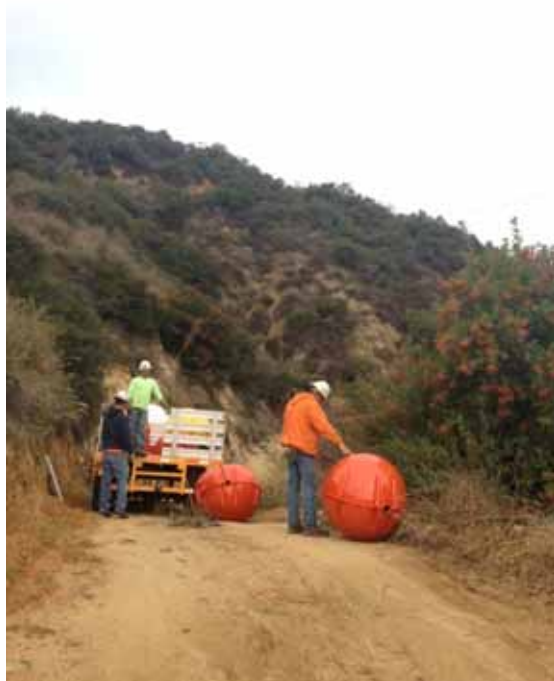
**Figure 7:** Crews unload marker balls to be hung on Segment 7 spans.

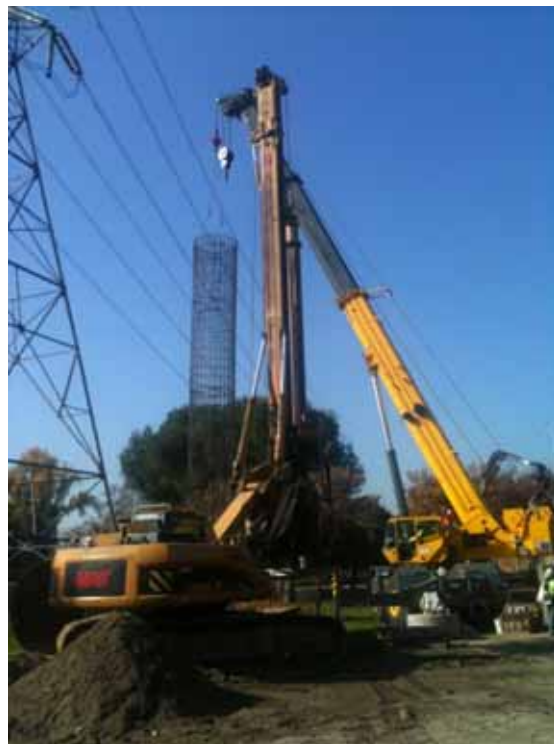
**Figure 8:** Crews load a rebar cage at M39-T4, Segment 7.

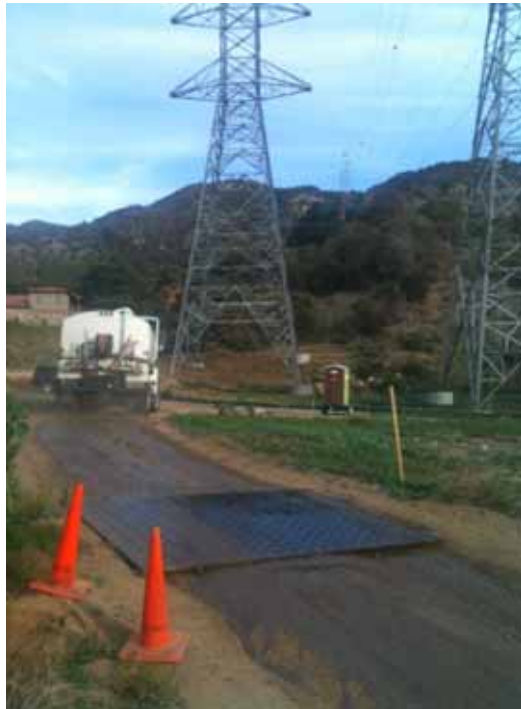
2. The CPUC EM spoke with crews during marker ball and light installation on Segment 7 about increasing the frequency of watering because of past incidents of fugitive dust at the site (see Figure 9).

**Figure 9:** A water truck at Tower M54-Ta, Segment 7.

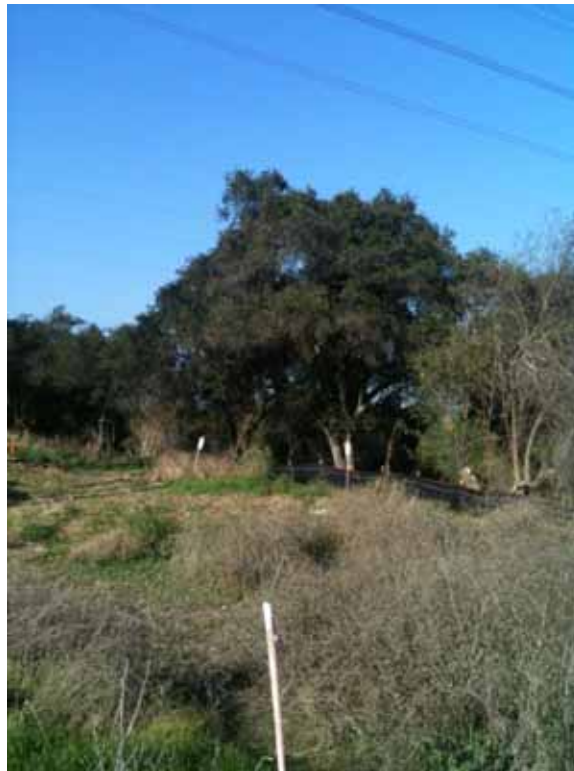
5. During the subject period, the CPUC EM observed that silt fence at the San Gabriel Junction had been installed within the dripline of oak trees at the site (see Figure 10). The CPUC EM spoke with the Segment 8 Lead Monitor on-site, who said she had already spoken to SCE about the fence placement.

**Figure 10:** A silt fence at San Gabriel Junction inside the dripline of an oak tree.
