PROJECT MEMORANDUM SCE TRANSMISSION PROJECTS, SEGMENTS 1–11

Subject: Weekly Report 214, February 26 to March 03, 2012

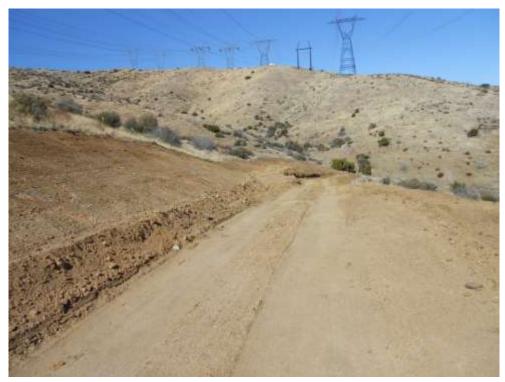
Figure 1: New access road to Midway-Vincent Upgrade Tower 86A, Segment 5.

- 3. Segment 5: Foundation work is 100% complete. H&M steel crews continued tower assembly and erection of Tower 19, 42, and 88A. Lattice tower erection is 97% complete and TSP erection is 100% complete. A total of 5.68 circuit miles of wire has been installed. H&H Grading continued BMP maintenance and site restoration throughout the segment. The new access road to Tower 86A is partially complete (see Figure 1).

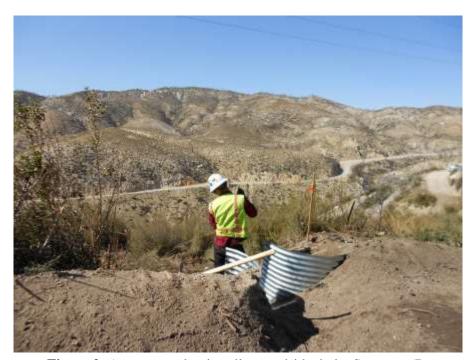
Figure 2: A crew member installs a roadside drain, Segment 6B.

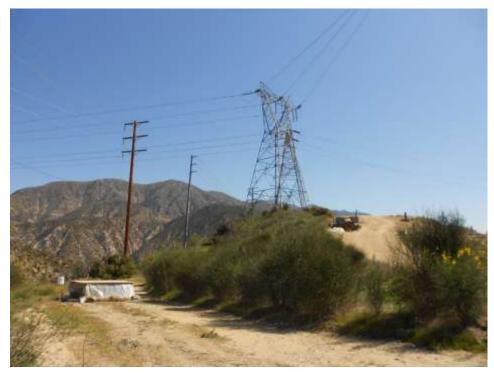
Figure 3: Newly established concrete washout and new structure foundation at Gould substation, Segment 11D.

- 5. Segment 11A: Construction activity on Segment 11A is now complete with the exception of jumpers at M11-T1 and M10-T5 which are awaiting material.
- 6. Segment 11D: Crews began foundation drilling at Structures 68 and 69 (see Figure 3).

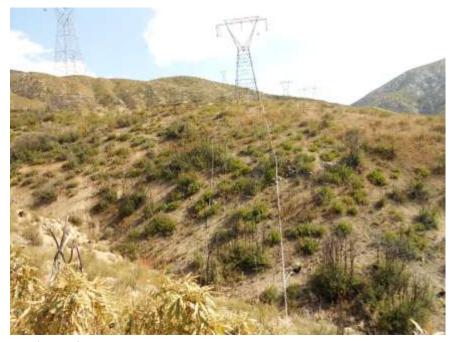
- 2. On March 1st, SCE issued PAR a Level 2 non-compliance for conductor touching the ground between Towers 62 and 63 on Segment 6B. This occurred during conductor removal (see Figure 4).

Figure 4: Conductor placed on ground during wire removal between Towers 62 and 63, Segment 6B.

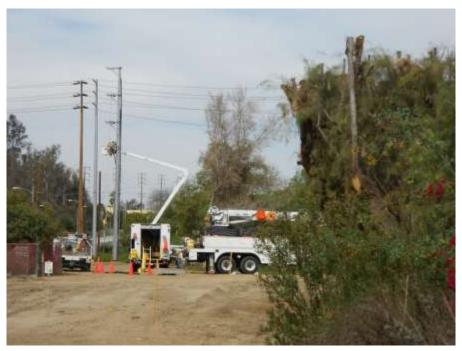
Figure 5: A 66 kV crew installs hardware on a pole, with an ESA for a bushtit nest shown in the foreground.

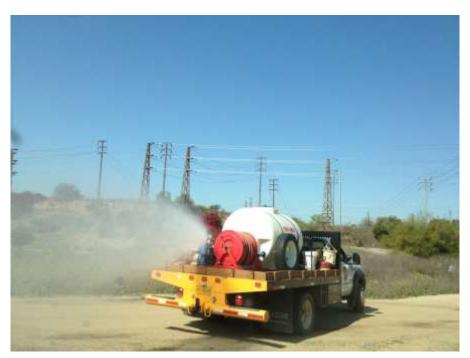
Figure 6: Dust control suppression during stringing preparation between towers M42-T5 and M42-T6, Segment 7.

- 2. Segment 7: Wilson crews mowed, installed BMPs and performed BMP inspections at tower sites and wire setup sites to keep environmental surveys active. Wilson continued assembly at six towers and prepped for conductor stringing (see Figure 6). Tri-State continued with foundation construction at five locations, within Whittier Narrows and adjacent to I-605 and Highway 60. DCX continued work on two foundations within a nursery adjacent to I-605. To date, 100% of the conductor of the existing 220 kV Antelope-Mesa line has been removed and 100% of the structures have been removed. Of the 78 new double circuit 500 kV structures on the Mira Loma-Vincent line, a total of 8.2% of the conductor is strung, 63% of the foundations are complete and the structure assembly is 40% complete.
