**PROJECT MEMORANDUM
SCE TRANSMISSION PROJECTS, SEGMENTS 1–11**

To: John Boccio, Project Manager, CPUC
From: Vida Strong, Aspen Project Manager
Date: June 26, 2012
Subject: Weekly Report 227, May 27 to June 2, 2012

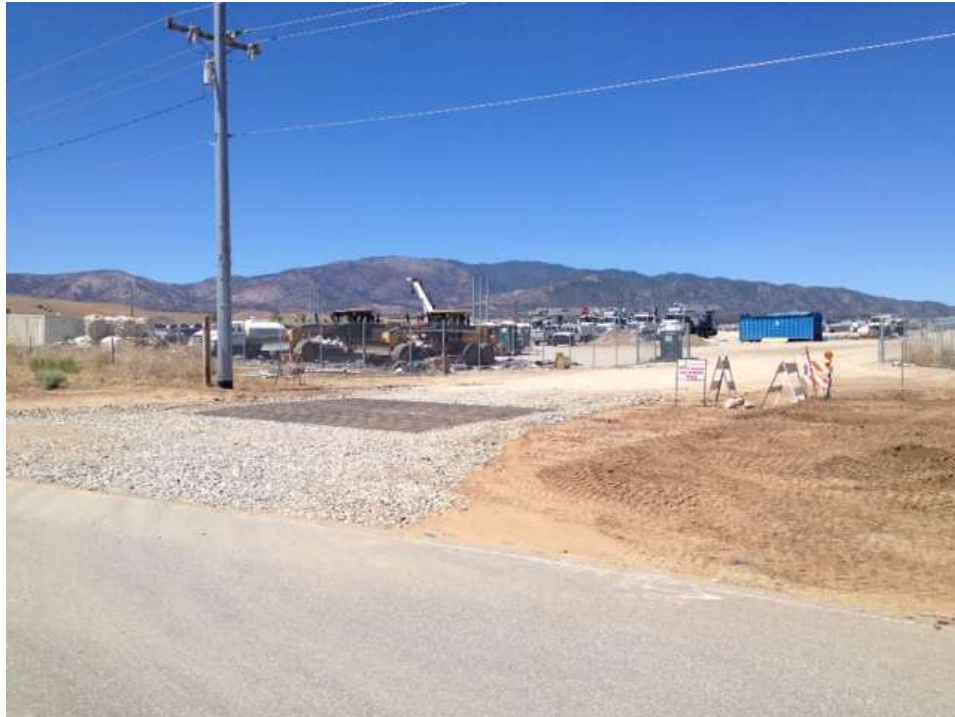
Figure 1: New shifted entrance to the Highwind Material Yard, Segment 3B.

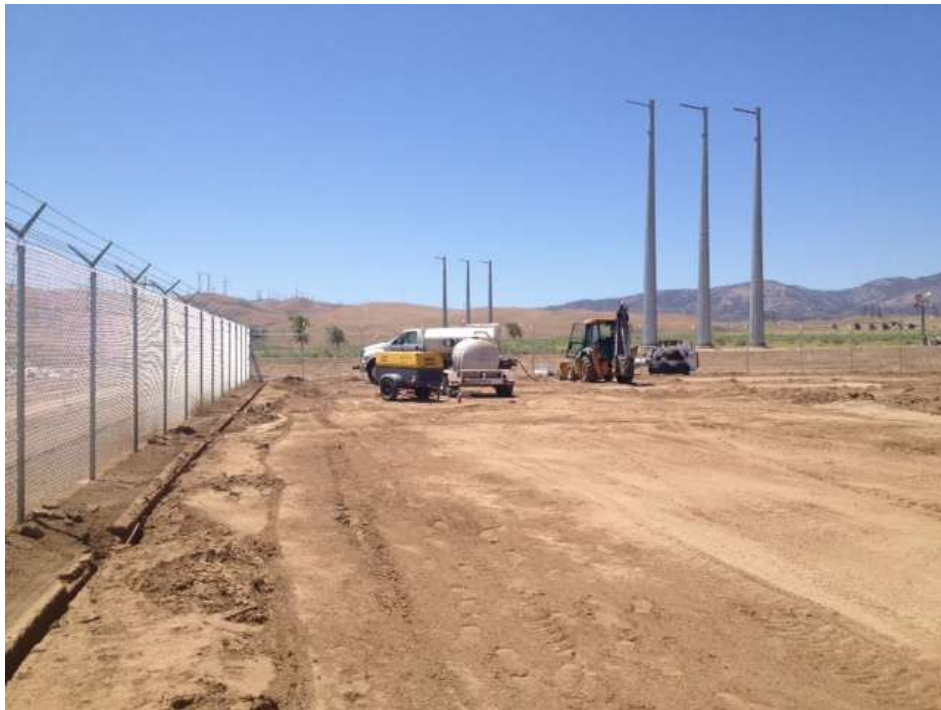
4. Highwind Substation: During the subject period, H&H Grading continued grading the new access road and drains that lead into the substation. After the Highwind Material Yard fence was moved, H&H Grading continued access road work up to Jameson Street. Perimeter fence installation occurred around the substation footprint and form work for the MEER building took place (see Figure 2). Grubbing and BMP placement is 100% complete.

Figure 2: Perimeter fence installation at Highwind Substation, Segment 3B.

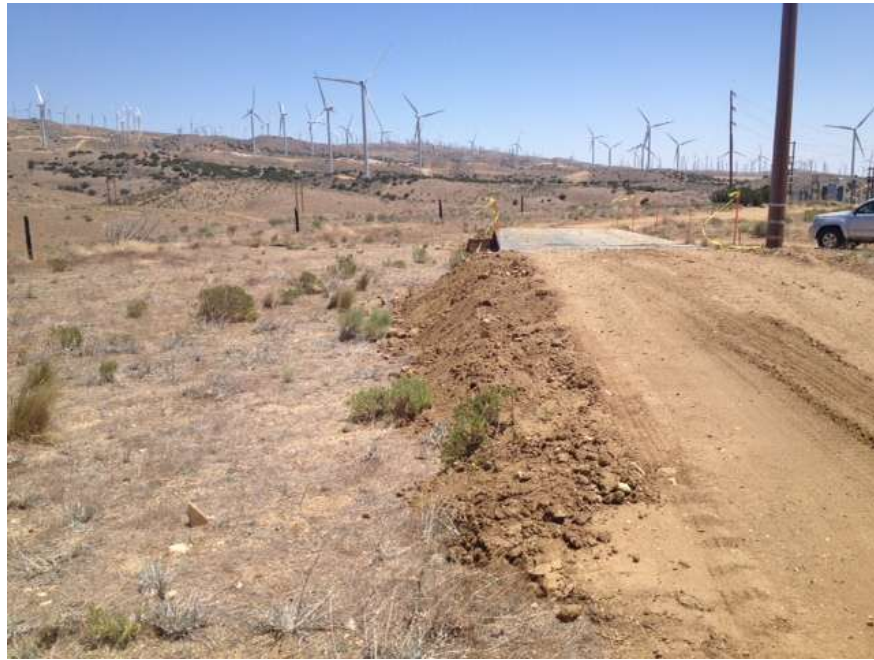
3. A temporary bridge called a Quickbridge was installed over the pipeline crossing on the access road north of Construct 41. Spoil ramps were placed on either side of the bridge for stabilization and safety reasons. The spoil ramps fall outside the existing road prism (see Figure 3). The CPUC EM notified the SCE Environmental Coordinator and project management. SCE will address this issue in the form of a non-compliance and a variance request will need to be processed.

Figure 3: Spoil ramp falling outside the existing road prism at the temporary bridge north of Construct 41, Segment 3B.

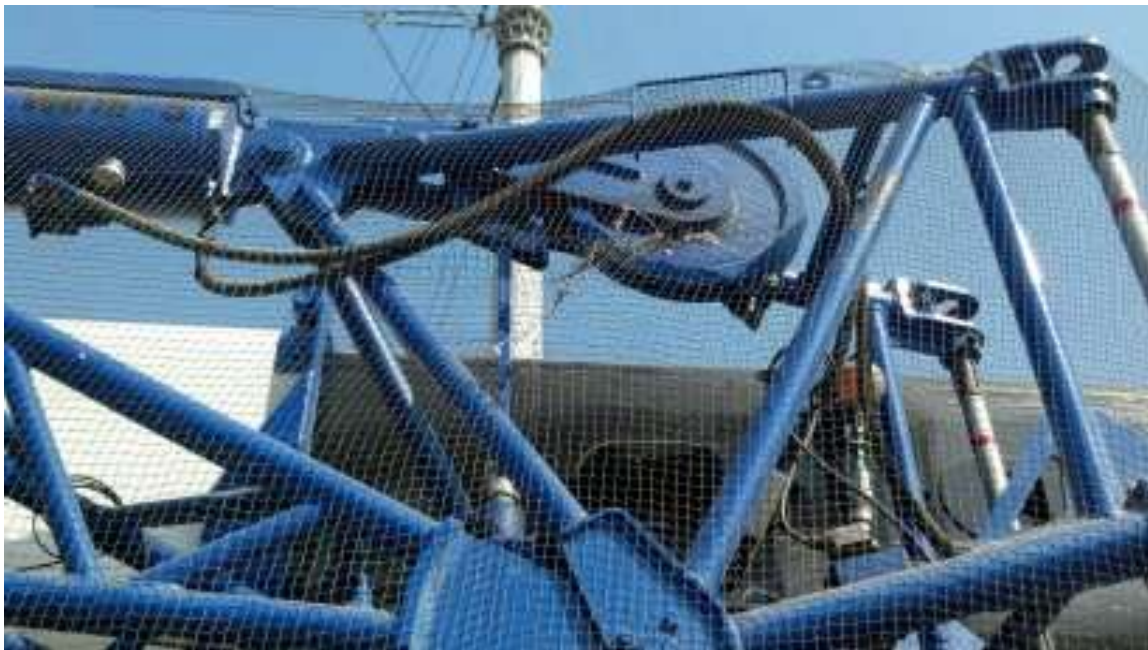
4. Coastal California gnatcatcher, yellow warbler, least Bell's vireo, Cooper's hawk and San Diego black-tailed jackrabbit were observed during the subject period by Biological Monitors.
5. Bird exclusionary netting over stationary equipment was inspected and repaired as needed (see Figure 4).

Figure 4: Bird netting over equipment was inspected and holes repaired at the 605 Yard.
