**PROJECT MEMORANDUM
SCE TRANSMISSION PROJECTS, SEGMENTS 1–11**

To: John Boccio, Project Manager, CPUC
From: Vida Strong, Aspen Project Manager
Date: November 15, 2012
Subject: Weekly Reports 245–247: September 31 to October 20, 2012

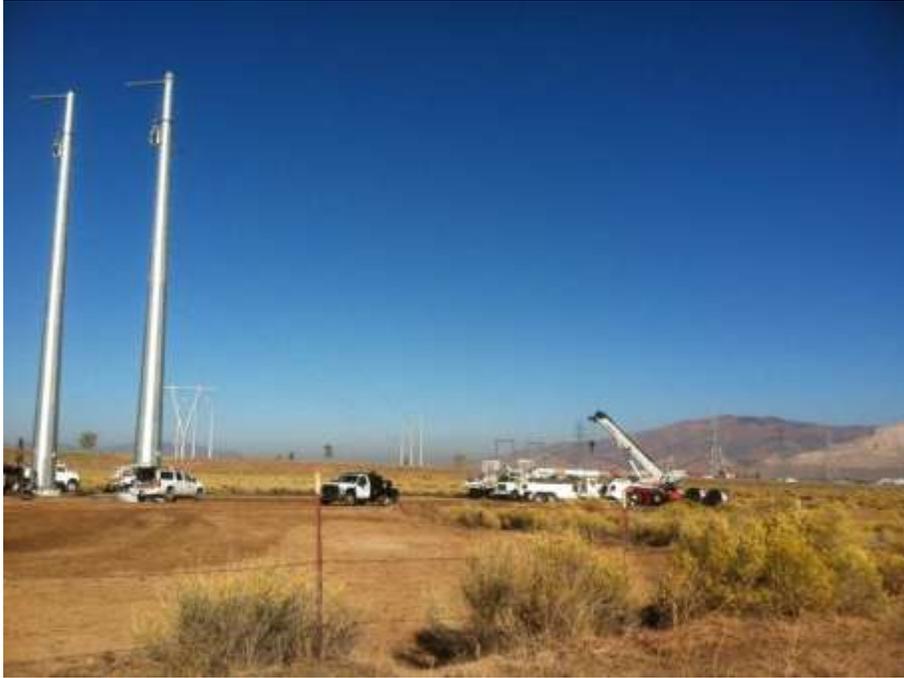
Figure 1: Segment 3B Wire Stringing operations at Construct 4.

8. Wire stringing occurred at Constructs 4 to 35, 55, and 56 (see Figure 1). Wire stringing was conducted by helicopter.
9. AC Mitigation road trenching occurred at PGE-A-GR06 and PGE-A-GR07. AC Mitigation zinc long and zinc short trenching occurred in the vicinity of Constructs 44 to 46. AC Mitigation well activity occurred at EP1901-GR01, EP1901-GR02, EP1901-GR03, EP1901-GR04, EP1901-GR05, EP1901-GR06, EP1901-GR08, EP1901-GR09, PGE-A-GR-2, PGE-A-GR-3, PGE-A-GR-4, PGE-A-GR-5, PGE-A-GR-6, PGE-A-GR-7, PGE-A-GR-9, PGE-A-GR-11, PGE-A-GR-12, and PGE-B-GR-2.

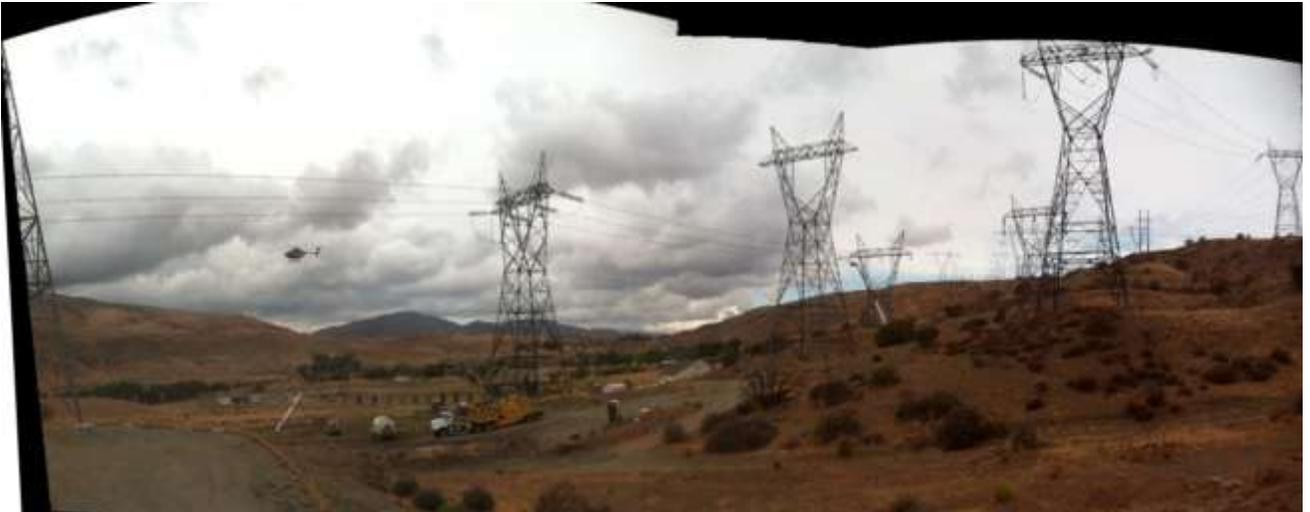
Figure 2: Segment 5 wire stringing operations at Construct 28B.

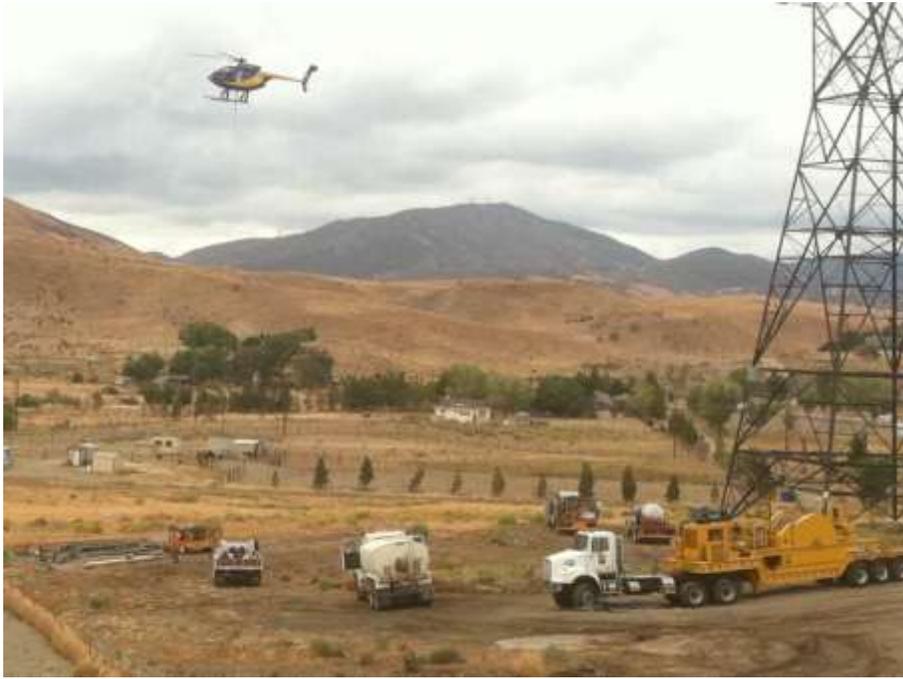
Figure 3: Segment 5 wire stringing operations at Construct 28B.

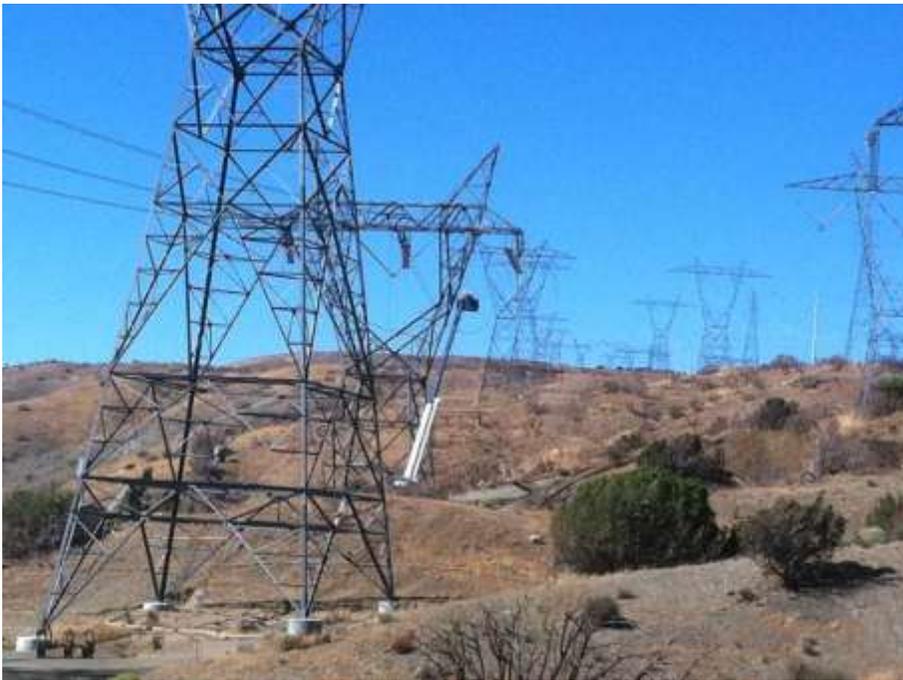
Figure 4: Segment 5 dead ending activities at Construct 28B.

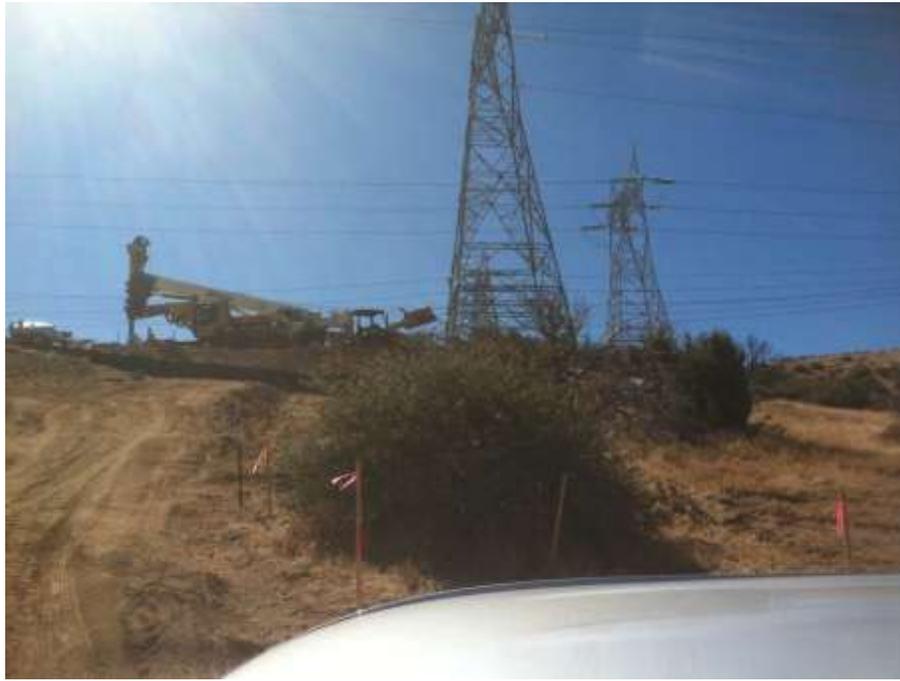
Figure 5: Sagebrush foundation excavation activities at Construct 236A.

5. Segment 5: Foundation work is 100% complete. Lattice tower erection is 100% complete and TSP erection is 100% complete. A total of 5.68 circuit miles of wire has been installed. Installation of matting material was placed on the Access Road that crosses Amargosa Creek, at the wet crossing between Constructs 48 and 49, and wet crossing maintenance was performed at Construct 61. BMPs were installed/maintained throughout the Segment 5 work area. Tower pad recontouring occurred at throughout the Segment. Tower stringing occurred from Construct 21 to 32 and 55 to 61 (see Figures 2, 3, 4). The Sagebrush Addendum work included foundation excavation and concrete pouring at Constructs 235A and 236A (see Figure 5). Additional tower pad recontouring took place at Construct 235A and 236A.

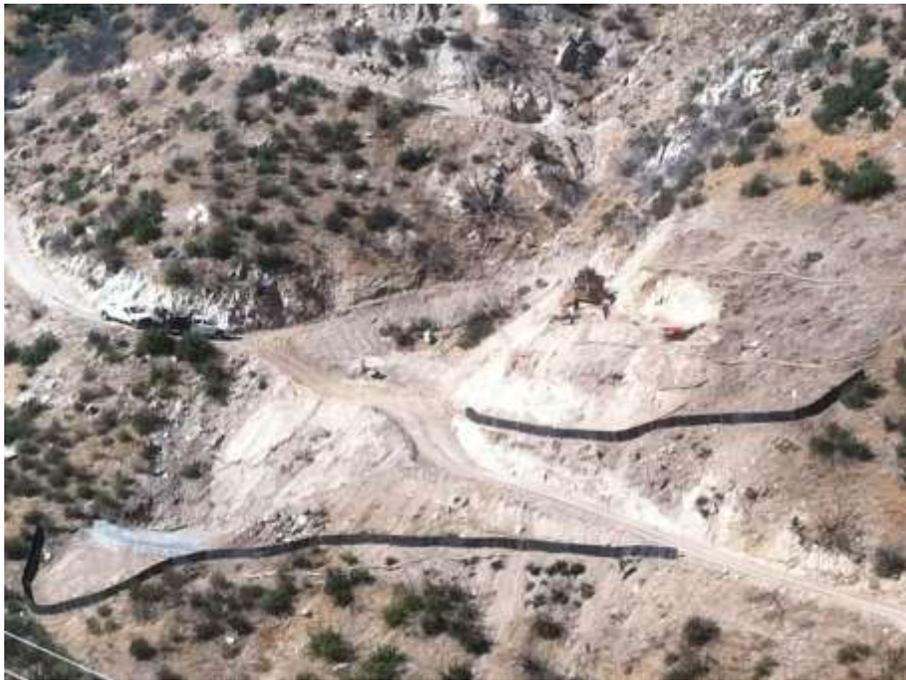
Figure 6: Segment 6 grading activities at Construct 33.

- Helicopter Support Yard (HSY) 1/2, and LZ 9.
 - Civil ID 205, 206, 207, 208 and JD ID 6-8-S-1, 6-8-S-2, and 6-8-S-4,
 - Constructs 1 to 6, 8, 10, 11, 14, 15, 17 to 23, 25 to 34, 36, 57, 60, 65, 68, 69, 70, 82, 85, 100, and 113 (see Figure 6).

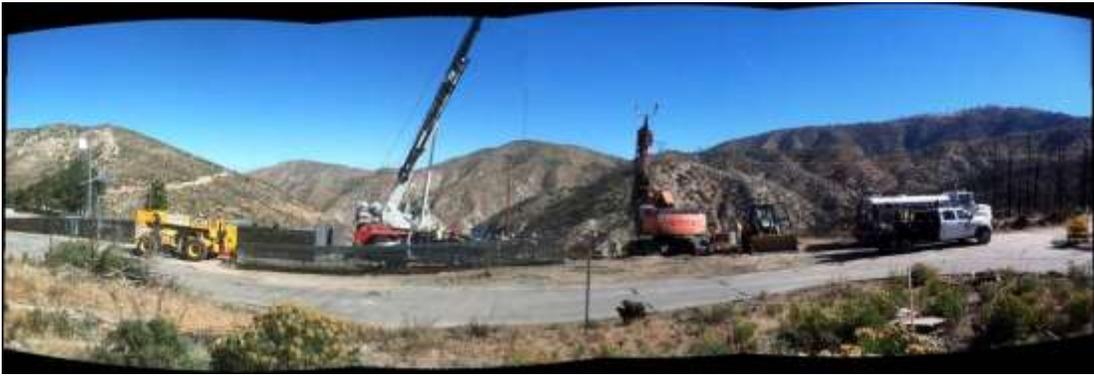
Figure 7: Segment 6 foundation excavation activities at Construct 34.

5. Structure (wreck-out) removal activities occurred at Rabbit Peak HAY and Constructs 55, 56, 65, 66, 67, and 72
6. Foundation excavation occurred at Constructs 1 to 23, 25 to 43, 45, 46, 47, 48, 50 to 57, 65 to 72, 82, 85, 95, and 99 (see Figure 7). Foundation pouring occurred at Construct 1, 2, 4, 5, 7 to 12, 14 to 20, 22, 27, 29, 30, 32, 33, and 34 (see Figure 8).

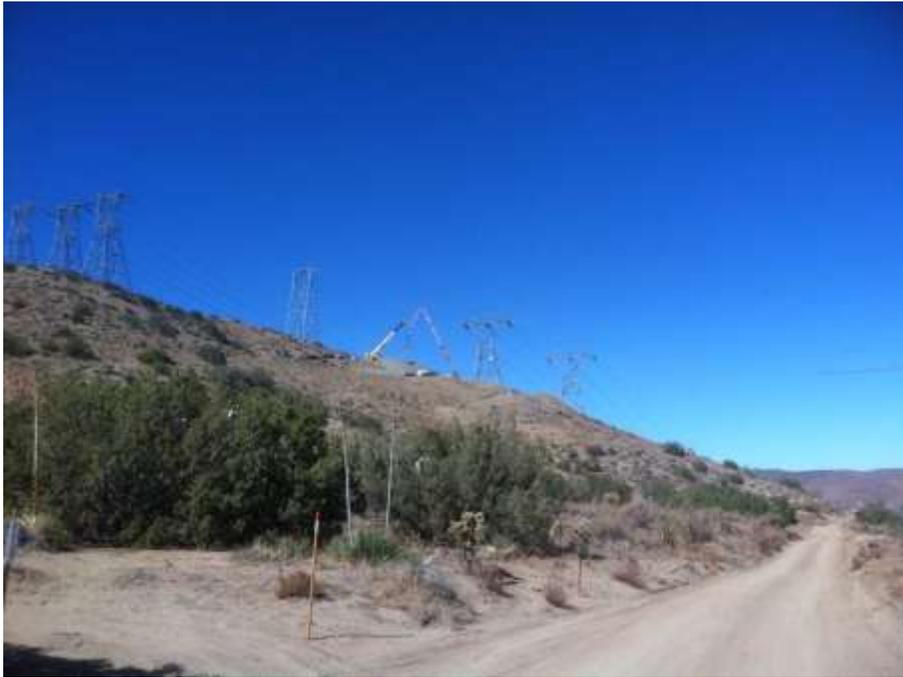
Figure 8: Segment 6 foundation pouring activities at Construct 5.

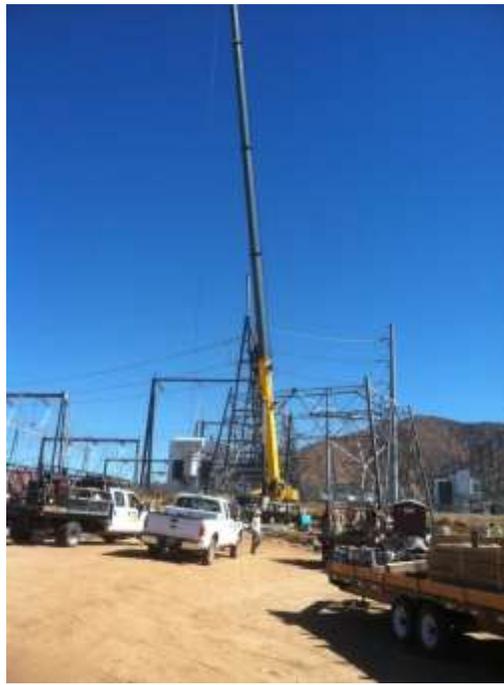
Figure 9: Segment 6 structure erection activities at Construct 2

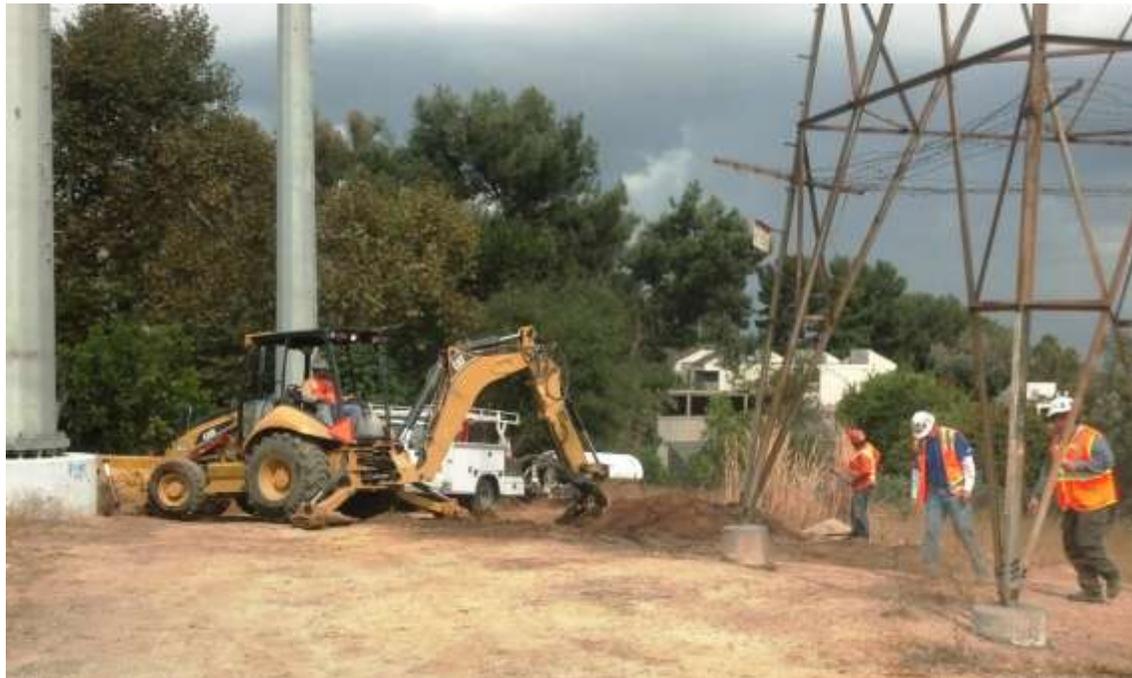
Figure 10: Crews removing 66kV foundations on Segment 7.

1. Segments 7 & 8, 66 kV: Crews performed BMP maintenance. Trenching, foundation excavation/removal (see Figure 10), pole installation/replacement, wire stringing, materials staging, tower assembly, and tower wreck-out also occurred.

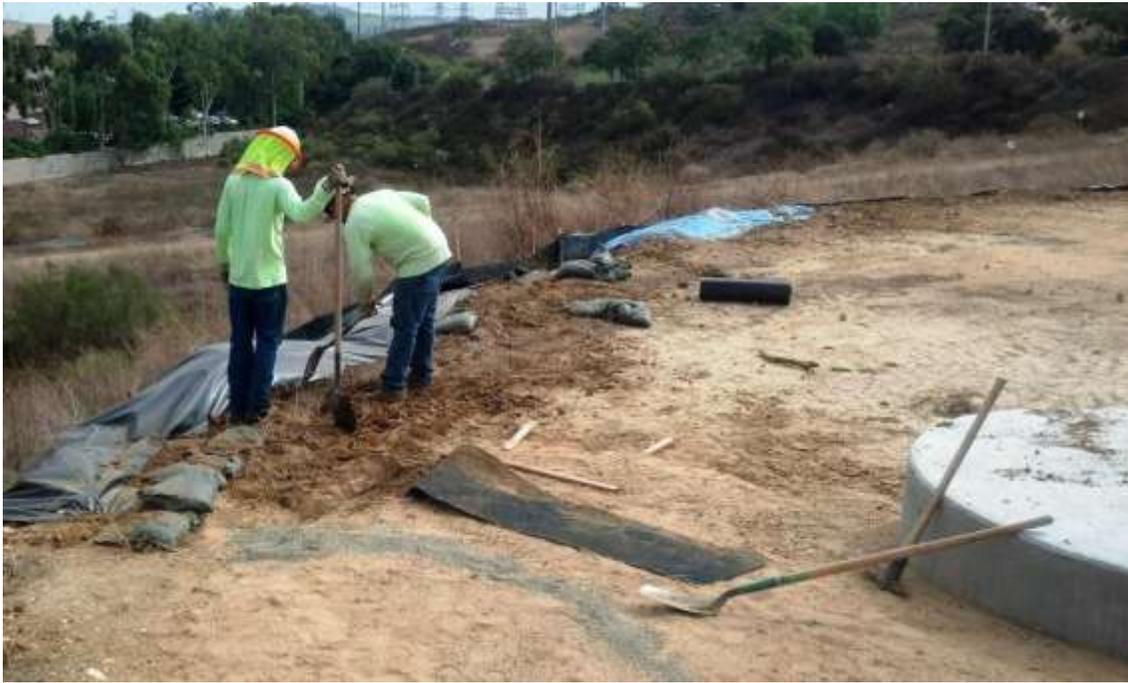
Figure 11: Crew installing BMPs at M41-T4 on Segment 7.

2. Segment 7: Wilson crews mowed, installed BMPs (see Figure 11) and performed BMP inspections at tower sites and wire setup sites to keep environmental surveys active. Wilson, DCX, and Tri-State crews mobilized equipment. Foundation excavation, foundation pouring, materials staging, tower assembly (see Figure 12), tower pad recontouring, vegetation trimming, and wire stringing occurred. To date, 100% of the conductor of the existing 220 kV Antelope-Mesa line has been removed and 100% of the structures have been removed. Of the 78 new double circuit 500 kV structures on the Mira Loma–Vincent line, a total of 14% of the conductor is strung, 95% of the foundations are complete and the structure assembly is 69% complete.

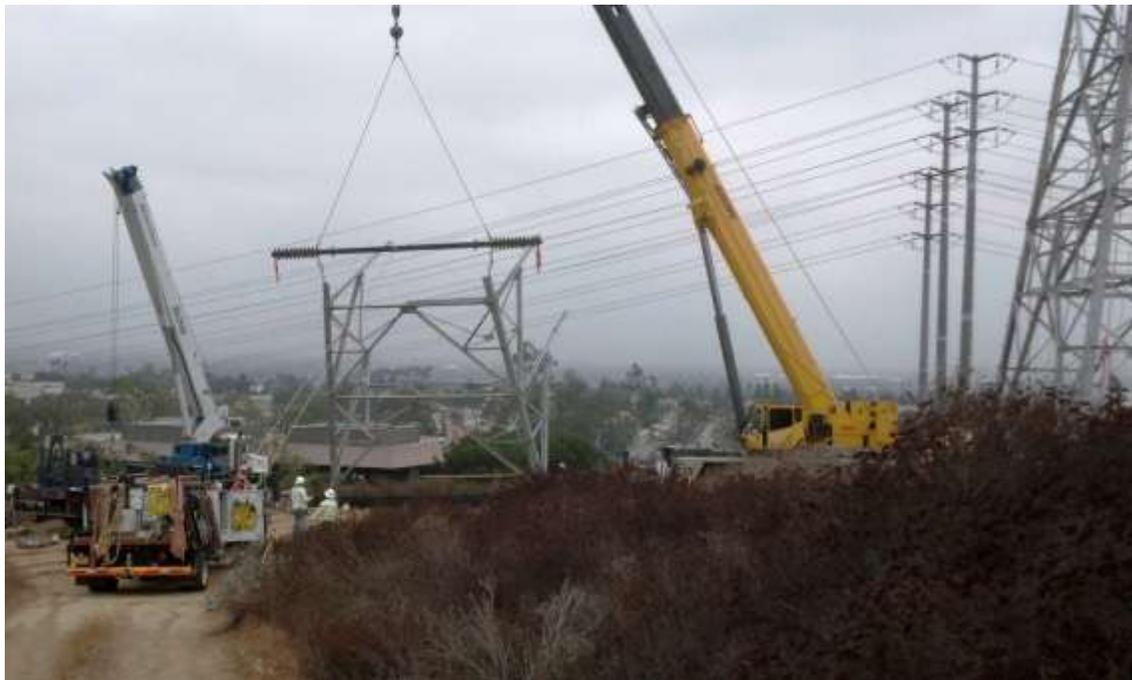
Figure 12: Tower assembly at M41-T3 on Segment 7.

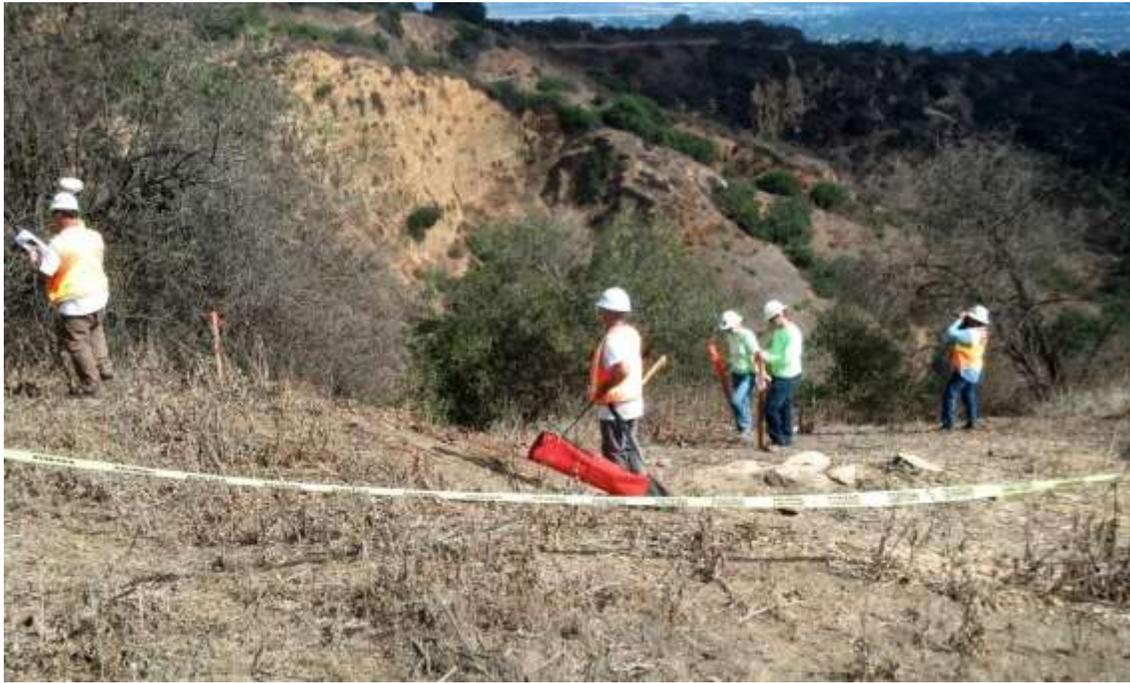
Figure 13: Mobilization and marking of boundaries at M44-T3, Segment 8, Phase 4.

6. Segment 8, Phase 4: Wilson and DCX crews mowed, installed, and maintained BMPs at tower sites and wire setup sites to keep environmental surveys active. Mobilization (see Figure 13), foundation excavation, foundation pouring, road grading, road recontouring, materials staging, tower assembly, tower erection, tower pad recontouring, vegetation clearing (see Figures 14, 15, & 16), and vegetation trimming occurred. To date, 100% of the conductor and 100% of the structures on the existing 220 kV Chino-Mesa line have been removed. In total, foundations are 82% complete and lattice steel towers are 72% complete.

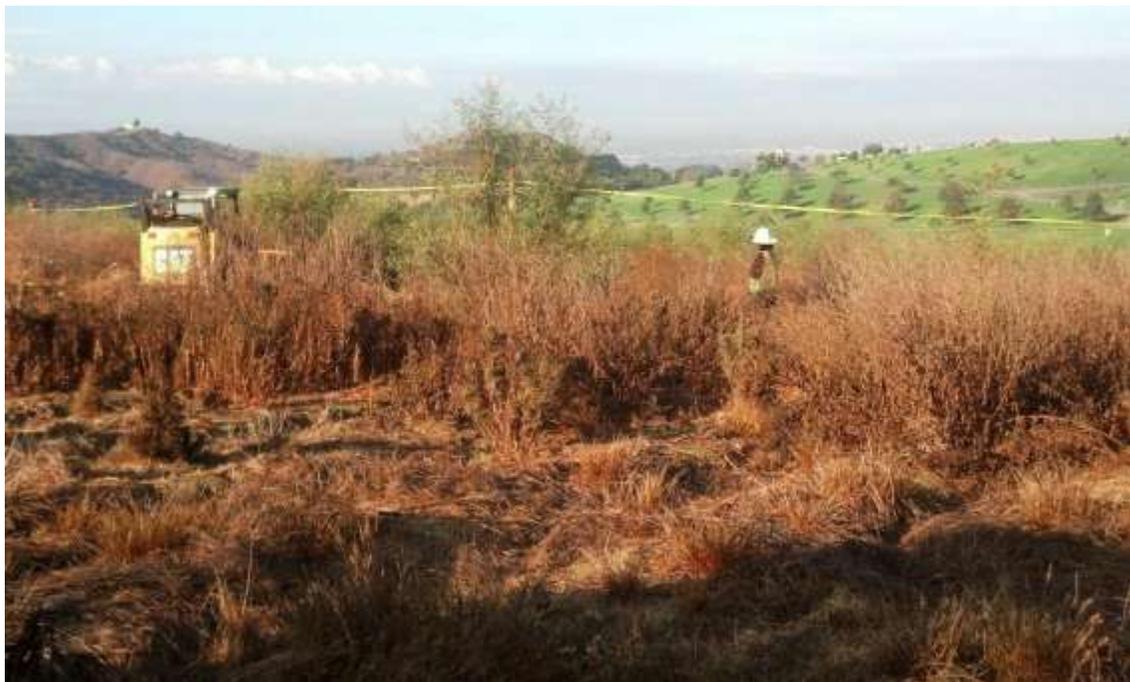
Figure 14: A biologist (right) works with the equipment operator to minimize impacts and stay within worksite boundaries at M44-T4, Segment 8, Phase 4.

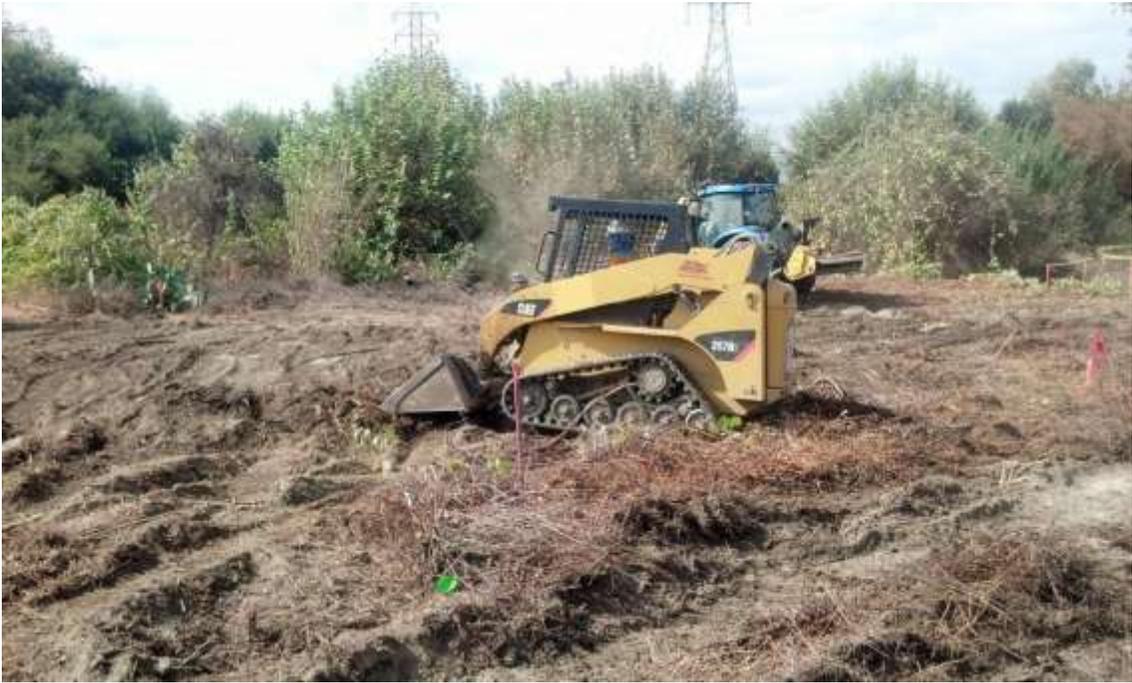
Figure 15: DCX crews clearing vegetation in Whittier Narrows at M42-T1A, Segment 8, Phase 4.

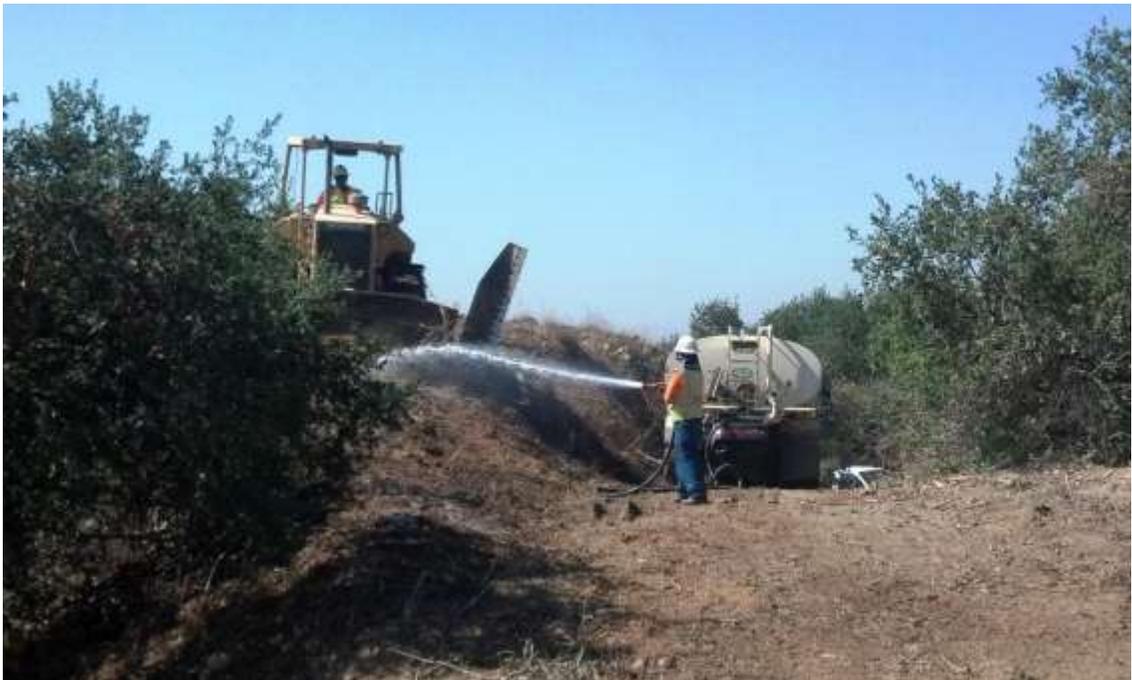
Figure 16: DCX crews clearing vegetation and spraying water for dust control at M45-T4, Segment 8, Phase 4.

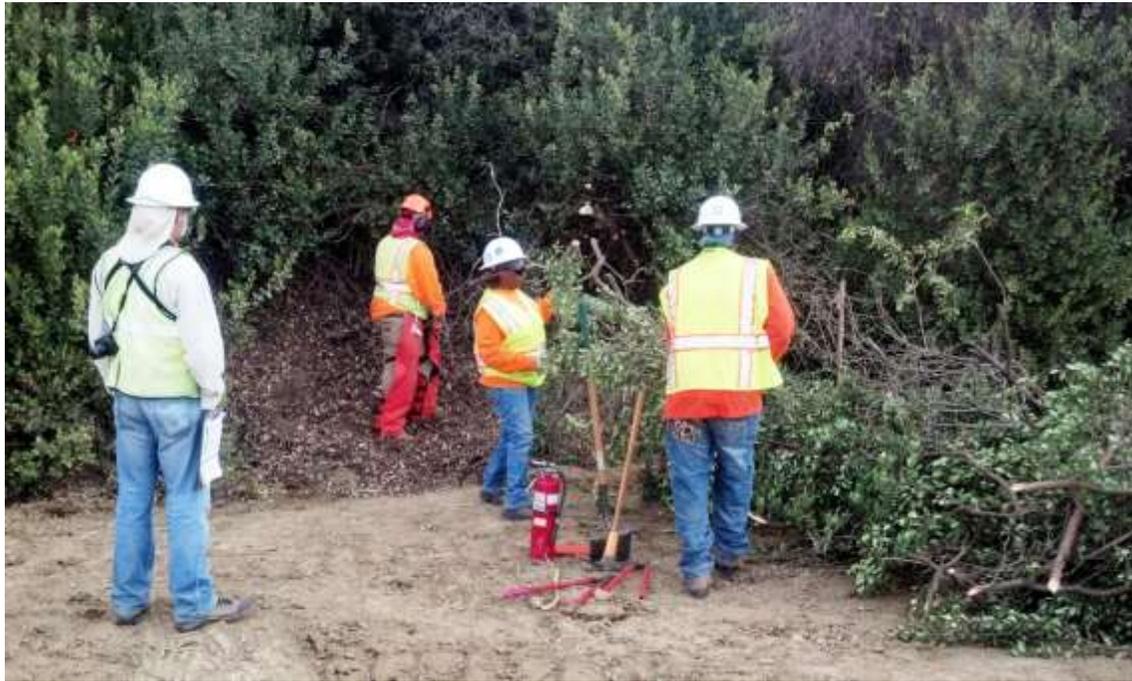
2. During the subject period, several woodrat middens were relocated as part of site clearing activities on Segment 8, Phase 4 (see Figures 17 & 18). On October 4, 2012, the CPUC EM noted a dead woodrat in the aftermath of vegetation clearing and compaction at M45-T4.

Figure 17: A biologist (left) observes as a DCX crew trims vegetation from around a woodrat midden near M45-T4, Segment 8, Phase 4.

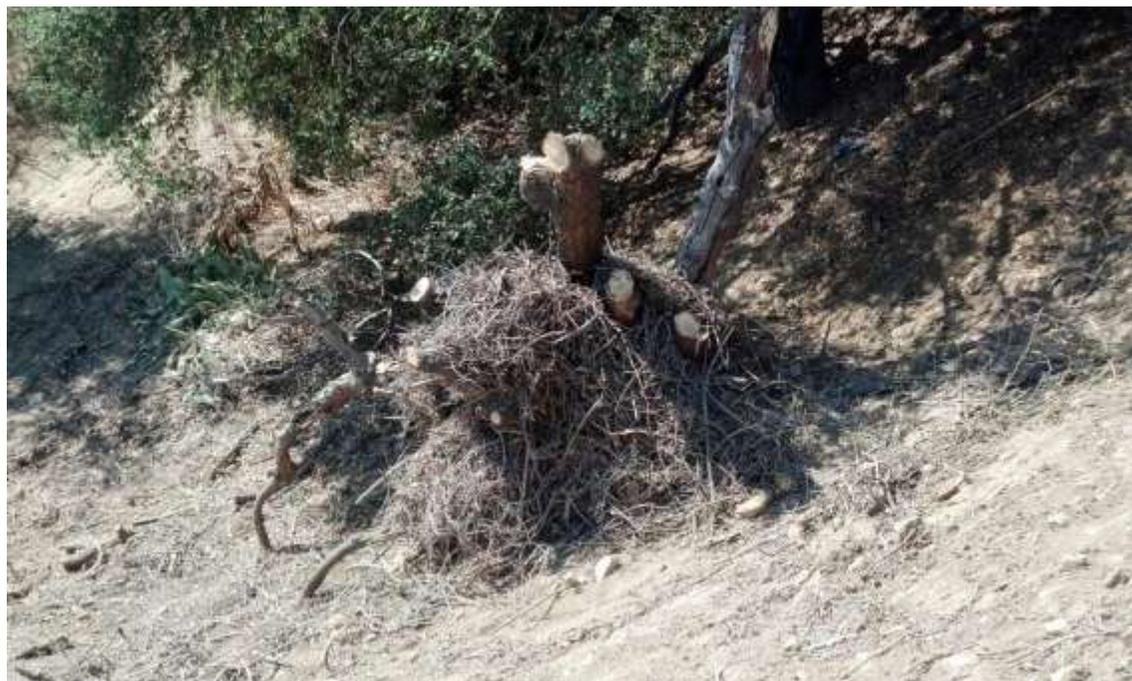
Figure 18: Woodrat midden cleared and waiting 24 hours for inhabitants to vacate near M45-T4, Segment 8, Phase 4.

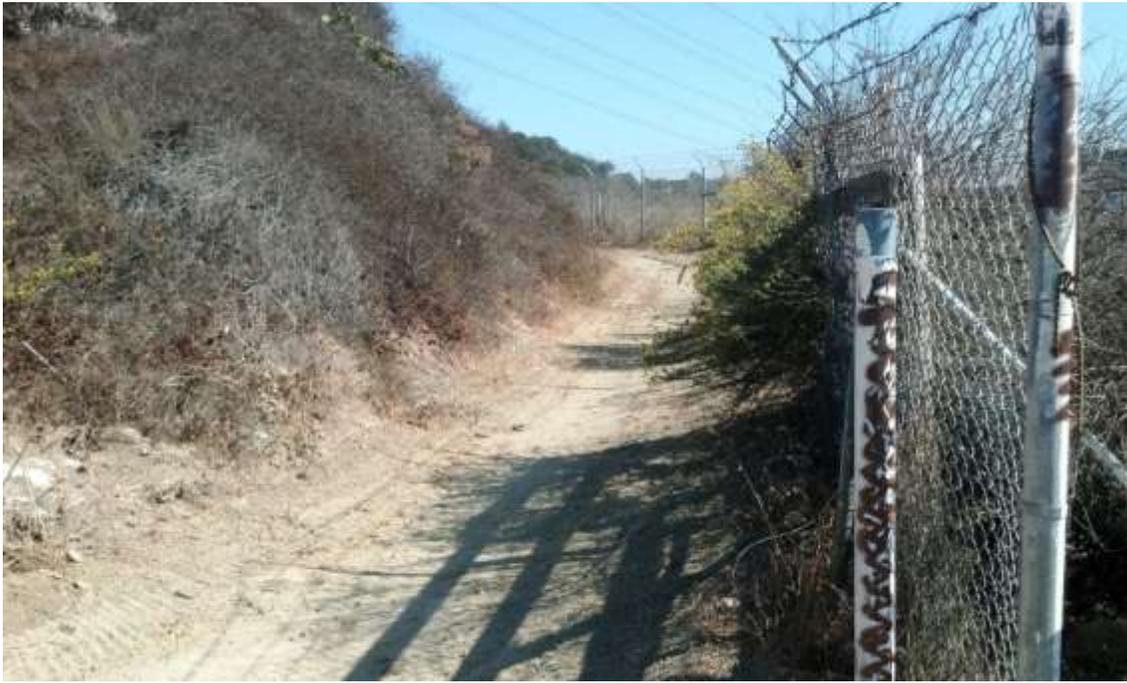
3. On October 2, 2012, the CPUC EM noted that a DCX was using a hiking trail as an unauthorized access road for a small tractor to conduct vegetation removal at M45-T4 (see Figure 19). The crew immediately stopped using the access road. No impacts occurred and the access road was flagged to prevent further use by construction crews.

Figure 19: Unauthorized access road/hiking trail utilized by a small bulldozer for vegetation clearing near M45-T4, Segment 8, Phase 4.

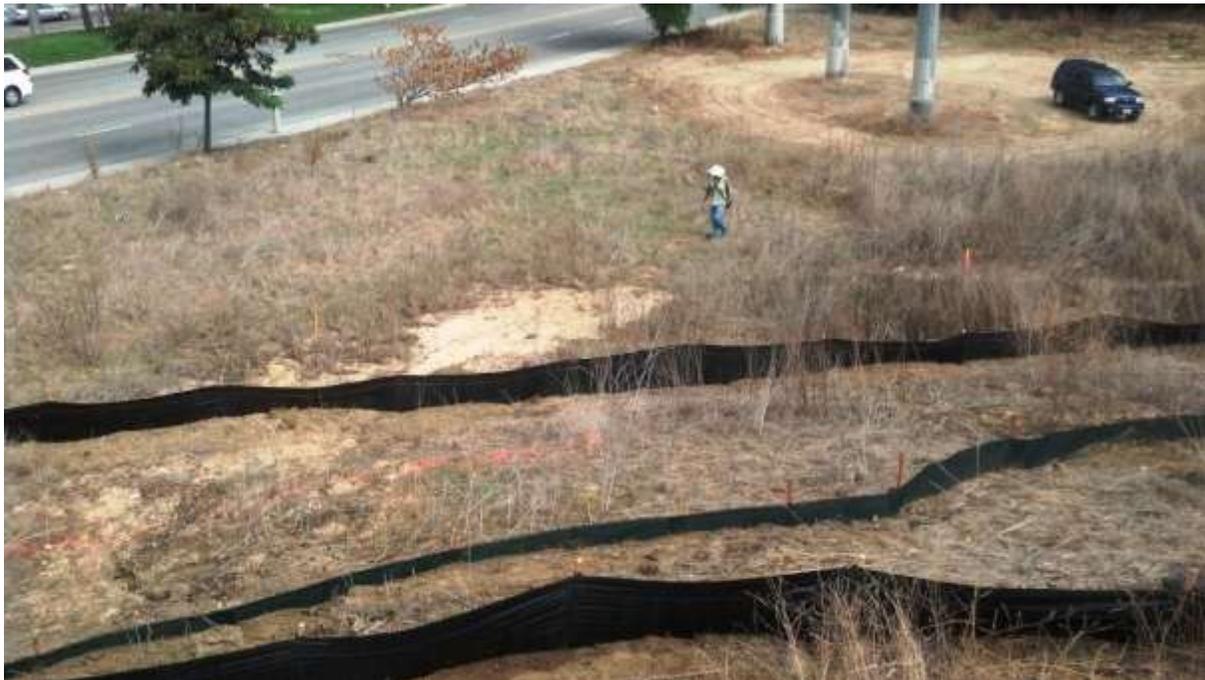
4. The CPUC EM noted to SCE staff that sediment had left the M41-T4 work area (see Figure 20) and rutting occurred on the access road (see Figure 21). The monitor also noted an old footer was on the site and asked SCE staff whether it should have been removed. SCE staff is assembling documentation to show the footer was not a part of TRTP.

Figure 20: Sediment has broken through BMPs during a storm event at M41-T4, Segment 7.

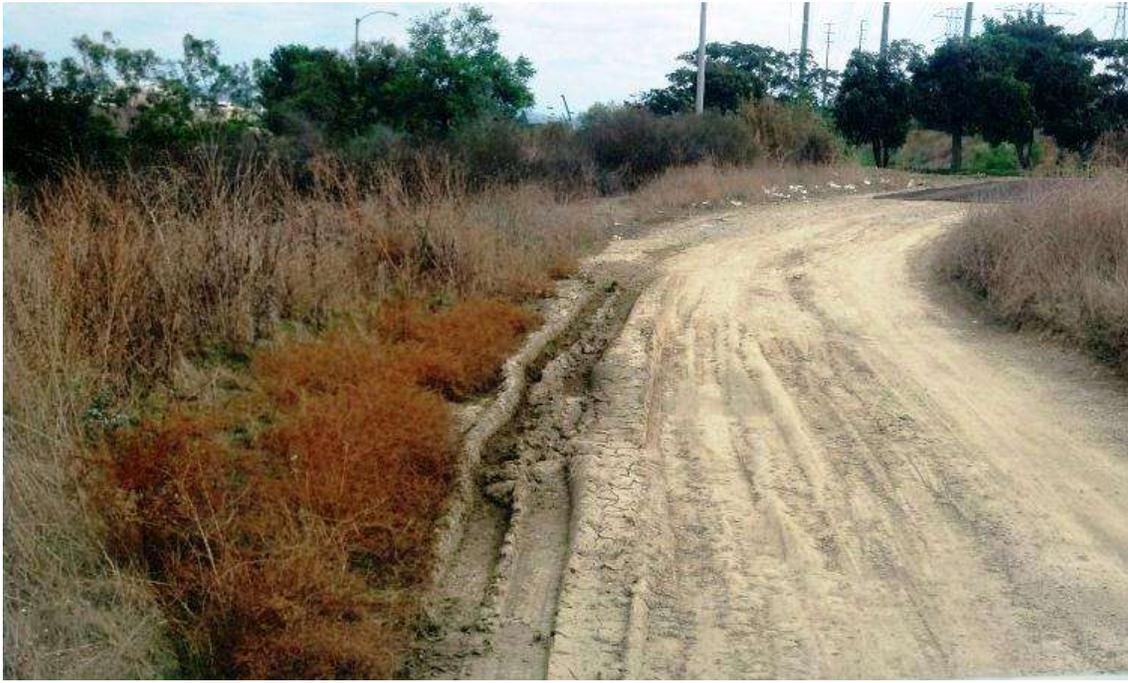
Figure 21: Rutting on the access road to M41-T4, Segment 7 after a storm event.
