**PROJECT MEMORANDUM
SCE TRANSMISSION PROJECTS, SEGMENTS 1–11**

To: Ken Lewis and Jason Coontz, Project Managers, CPUC
From: Vida Strong, Aspen Project Manager
Date: December 9, 2013
Subject: Weekly Report 302: November 3 to November 9, 2013

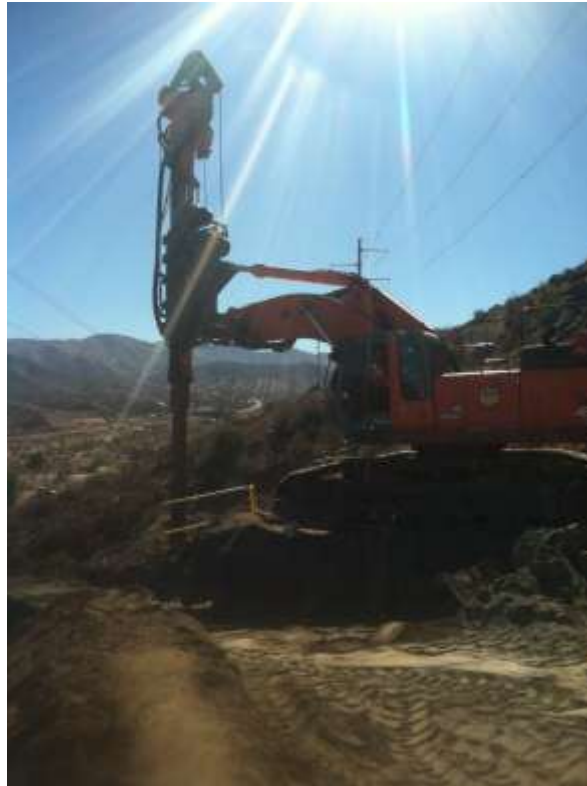
Figure 1: Foundation activities occurring at Construct 8 on Segment 6.

1. Red Flag warning was observed on November 5 and 6. No construction activities occurred on these days in accordance to the Project's Fire Plan.
2. Foundation excavation occurred at Constructs (towers) 5 and 8 (see Figure 1).

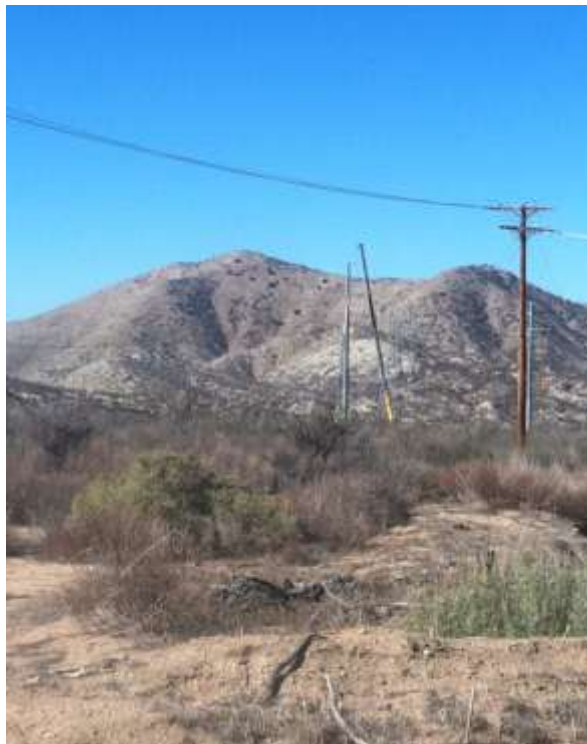
Figure 2: Structure erection activities at Construct 16 on Segment 6.

3. Structure assembly and erection occurred at Constructs 1, 11, 12, 14, 15, 16, 17, and 21 (see Figure 2).
4. Grading occurred at Constructs 9, 20, and 113, and Loop Road L between Constructs 95 and 100.

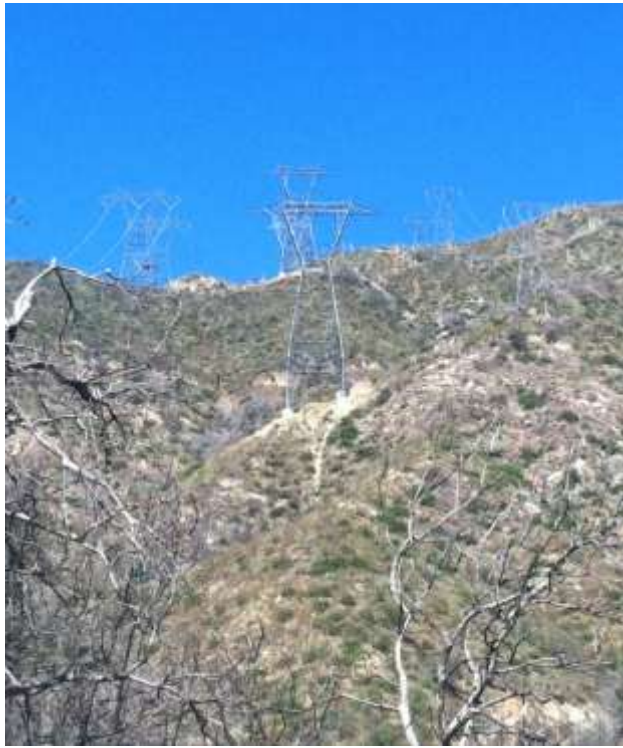
Figure 3: Construct 76 on Segment 6 awaiting the re-installation of perimeter controls.

7. Foundation wreck-out occurred at Constructs 5, 8, 9, 10, and 11.
8. BMP installation, maintenance, and inspection occurred at various construction locations. Perimeter BMPs were re-installed at Constructs 73, 74, 75, 76, 77, 78, and 80 (see Figure 3).

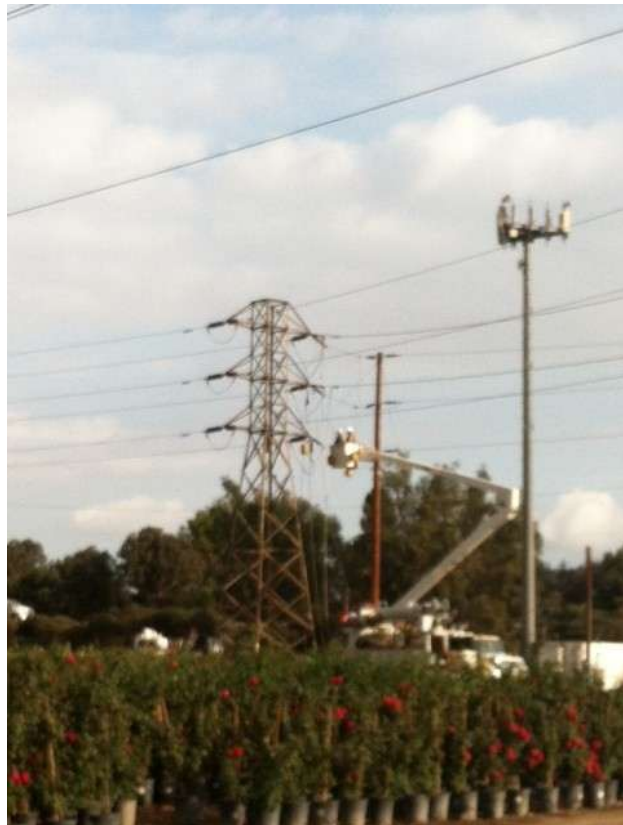
Figure 4: SCE crews stringing towers along the 605 Freeway, Segment 7 66-kV.

1. Material was staged at Rio Hondo Contractor Yard.
2. SCE crews strung wire from Towers M5-T2 through M5-T4, and set Pole 4787835E along the 605 Freeway (see Figure 4).

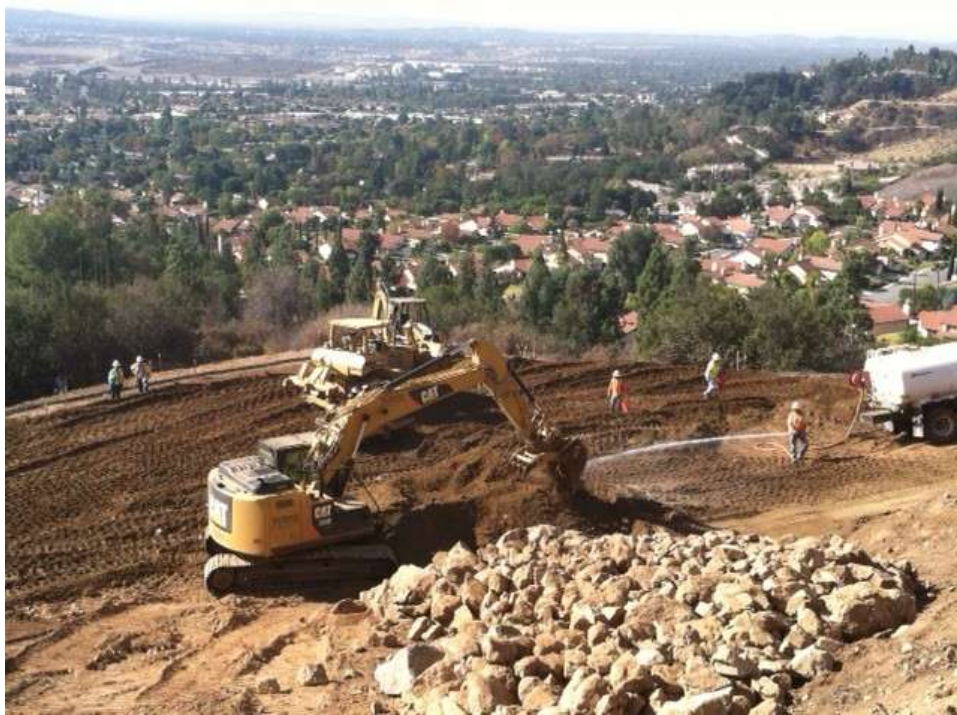
Figure 5: Union Engineering crews grading access road to Tower M27-T3 in Duarte, Segment 7.

3. Union Construction continued vegetation clearing and grading of the access road to Tower M27-T3 in Duarte (see Figure 5).

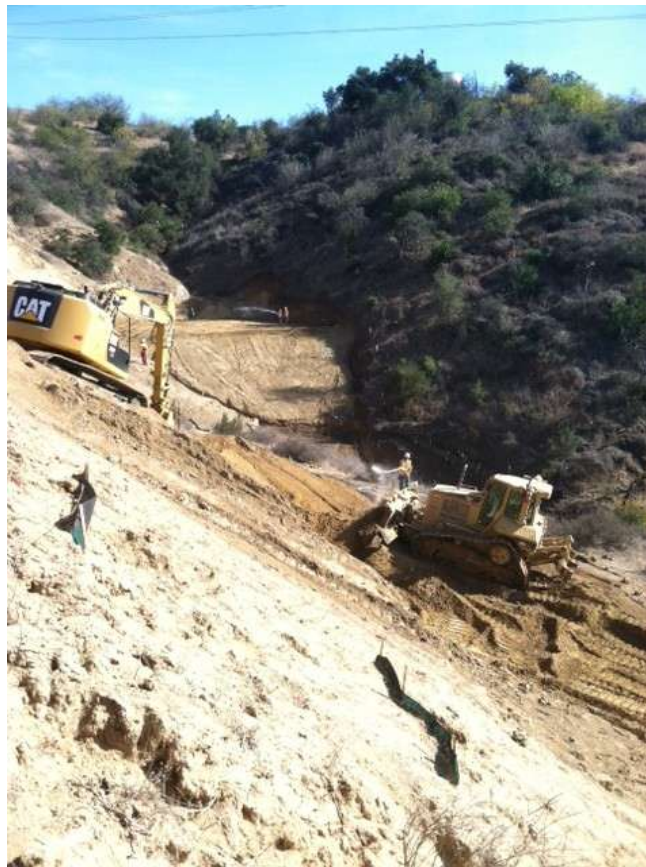
Figure 6: Grading access road to Segment 8, Tower M57-T1, in Tonner Canyon.

4. Union Construction continued grading of the access road to Tower M57-T1 in Tonner Canyon (see Figure 6).
5. Foundation removal occurred at Towers M28-T3, M60T3, M61T4, and M63T3 in Chino Hills.
6. The demolition of Towers M60-T2, M60-T3, M61-T2, M61-T3, M61-T4, M62-T3, M62-T4, and M62-T5 in Chino Hills continued in preparation for the future underground work (see Figure 7).
7. Maintenance of erosion control devices took place at various work areas.
8. To date, 100% of the conductor and structures have been removed from the existing 220 kV Chino-Mesa and Mira Loma–Walnut and Mira Loma–Olinda lines.

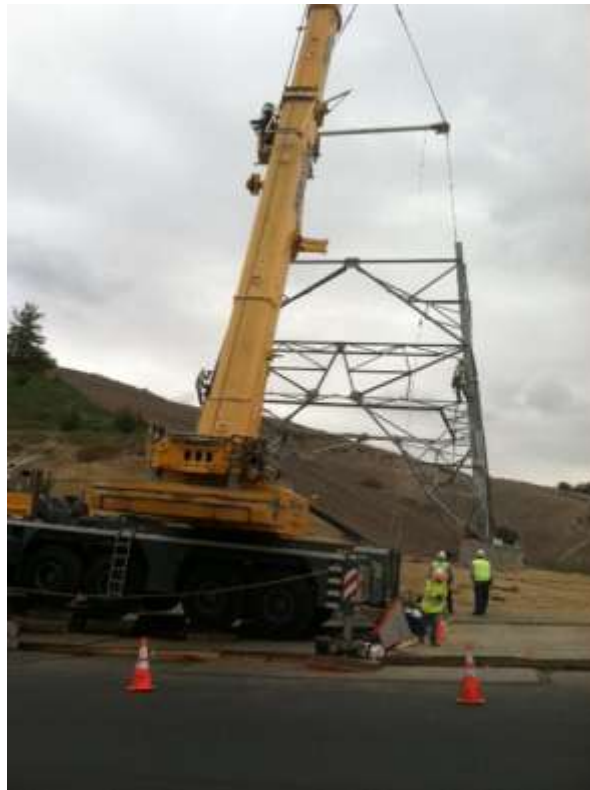
Figure 7: Removal of lattice tower in Chino Hills, Segment 8.

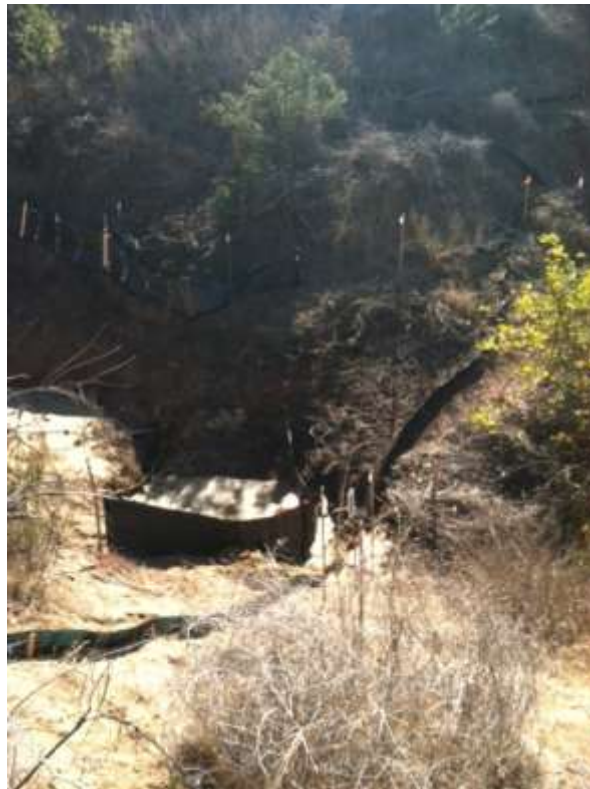
2. On November 8 at Segment 8, Tower M57-T1, an onsite incident was identified when offsite sediment discharge was observed. A water truck being used for fugitive dust control and compaction experienced equipment malfunction when the hose attached to the pump became detached and released approximately 200-300 gallons of water on the upper landing of the site. The water flowed downhill, overwhelming multiple BMPs with sediment and ultimately leaving the Project limits, entering a jurisdictional drainage and into an Environmentally Sensitive Area (ESA). The contractor installed multiple BMPs on the slope; however, the amount of water was too much for these BMPs to contain the amount of sediment flow (see Figure 8).

Figure 8: Sediment and water overflow of BMPs after accidental water release at Tower M57-T1, Segment 8.
