**PROJECT MEMORANDUM  
SCE TRANSMISSION PROJECTS, SEGMENTS 1–11**

**To:** Jason Coontz, Project Manager, CPUC  
**From:** Vida Strong, Aspen Project Manager  
**Date:** March 19, 2014  
**Subject:** Weekly Report 318: February 23 to March 1, 2014

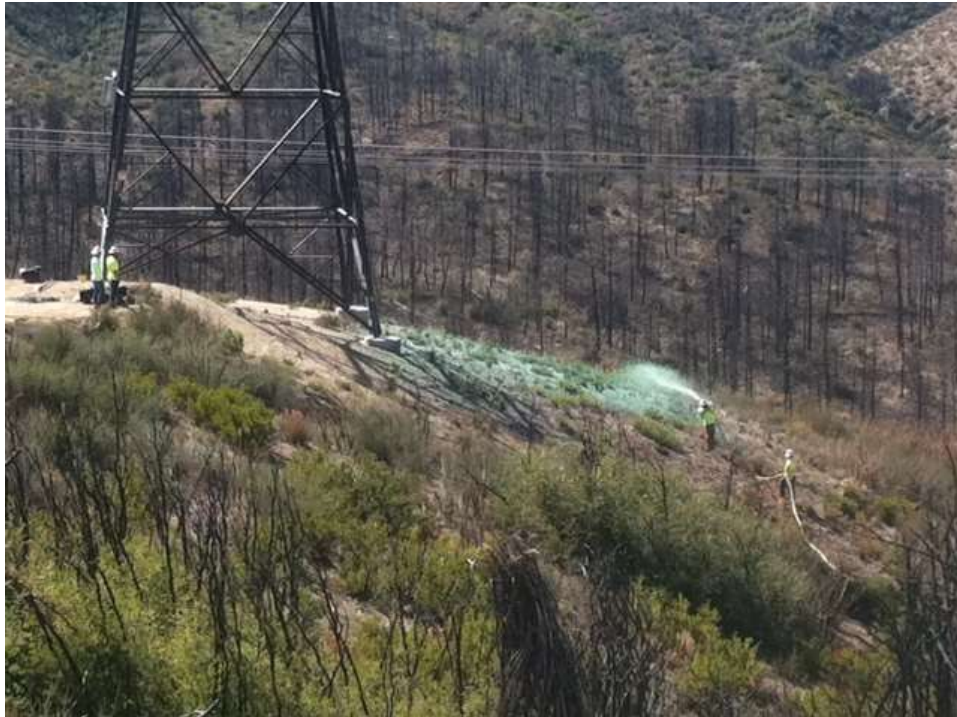
Figure 1: Crews spraying hydromulch at Construct 63, Segment 6B.

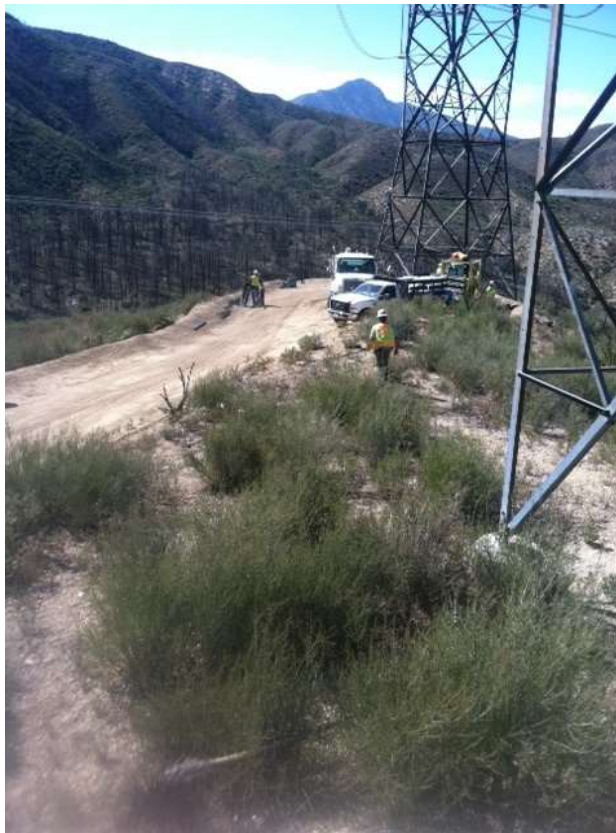
Figure 2: BMP removal occurring at Construct 63, Segment 6B.

1. Vegetation clearing occurred along the access road to the Shortcut Helicopter Assembly Yard (HAY) and Construct (tower) 43.
2. Road grading activities occurred on Constructs 59, 63, 100, and 113, Puller/Tensioner Site 62/63, Civil ID M54-T1A, Loop Road F, Loop Road G, and Loop Road H.
3. Drainage improvements and wet crossing installation/maintenance occurred at Civil ID 274 and 277, and Loop Road G and H.
4. Structure assembly and erection occurred at Construct 63.
5. Wire stringing operations (such as preparation, wire install, clipping wire, and wire cleanup) occurred at Construct 12.
6. BMP installation, maintenance, and inspection occurred at various construction locations (see Figure 1).
7. BMP removal occurred at Civil ID 274 and 277, Constructs 58, 59, and 61, Puller/Tensioner Site 62/63, and Loop Road H (see Figure 2).

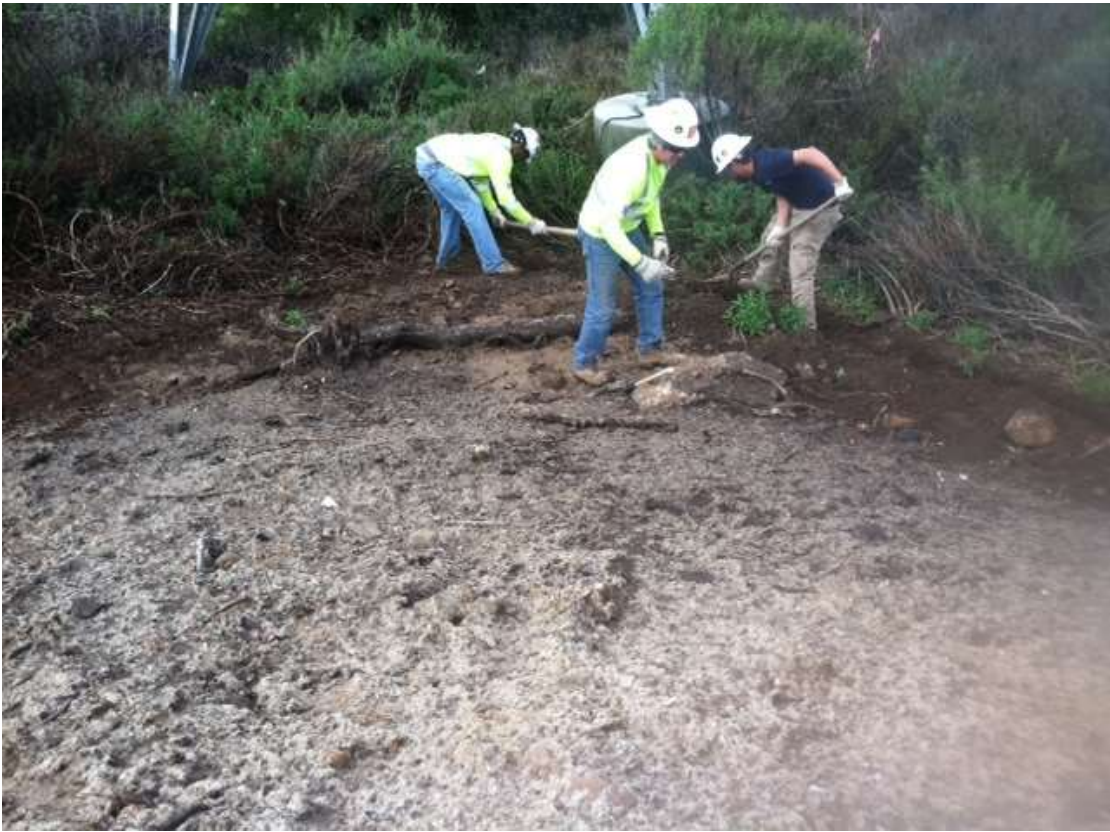
Figure 3: Silt fence installation occurring at Chaney Trails pull site, Segment 11B.

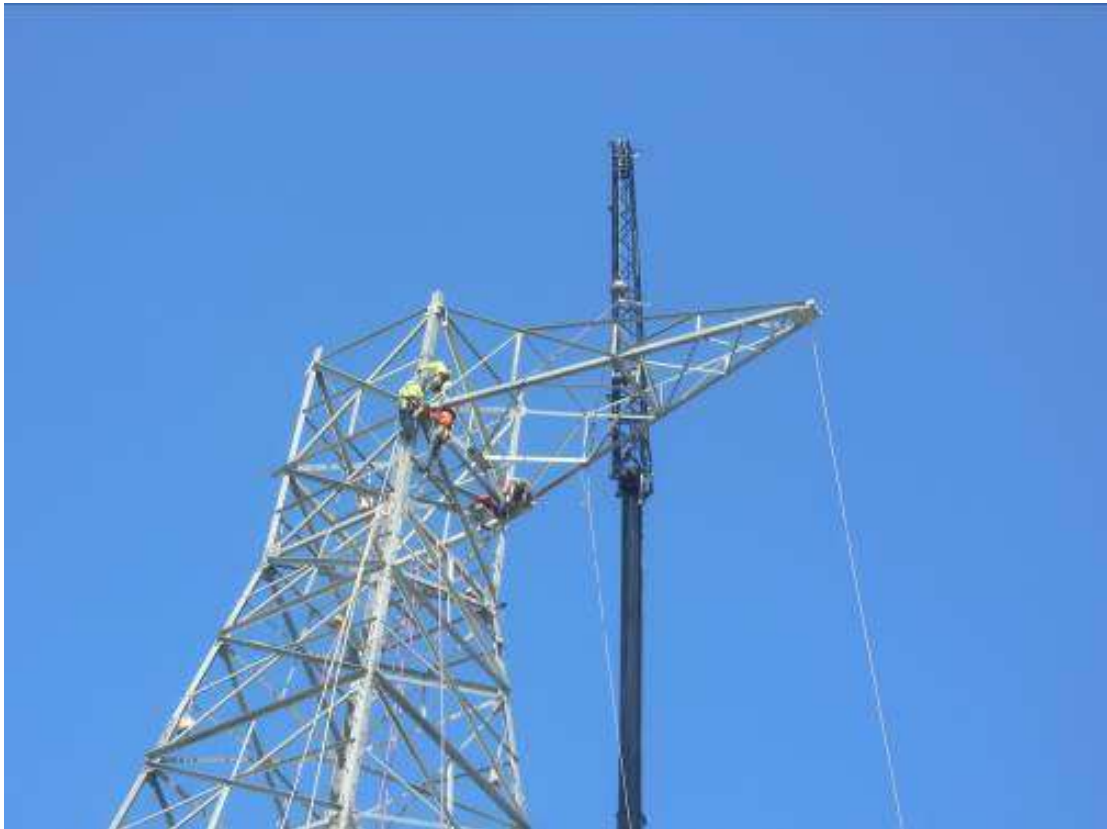
Figure 4: Assembly crews installing arm at Tower M35-T3, Segment 7.

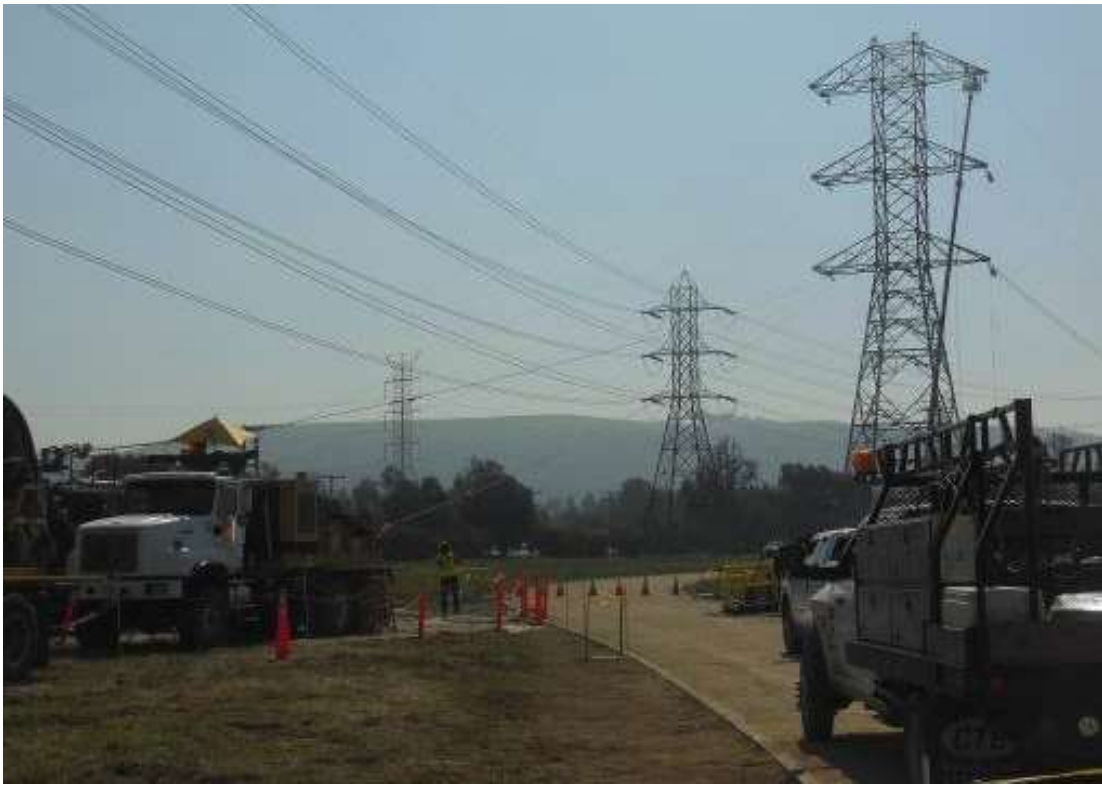
Figure 5: Wire pulling operations occurring between Towers M36-T2 and M37-T3, Segment 7.

3. BMPs were installed/maintained at various locations.
4. Vegetation clearing occurred at Wire Stringing Sites (WSS) 7.12, 7.13, 7.21, 7.36, and 7.37.
5. PAR crews conducted grading activities at Tower M27-T2.
6. Union Construction crews continued road grading, retaining wall installation, and keyway development at Tower M27-T3.
7. Foundation installation occurred at Tower M27-T2.
8. Assembly activities were conducted at Towers M30-T1, M31-T3, M31-T4, M32-T2, M32-T3, M34-T2, M34-T3, M35-T2, M35-T3, M39-T5, and M40-T3 (see Figure 4).
9. FAA lighting was installed at Tower M40-T3.
10. Wire stringing operations (such as preparation, wire install, clipping wire, and wire cleanup) continued between Towers M36-T2 and M37-T3 (see Figure 5).

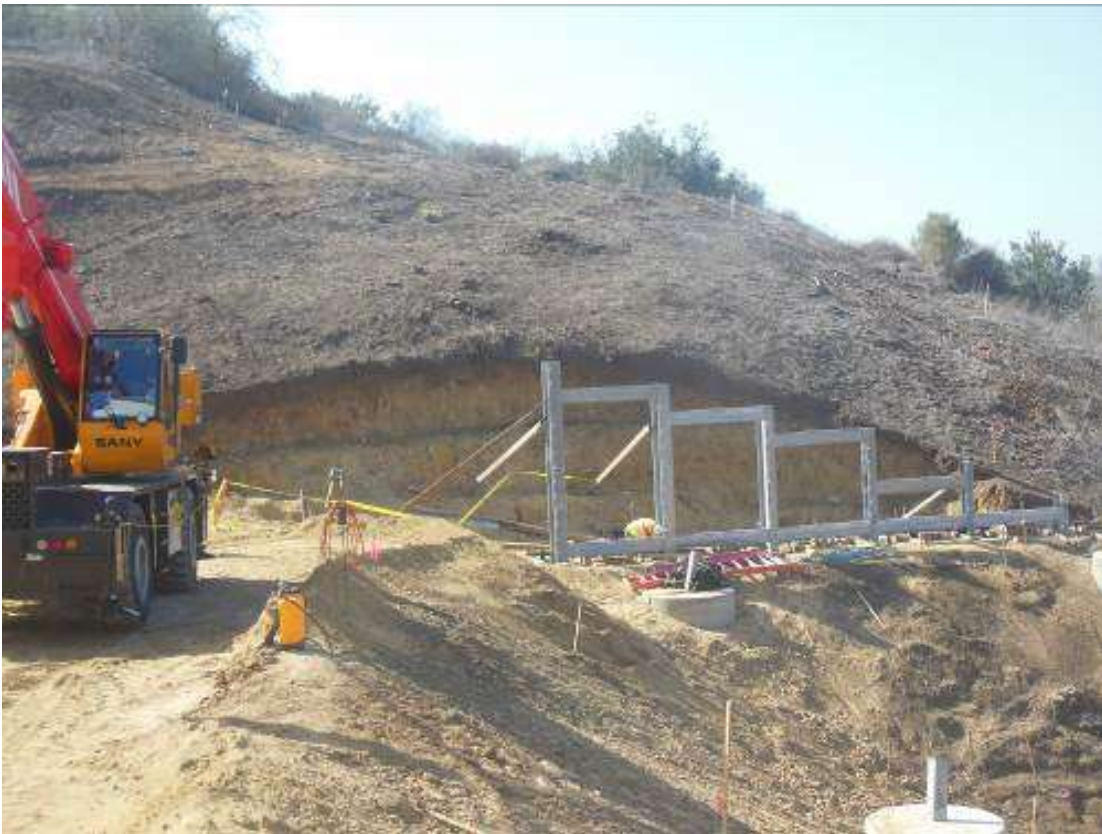
Figure 6: Installation of the southern retaining wall at Tower M57-T1, Segment 8, Phase 1.

12. Union Construction crews continued road grading, retaining wall installation, and keyway development at Tower M57-T1 (see Figure 6).
13. Maintenance of erosion control devices took place at various work areas.
14. To date, 100% of the conductor and structures have been removed from the existing 220 kV Chino-Mesa and Mira Loma–Walnut and Mira Loma–Olinda lines.

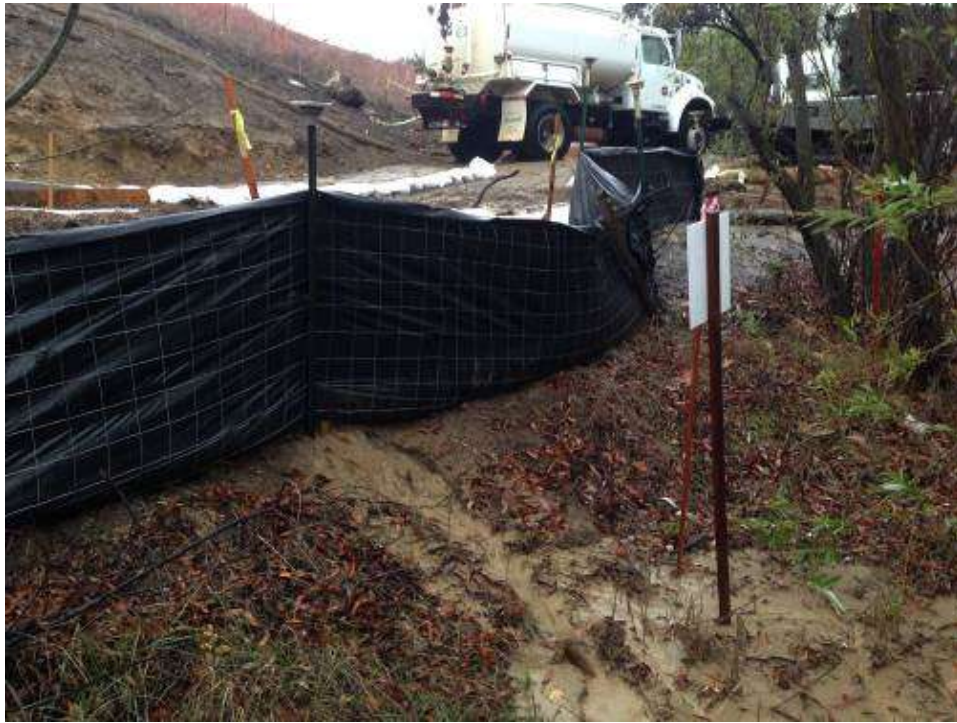
3. SCE's Monitors conducted inspections of SWPPP erosion control devices along Segments 7 and 8. On February 28, the SCE Monitor observed sediment-laden runoff exiting the work area at Tower M49-T1 (Segment 8/Phase 4) and flowing into Jurisdictional Drainage (JD) ID# 8-20-S-400 within critical habitat for California gnatcatcher (see Figure 7). On March 1, the SCE Monitor reported failed BMPs that subsequently resulted in the flow of silt-laden water directly into JD ID# 8-33-S-200 and 8-34-S-1 near Tower M57-T1 (Segment 8/Phase 1). The silt fencing and sandbag BMPs had been washed out due to the storm that occurred the previous days (see Figure 8).

Figure 7: Runoff breaching silt fence BMP at Tower M49-T1 and flowing into JD ID# ID# 8-20-S-400, Segment 8, Phase 1 (photo courtesy of FRED).

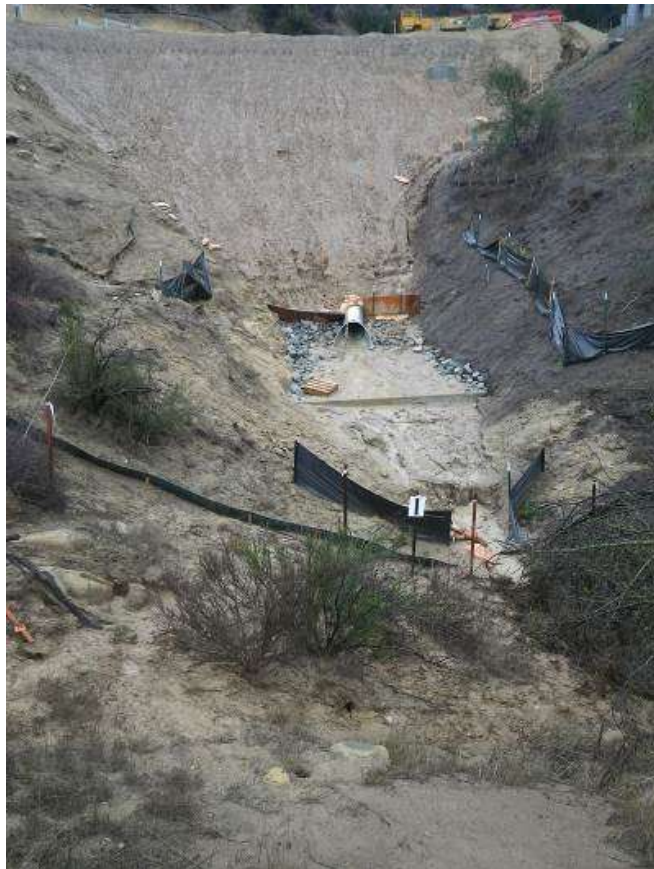
Figure 8: BMPs (silt fence and sandbags) blown out due to storm flows at Tower M57-T1, Segment 8, Phase 1 (photo courtesy of FRED).

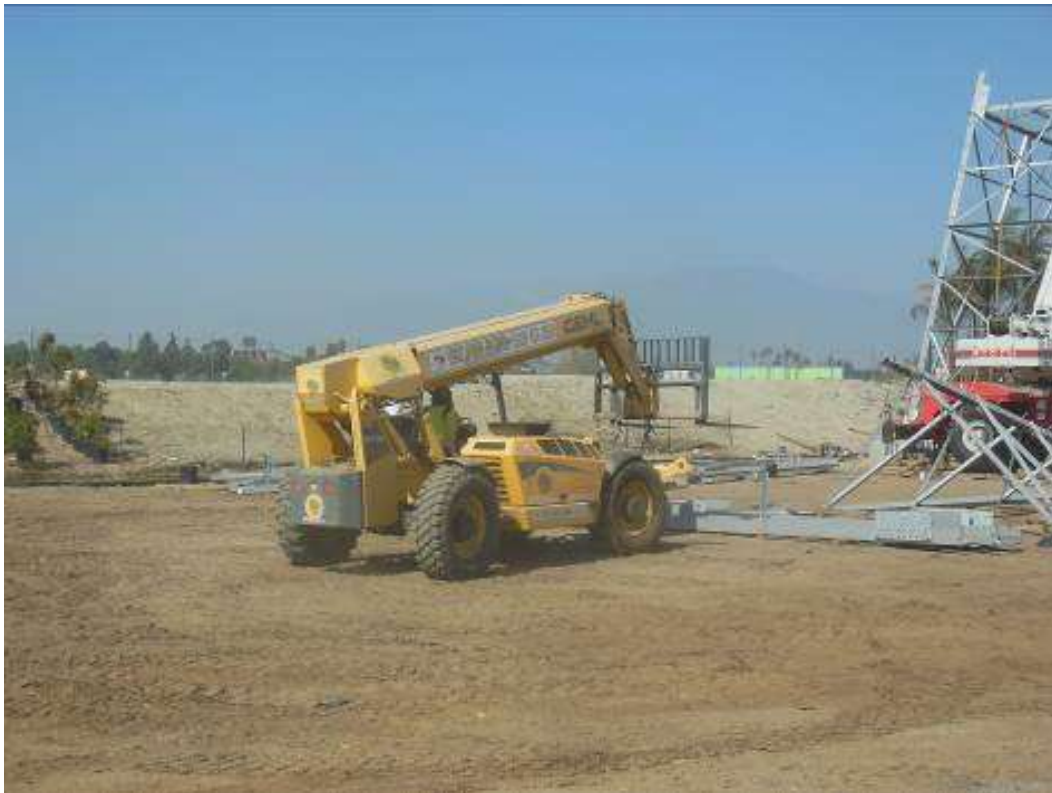
8. On February 24, the CPUC Monitor observed a forklift driving outside of approved disturbance limits while hauling material at Tower M35-T3 (Segment 7) (see Figure 10). The CPUC Monitor immediately notified the BMCD Field Coordinator.

Figure 10: Forklift driving outside of approved disturbance limits (blue staking) at Tower M35-T3, Segment 7
