**PROJECT MEMORANDUM
SCE TRANSMISSION PROJECTS, SEGMENTS 1–11**

To: Jason Coontz, Project Manager, CPUC
From: Vida Strong, Aspen Project Manager
Date: March 27, 2014
Subject: Weekly Report 319: March 2 to March 7, 2014

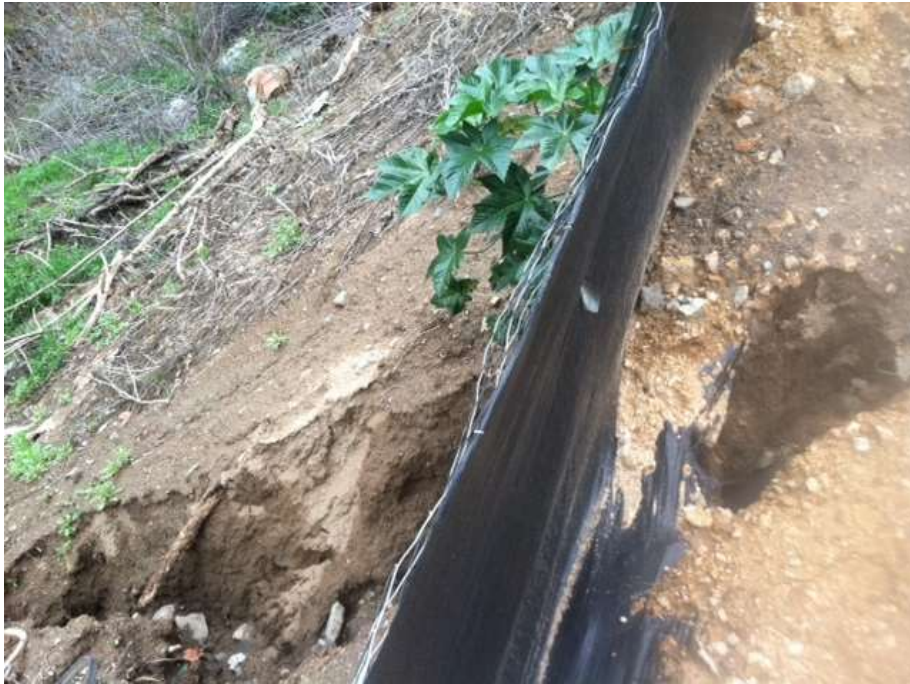
Figure 1: Erosion at soil storage area adjacent to the southern entrance to Loop Road L, Segment 6C.

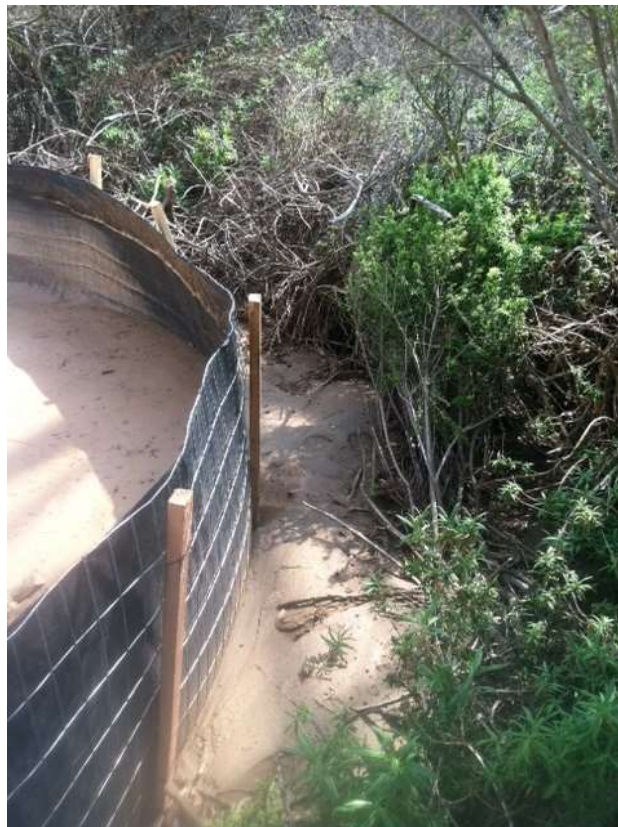
During post-storm reviews of the Segment 6 and 11 rights-of-way, the following areas were observed to have off-site sediment flows: Segment 6 Constructs 8, 10, 16, 18, 19, and 23; Segment 11C Constructs 4, 19, and 25X; Aliso HAY, Rabbit Peak HAY, and Segment 11B Chaney Trails Wire Pull Site.

Figure 2: Sediment flow beyond the site boundary at Chaney Trails Pull Site, Segment 11B.

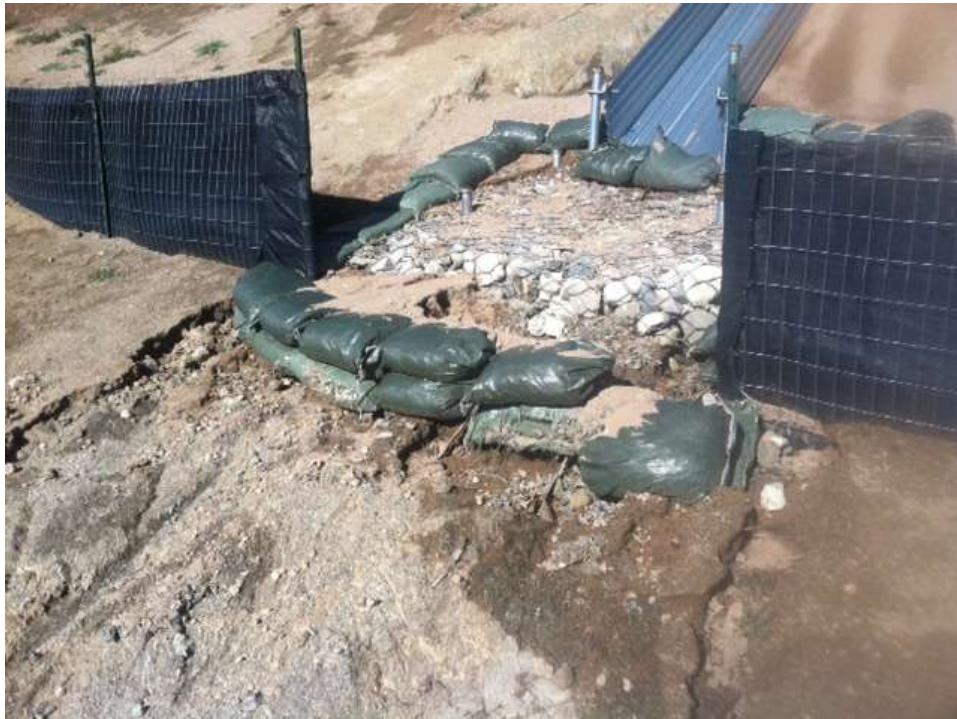
4. On March 3, LA County Department of Public Works issued a Notice of Violation-NPDES Correction Notice for erosion occurring at the bottom of Construct 5 on Segment 6 slope. SCE was issued a “Stop Work” order at the site and given 5 days to perform corrective actions at this site (see Figures 3 through 6).

Figure 3: Sediment filled rock dissipater at Construct 5, Segment 6A.

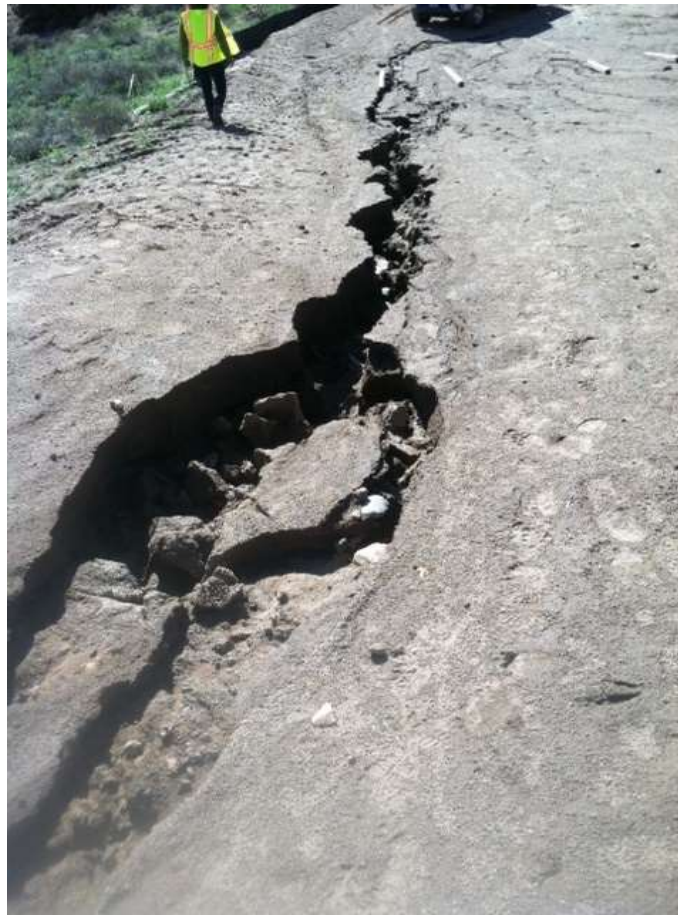
Figure 4: Gullying shown along the slope below Construct 5, Segment 6A.

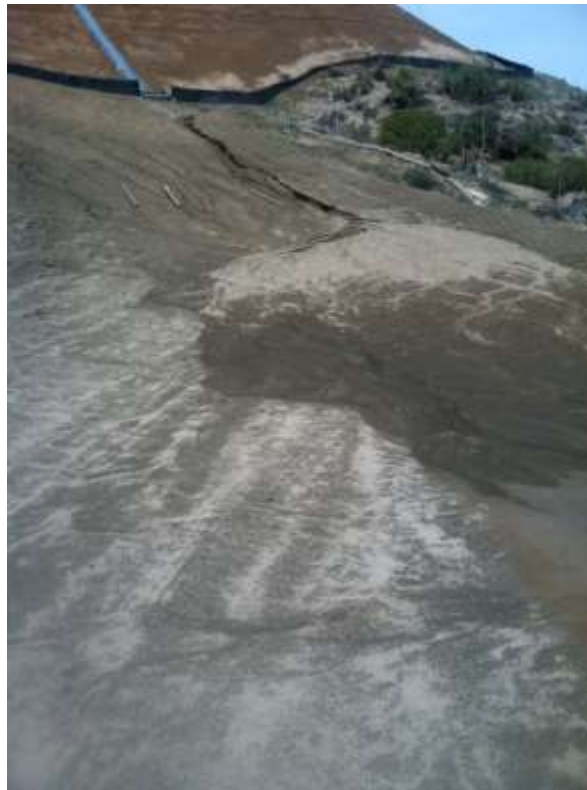
Figure 5: Gullying seen on the slope beyond Construct 5, Segment 6A.

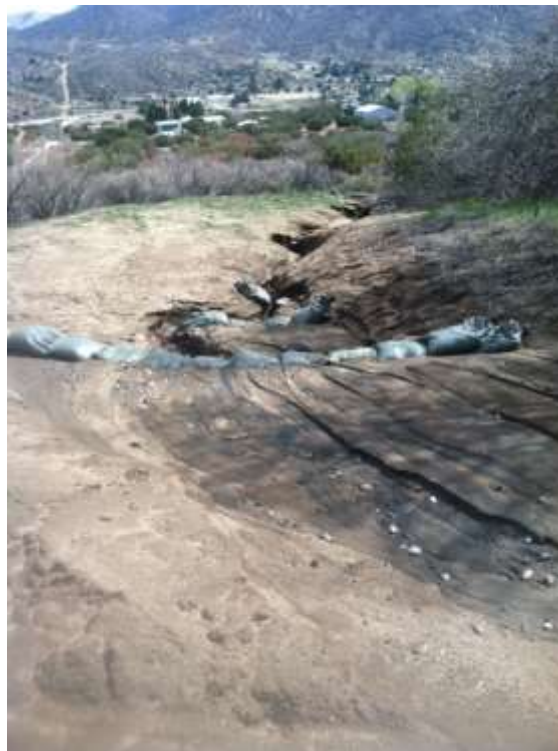
Figure 6: Runoff and sediment build up in drainage area adjacent to Juniper Ridge Road, as a result of Construct 5, Segment 6A slope.

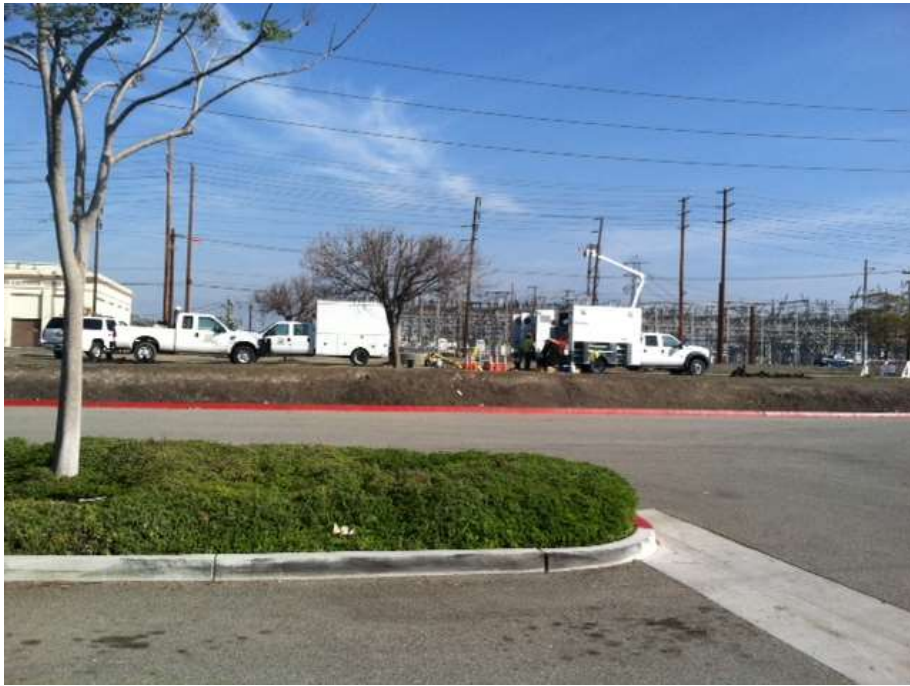
Figure 7: SCE crews pulling cable through underground vaults along Edison Avenue in the City of Chino.

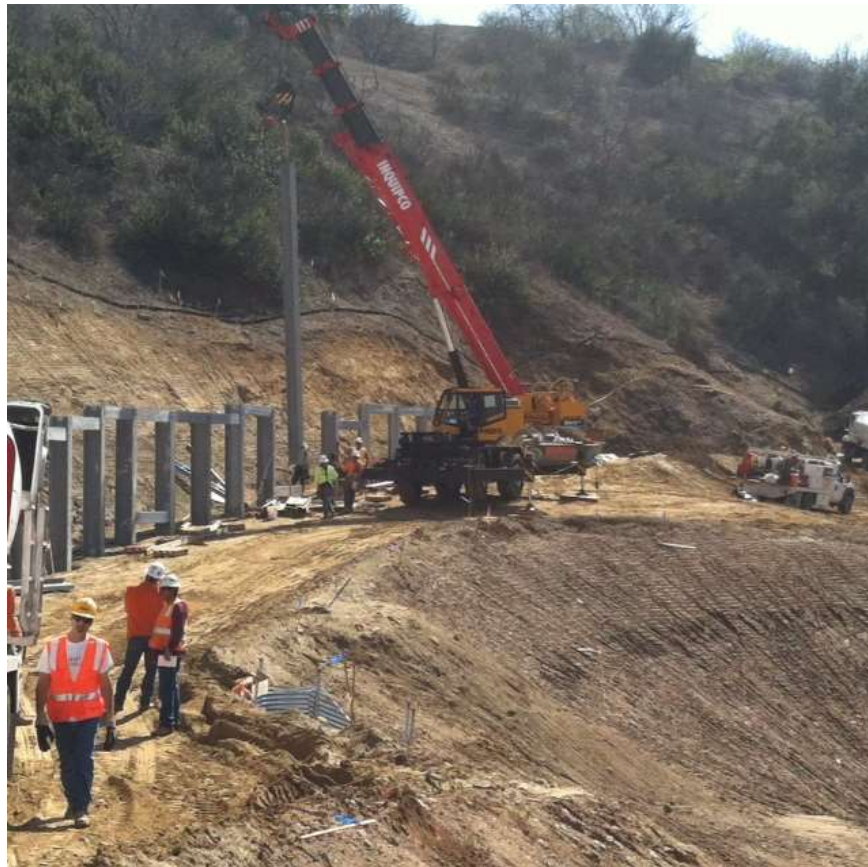
11. During the subject week, BMP maintenance activities were conducted at locations along the Chino Hills underground right-of-way.
12. Union Construction crews continued road grading and retaining wall installation at Tower M57-T1 (see Figure 8). Due to the rain storm the previous week, much of the subject week was dedicated to storm repairs on the site and the access road.
13. Maintenance of erosion control devices took place at various work areas.
14. To date, 100% of the conductor and structures have been removed from the existing 220 kV Chino-Mesa and Mira Loma–Walnut and Mira Loma–Olinda lines.

Figure 8: Union Construction crews continued road grading and retaining wall installation at Tower M57-T1 in Tonner Canyon, Segment 8, Phase 1.

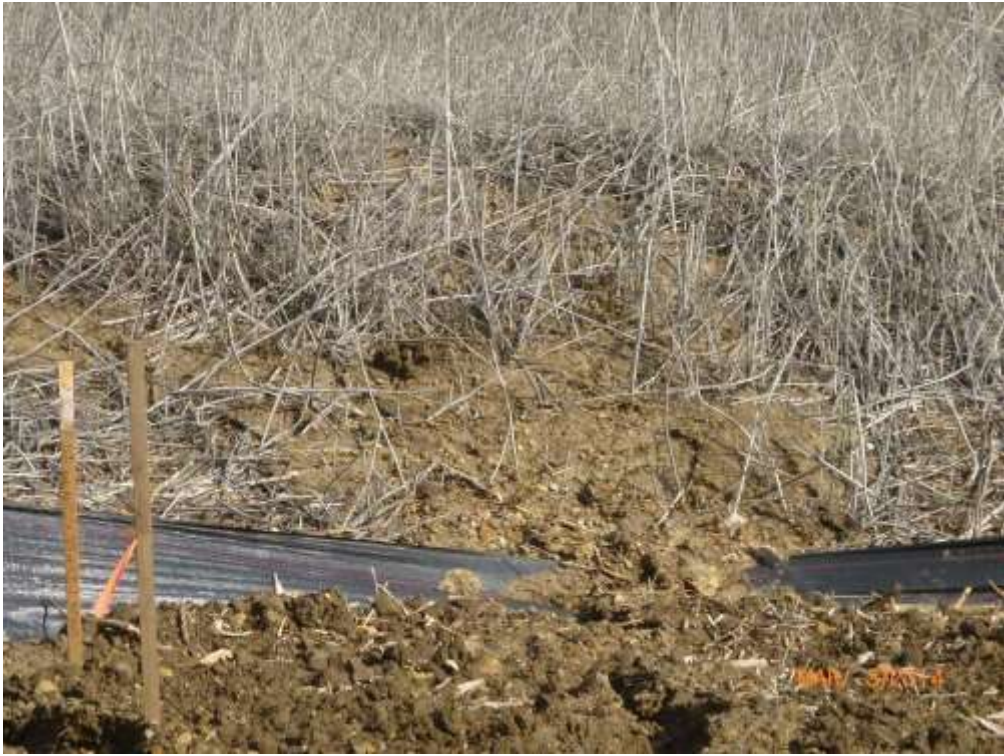
Figure 9: Post storm inspections identified multiple locations where sediment overtook BMPs and traveled off site, including Tower M49-T1 (photo courtesy of FRED).

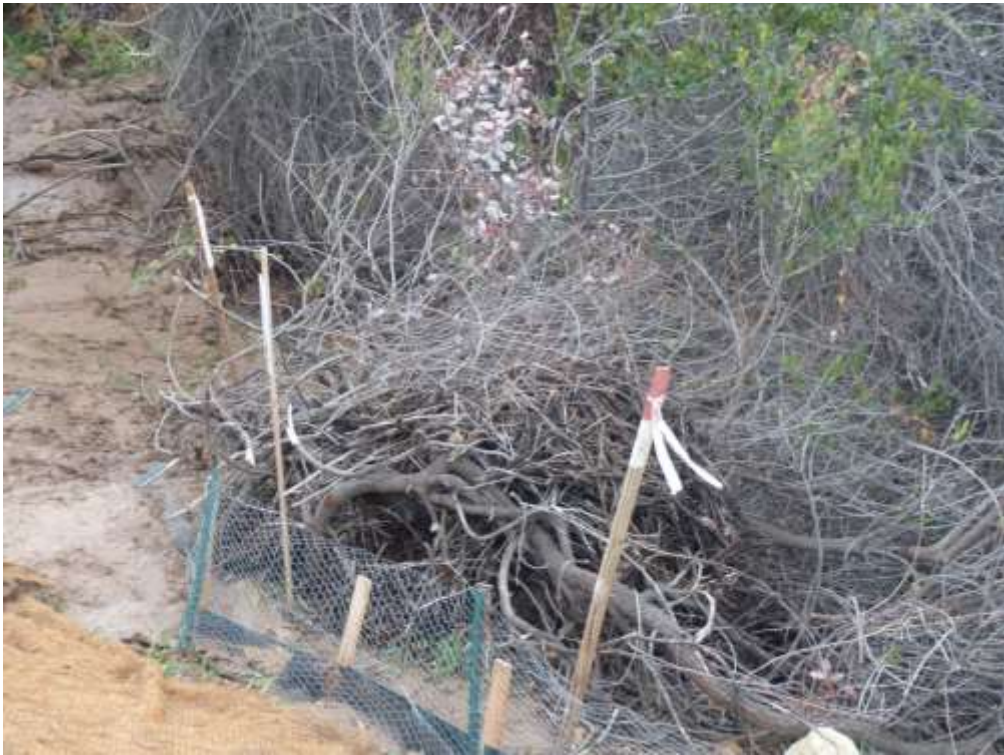
Figure 10: Post storm inspections identified multiple locations where sediment overtook BMPs and traveled off site into a woodrat midden, Tower M27-T3 (photo courtesy of FRED).
