**PROJECT MEMORANDUM
SCE TRANSMISSION PROJECTS, SEGMENTS 1–11**

To: Jason Coontz, Project Manager, CPUC
From: Vida Strong, Aspen Project Manager
Date: April 07, 2014
Subject: Weekly Report 320: March 9 to March 15, 2014

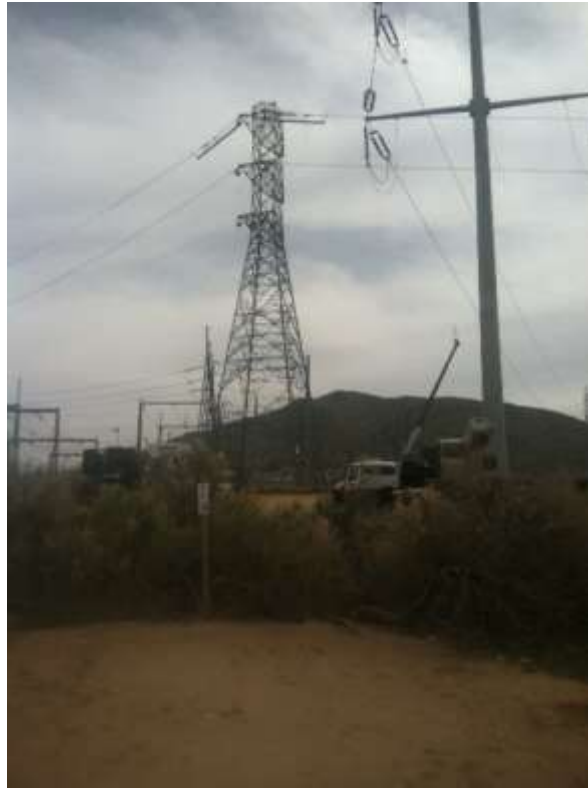
Figure 1: Tower assembly and wire work conducted on Segments 6 and 11 during an outage of adjacent lines.

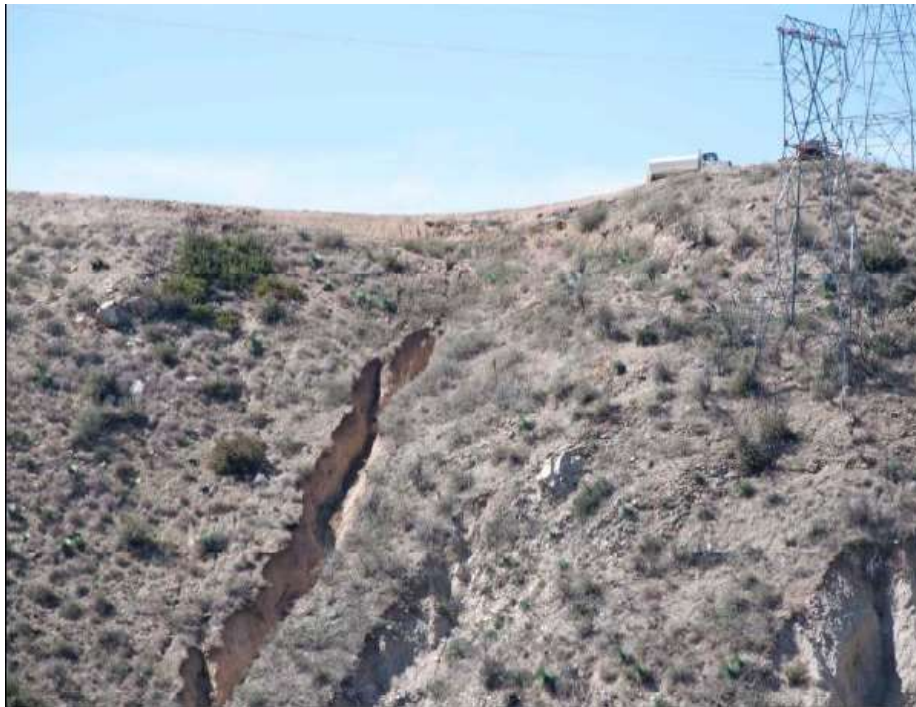
On March 11, an extensive field investigation was performed at Constructs 53X and 54, and Puller/Tensioner Site 54 on Segment 11C to review the debris/sediment slide onto Big Tujunga County Road that had resulted from the February storm. Participants in the review included SCE engineering and consultants, and ANF representatives.

Figure 2: Offsite erosion after early March storm at Tower 54, Segment 11C.

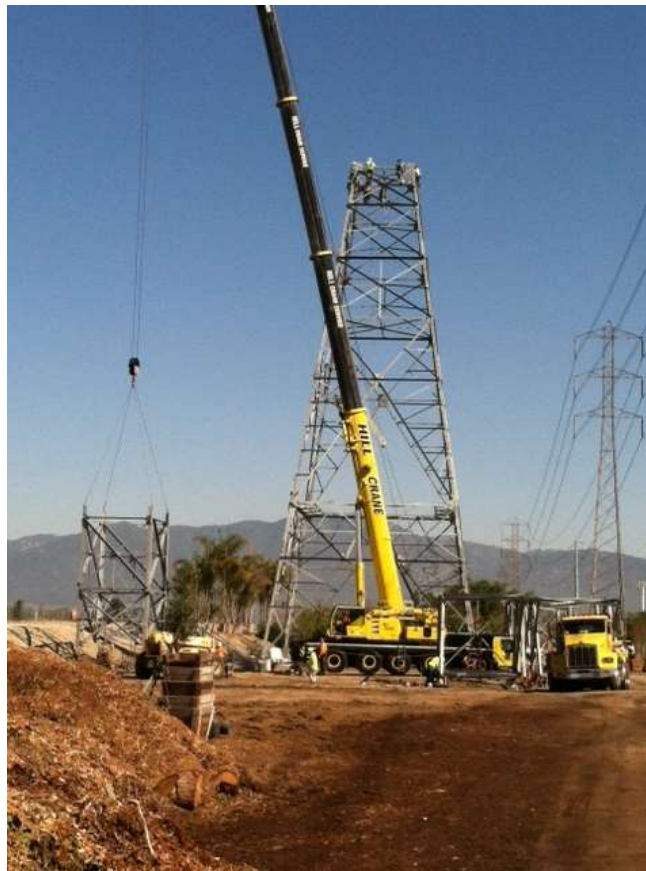
Figure 3: Tower assembly on Segment 7.

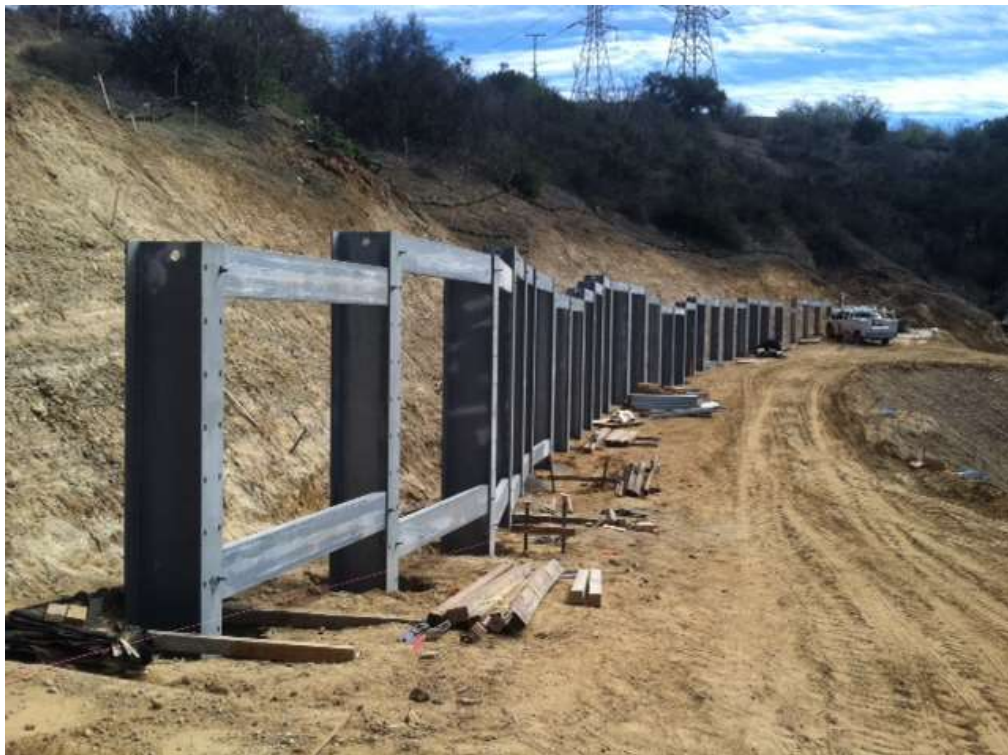
Figure 4: Wall construction along the access road for Tower M57-T1 in Tonner Canyon, Segment 8, Phase 1.

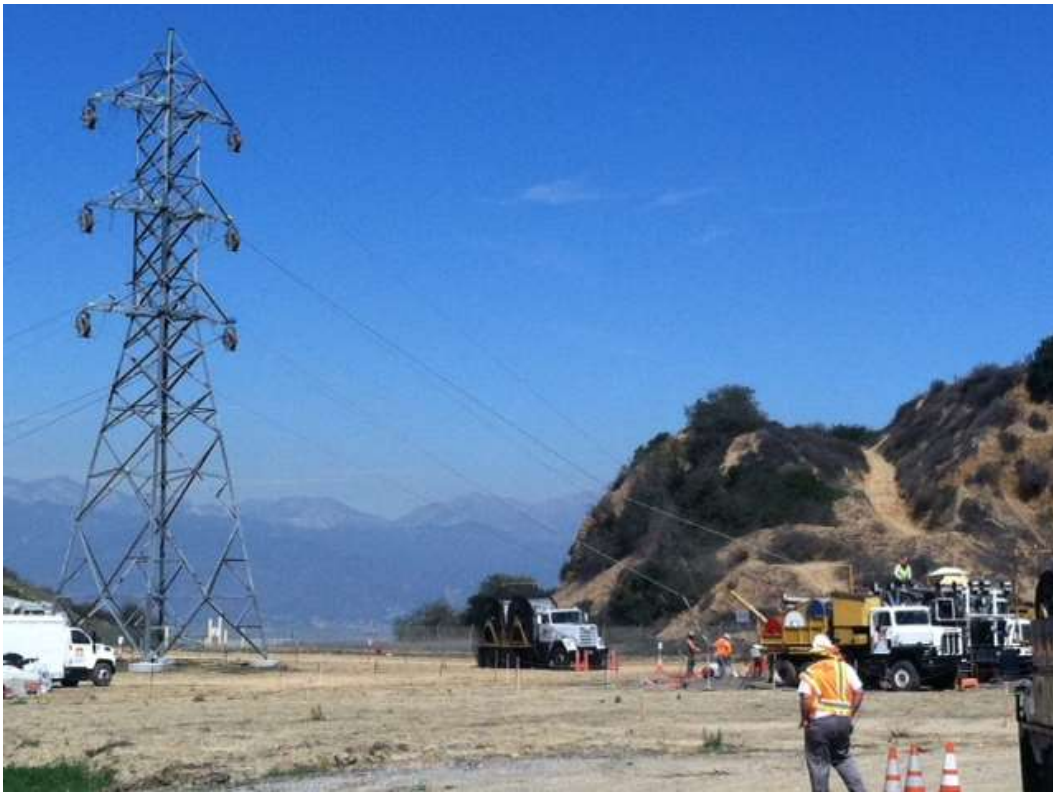
17. BMPs were installed/maintained at various locations.
18. Patriot Construction crews continued excavation activities, including trenching and placing pipe, fill placement, and grading work at Tower M43-T3.
19. Patriot crews conducted fence preparation work at Tower M44-T3.
20. Patriot crews continued to construction activities on the soldier pile wall for the access road to Tower M49-T1 and grading of the upper pad.
21. PAR crews continued foundation installation at Tower M49-T2.
22. Assembly activities were conducted at Towers M50-T4, M51-T4, and M52-T1.
23. Wire stringing operations (such as preparation, wire install, clipping wire, and wire cleanup) continued between Towers M44-T4 through M45-T2, excluding M44-T5, M7-T2A through M7-T1, M7-T3 through M6-T3, M55-T1 through M52-2, and all associated WSS (see Figure 5).

Figure 5: Wire stringing activities near Rose Hills, Segment 8, Phase 4.

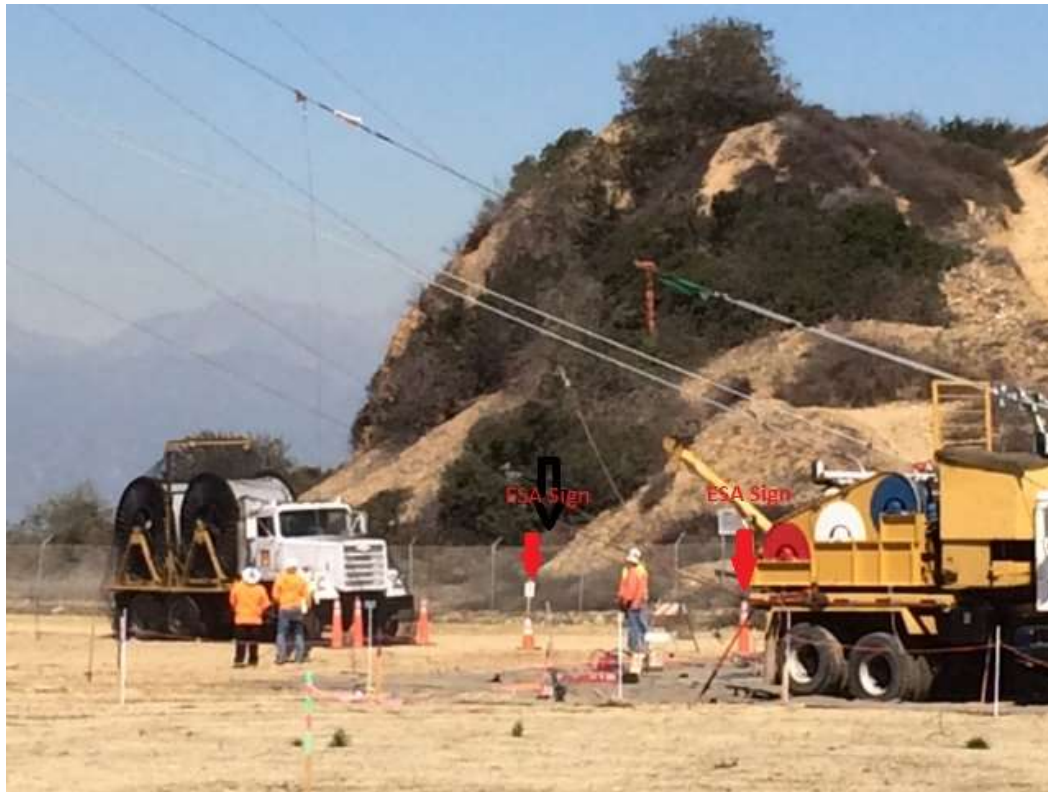
8. On March 10, SCE Biological Monitors observed a PAR crew enter and start work in a designated nest ESA prior to ESA signs being removed at Tower M45-T2 on Segment 8 (see Figure 6). No activity was observed at the nest when the crew was working and the nest had been deemed inactive just a few minutes prior in consultation with the SCE Biologist. The SCE Biologist notified the BMCD Field Coordinator that the resource was inactive and that work may resume. This message was relayed to the contractor however; the area was still marked as an ESA.

Figure 6: PAR crews staged equipment within a clearly marked ESA, Segment 8, Phase 4.

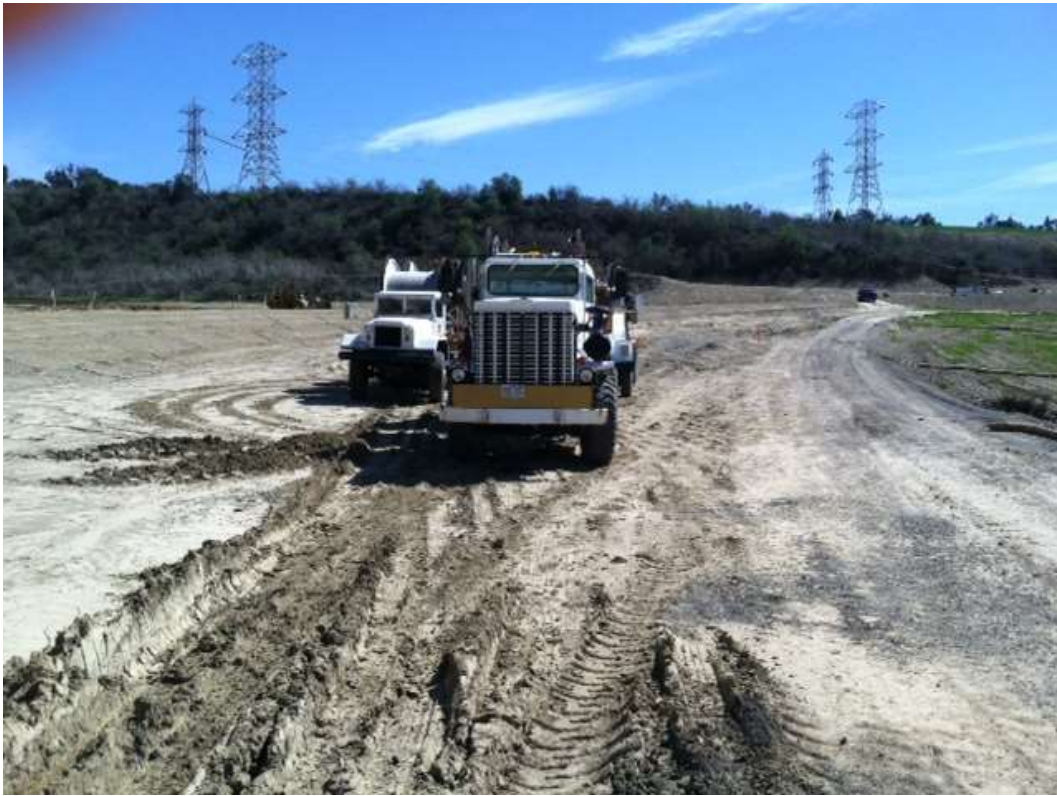
10. On March 12, the CPUC EM observed three wire pulling trucks parked off of an approved access road in Segment 8 near Tower M44-T5 (see Figure 7). The CPUC EM notified the BMCD Field Coordinator of the observation. The wire pullers were moved to an approved work area the next day.

Figure 7: Construction vehicles were observed parked in an unapproved area on Segment 8, Phase 4.
