**PROJECT MEMORANDUM
SCE TRANSMISSION PROJECTS, SEGMENTS 1–11**

To: Jason Coontz, Project Manager, CPUC
From: Vida Strong, Aspen Project Manager
Date: April 17, 2014
Subject: Weekly Report 322: March 23 to March 29, 2014

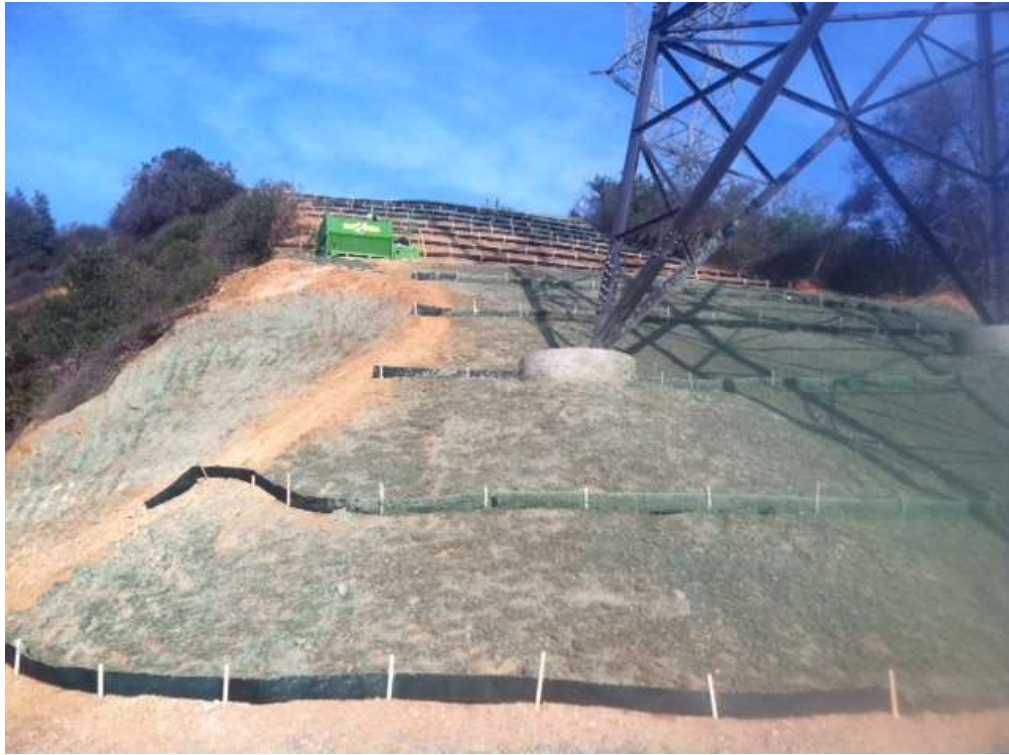
Figure 1: Hydromulch and Prowattle application on the slope of Construct 113, Segment 6C.

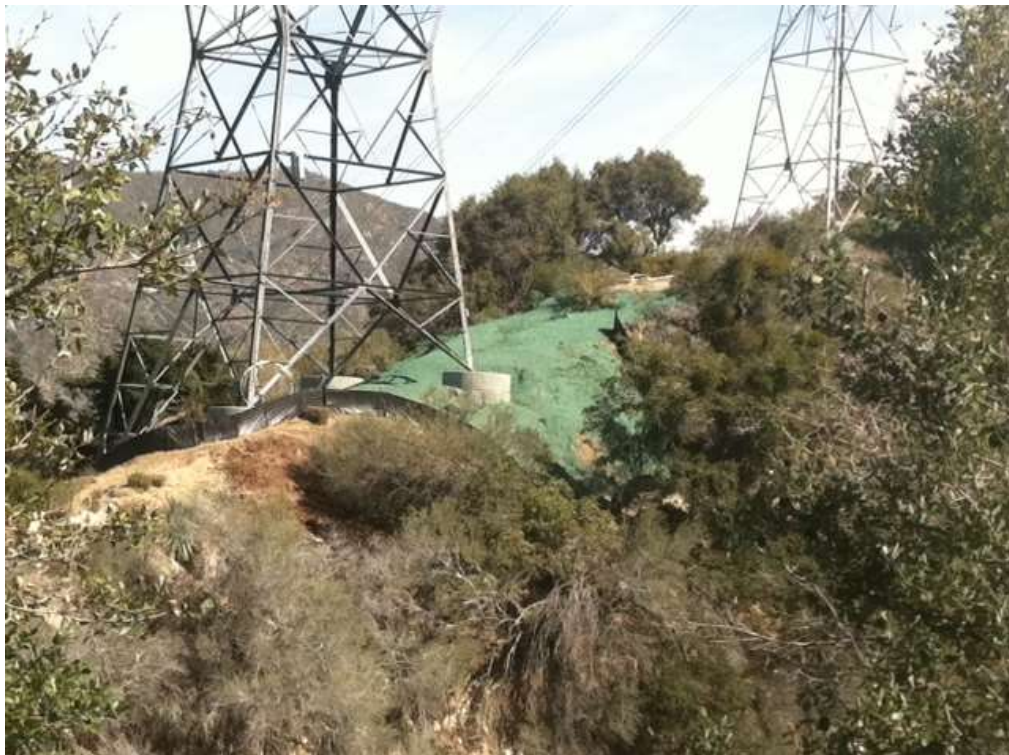
Figure 2: Recently completed hydromulch application at Construct 81, Segment 6C.

1. Construction of the Segment 6 transmission line has been completed. Remaining work including the installation of marker balls and restoration activities at temporary disturbed areas have yet to be scheduled. Post-construction clean up and erosion control maintenance is ongoing.
2. Road grading activities related to closeout and/or post storm cleanup efforts occurred at Constructs (towers) 9, 14, 16, 19, 23, 28, and 54, Pull Site 54, Puller/Tensioner 28/29, and Puller/Tensioner 113 (see Figure 1).
3. Drainage improvements and wet crossing installation/maintenance related to post storm cleanup efforts occurred at Civil ID 181.
4. BMP installation, maintenance, and inspection occurred at various construction locations (see Figure 2).

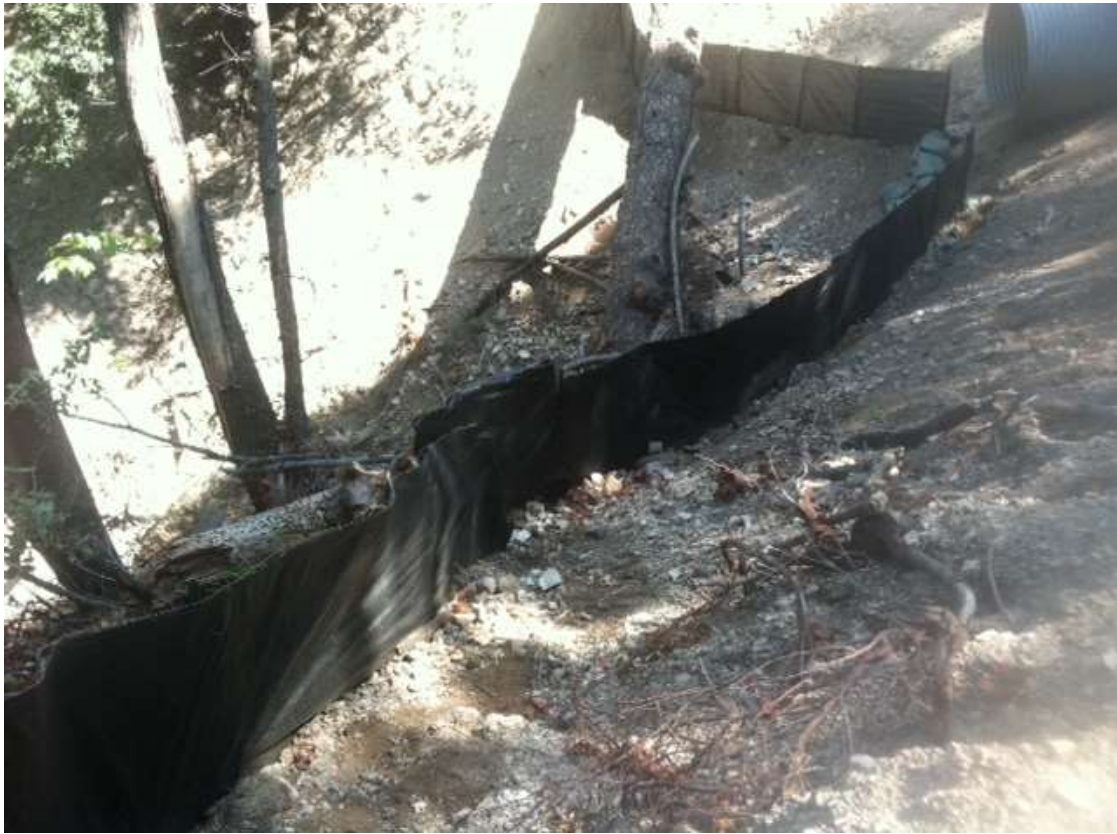
Figure 3: Silt fence and erosion repaired at Loop Road L at Mile 8.0.

On March 29, the CPUC EM reviewed the sites listed in SCE’s USFS’s Corrective Action Plan (CAP) as completed in the field with the Professional Engineer that assisted in the CAP development both on/off the Forest Service lands. The CPUC EM verified that all sites noted to have had correction performed had been completed and observations were discussed with the USFS Soil Scientist and USFS Project Manager (see Figure 3, 4, and 5).

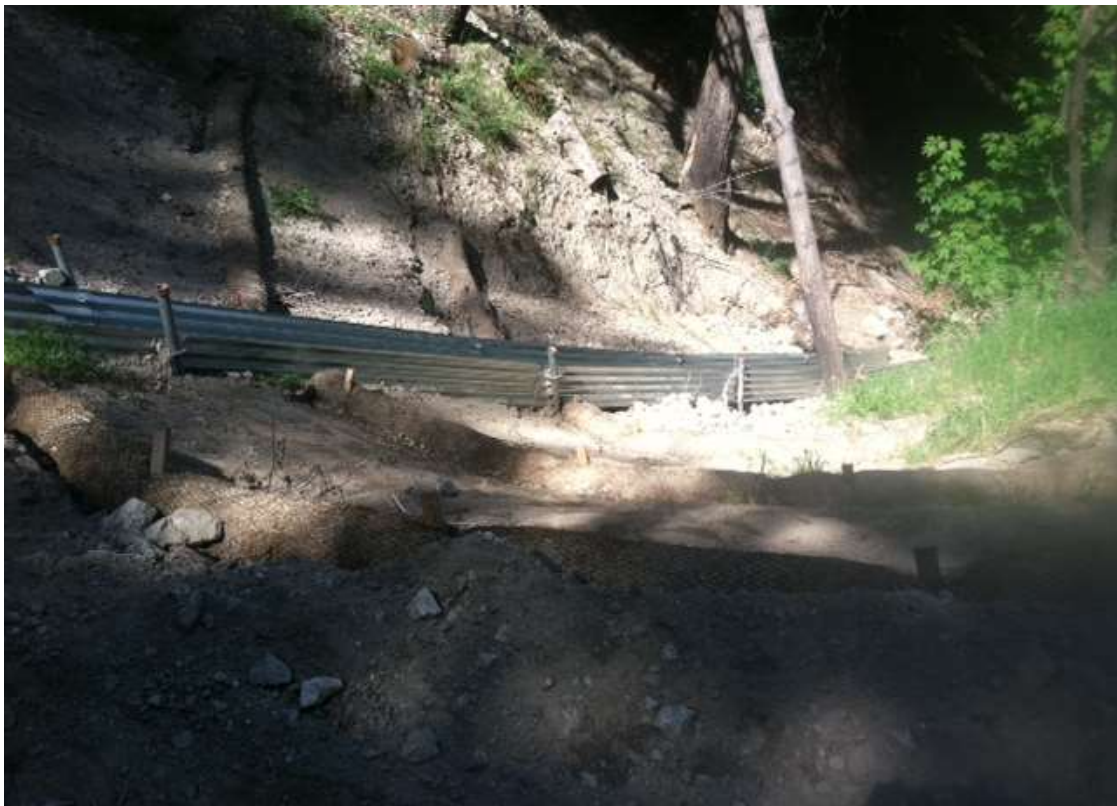
Figure 4: Straw wattles and slope have been repaired on Loop Road L Mac Drain at Mile 6.5.

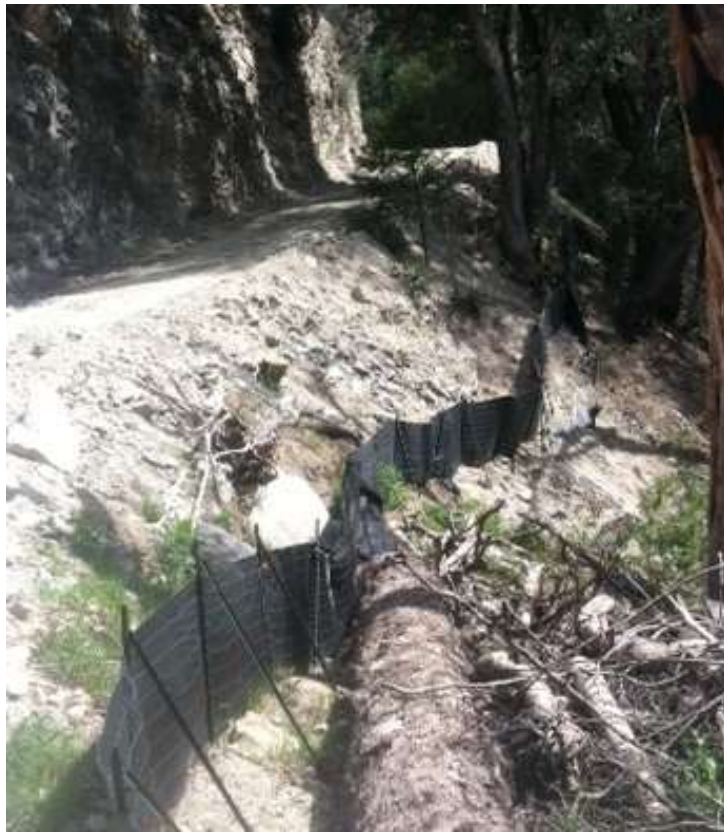
Figure 5: Silt fence repaired on Loop Road L at Mile 6.0. Housekeeping issues were identified to the PE present; damaged silt fence remained onsite and appears to be buried by new fencing install.

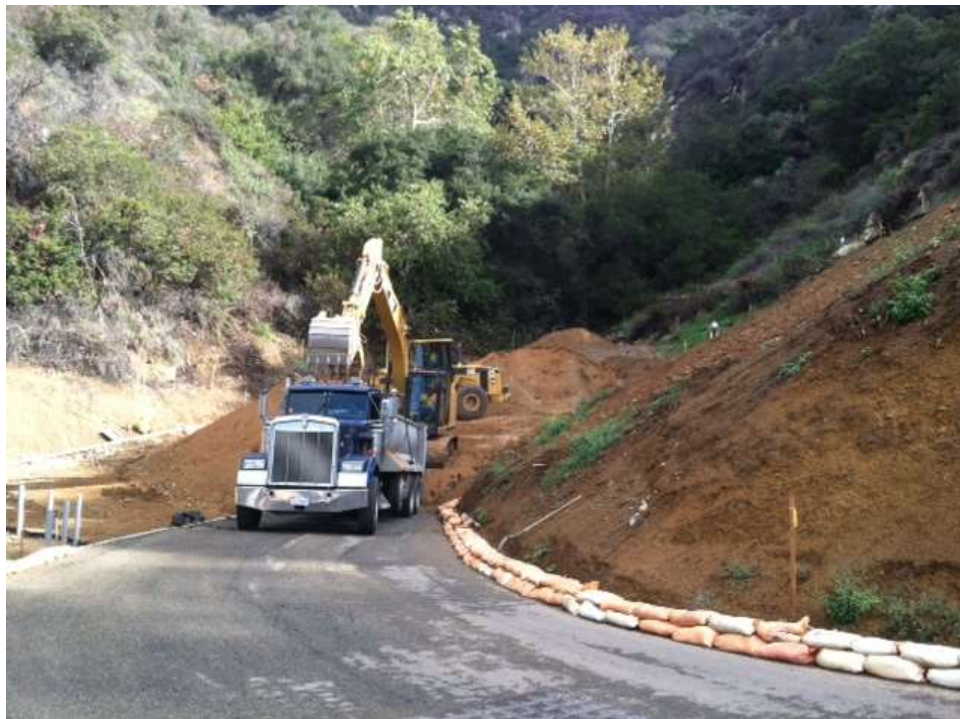
Figure 6: Soil export at M27-T3 in the City of Duarte, Segment 7.

3. BMPs were installed/maintained at various locations.
4. Union Construction crews continued road grading, Hilfiger and soil nail wall excavation and installation, soil export, and BMP maintenance and installation at Tower M27-T3 (see Figure 6).
5. Foundation installation occurred at Tower M27-T2.
6. Assembly activities were conducted at Towers M29-T4, M29-T5, M31-T4, M32-T2 through M32-T5, M34-T2 through M34-T6, M35-T2, M35-T3, and M35-T4.
7. Wire stringing operations to correct conductor sag occurred between Towers M36-T1 and M36-T4.

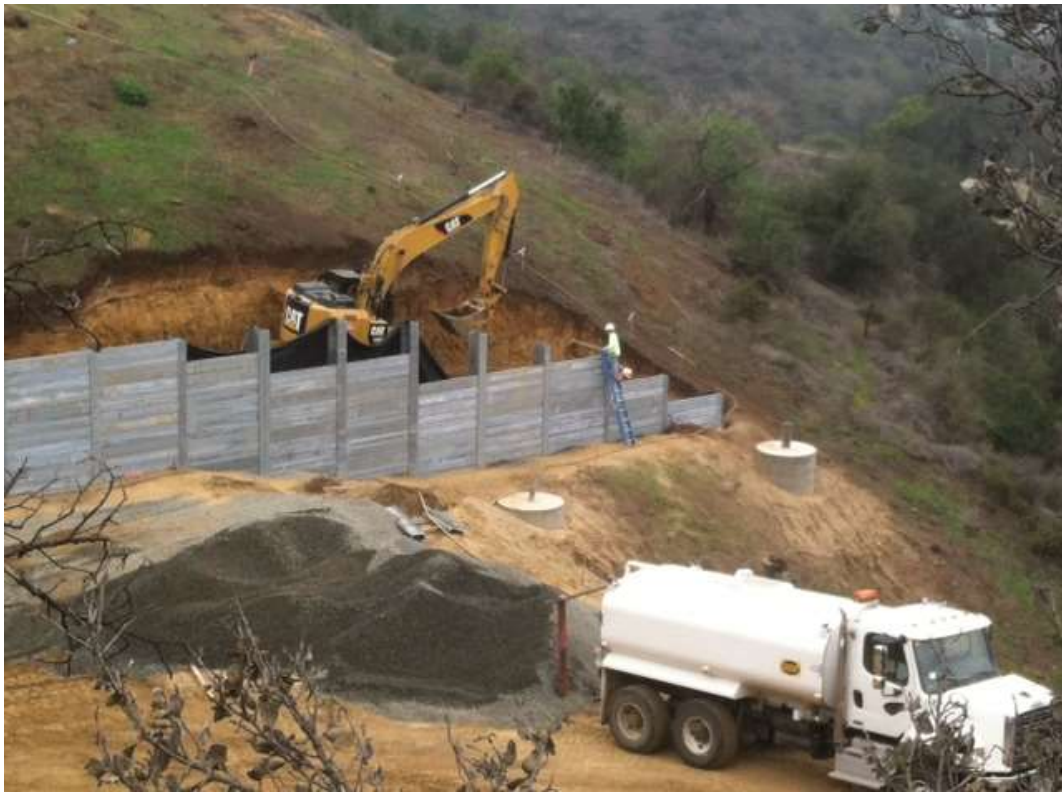
Figure 7: Union Construction crews continued road grading, placing drain material, and retaining wall installation, Tower M57-T1, Segment 8, Phase 1.

8. During the subject week, BMP maintenance activities were conducted at locations along the Chino Hills underground right-of-way.
9. Union Construction crews continued road grading, and drain material and retaining wall installation at Tower M57-T1 (see Figure 7).

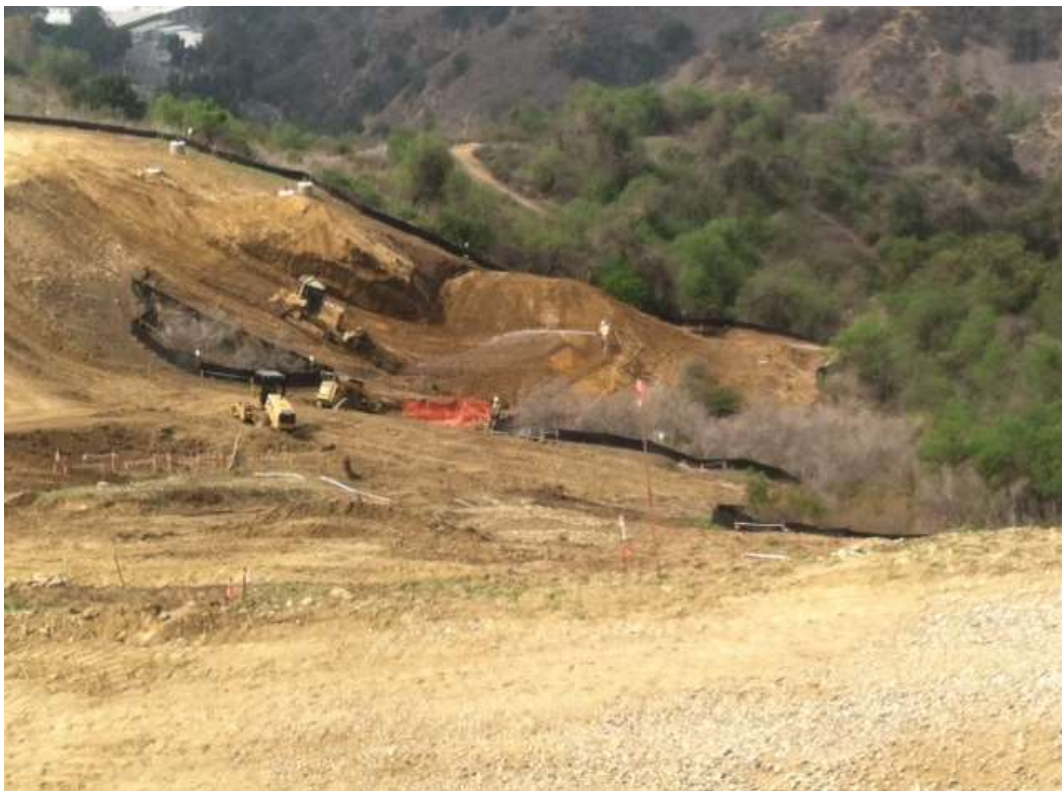
Figure 8: Patriot Construction crews continued excavation activities, including trenching, pipe and fill placement, and grading work at Tower M43-T3, Segment 8, Phase 4.

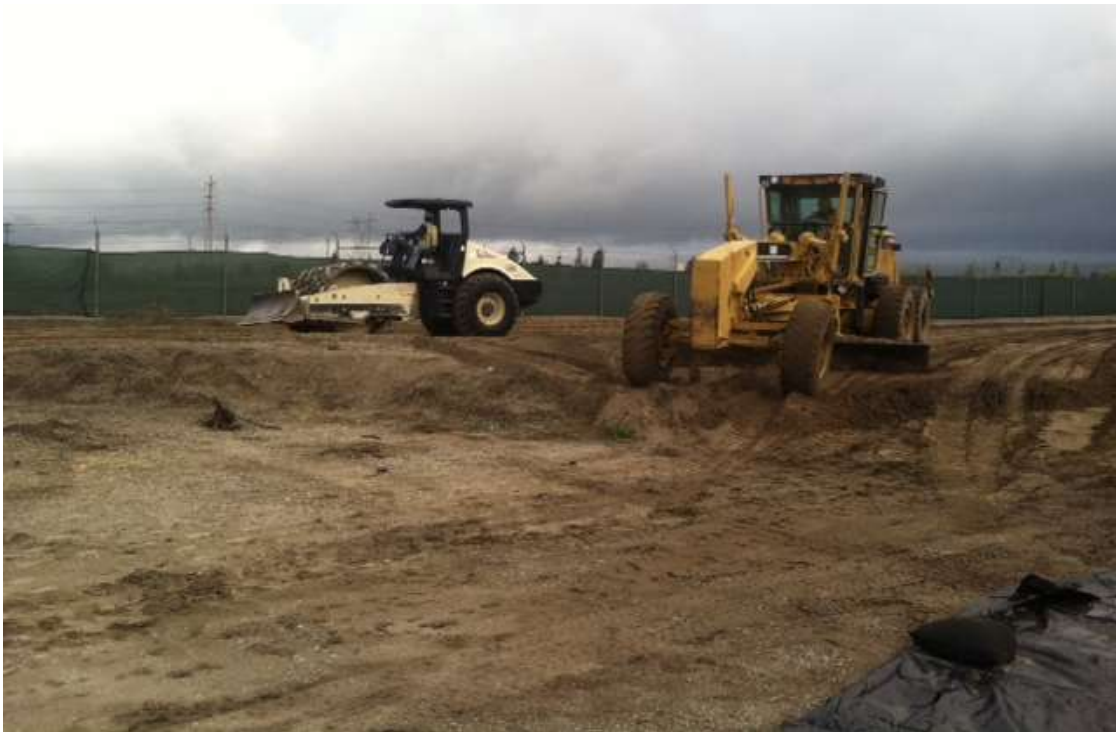
Figure 9: KGC developing a previously undisturbed portion of the Rancho Vista Materials Yard in preparation for material storage for the CHUG work.

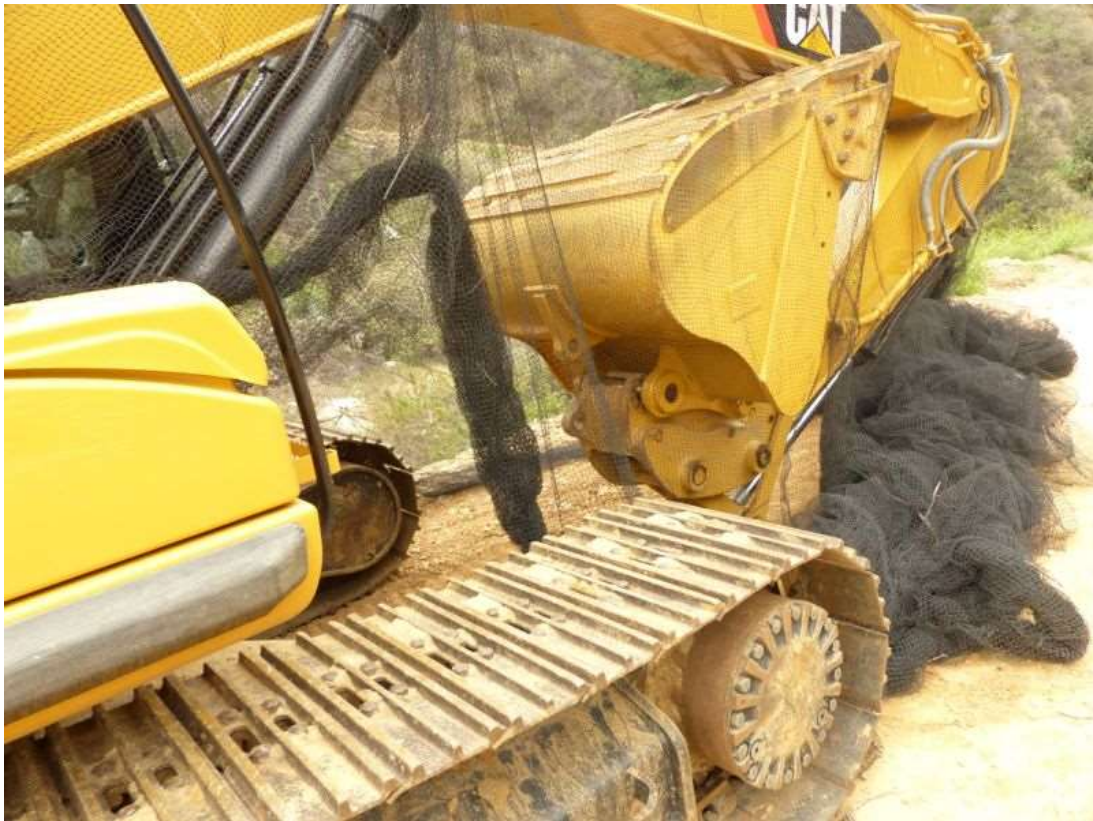
7. On March 27, a Biological Monitor reported that an SCE SWPPP Monitor had observed a southern California rufous-crowned sparrow (a California species of special concern) trapped within improperly secured bird-deterrent netting on an excavator staged on the access road to Tower M27-T2 on Segment 7 (see Figure 10). Without handling the sparrow, the SWPPP Monitor released it from the netting unharmed.

Figure 10: A Southern California rufous-crowned sparrow (a CDFW species of special concern) was found trapped under bird netting draped over project equipment, Segment 7 (photo courtesy of SCE's FRED database).
