**PROJECT MEMORANDUM
SCE TRANSMISSION PROJECTS, SEGMENTS 1–11**

To: Jason Coontz, Project Manager, CPUC
From: Vida Strong, Aspen Project Manager
Date: July 15, 2014
Subject: Weekly Report 334: June 15 to 21, 2014

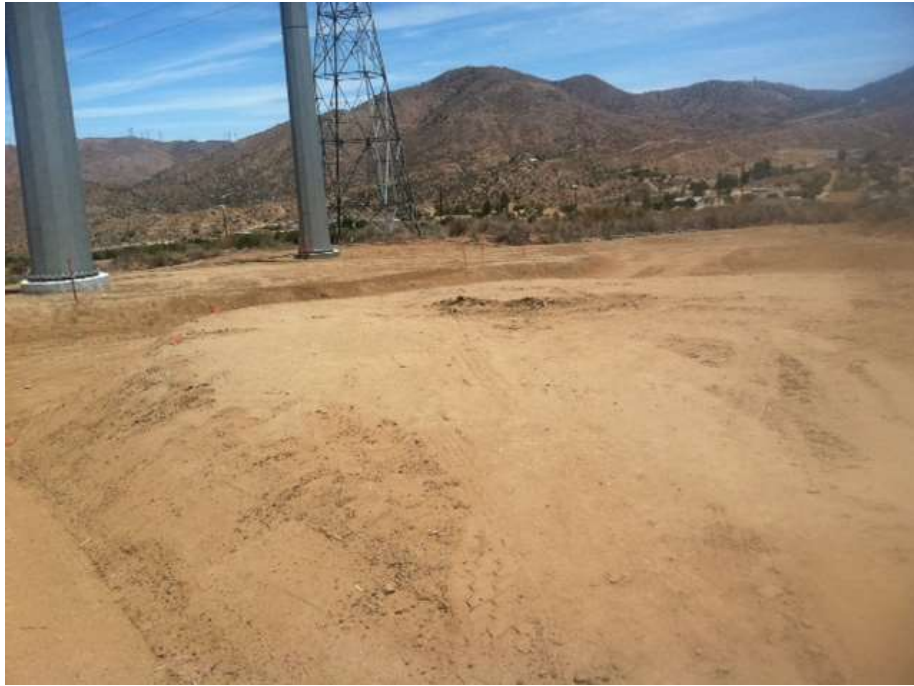
Figure 1: Site finalization completed at Construct 7, Segment 6A.

1. Construction of the Segment 6 transmission line has been completed. Remaining work including the installation of marker balls and restoration activities at temporary disturbed areas have yet to be scheduled. Erosion control maintenance, weed abatement, and road finalization is ongoing (see Figure 1).

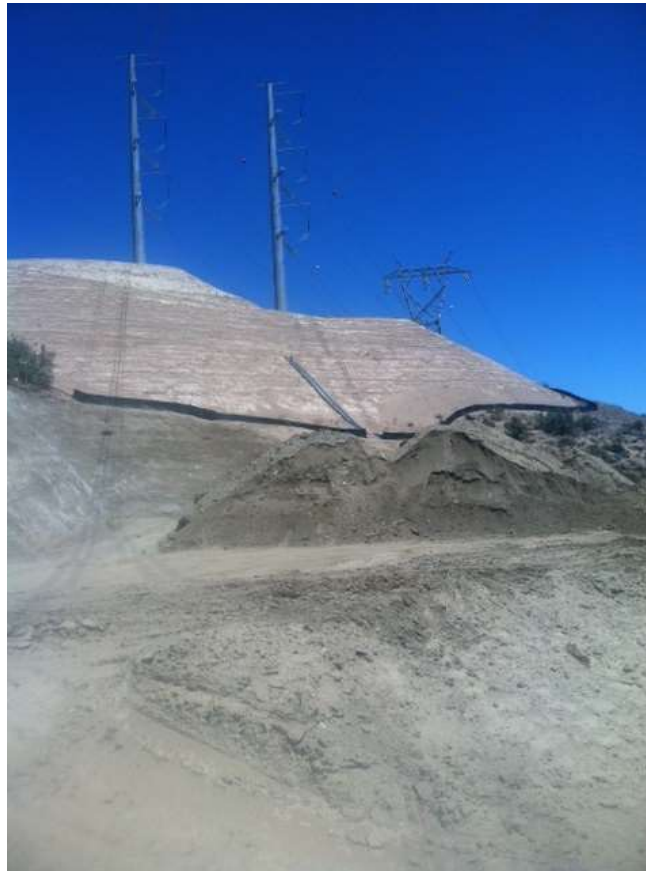
Figure 3: Uncovered stockpile at Construct 5, Segment 6A.

6. On June 17, the CPUC EM noted uncovered stockpiles in the Acton area. One of these stockpiles has been left undisturbed long enough to grow a considerable amount of weeds. It is required that stockpiles be covered after 14 days of inactivity according to the Project SWPPP and California General Permit (see Figure 2 and 3).

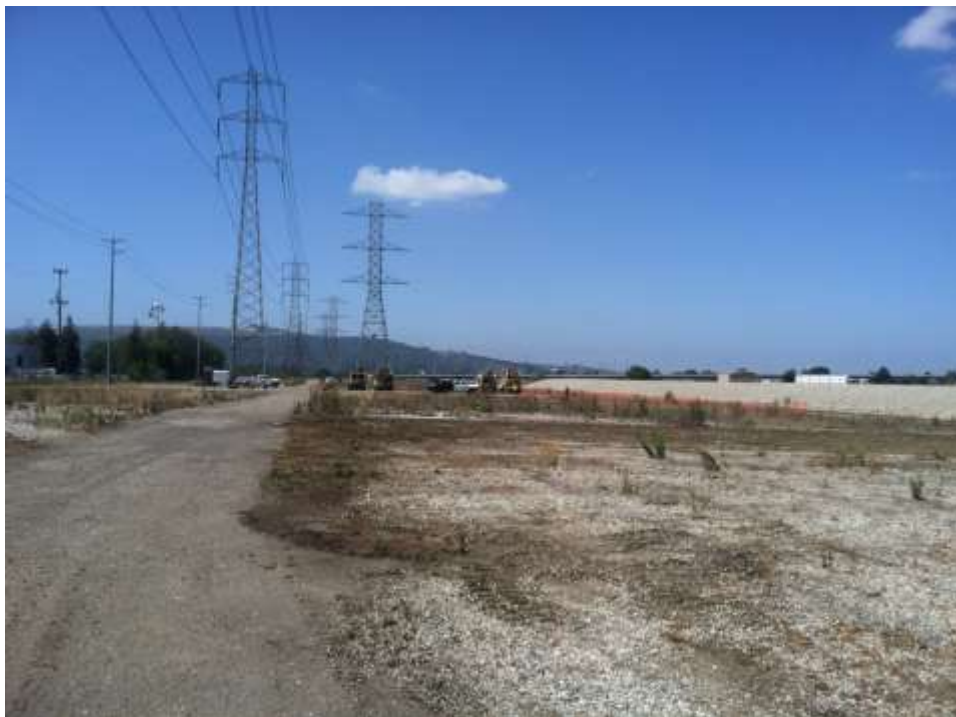
Figure 4: PAR equipment set up within the Segment 7 right-of-way in preparation for installation of conductor over the 10 Freeway.

2. BMPs were installed/maintained at various locations.
3. Union Construction crews continued road grading, foundation installation, and BMP maintenance and installation at Tower M27-T3.
4. Assembly activities were conducted at Tower M27-T2.
5. Wire stringing operations (such as preparation, wire install, clipping wire, and wire cleanup) continued between Towers M32-T1 through M35-T1 (see Figures 4 & 5).

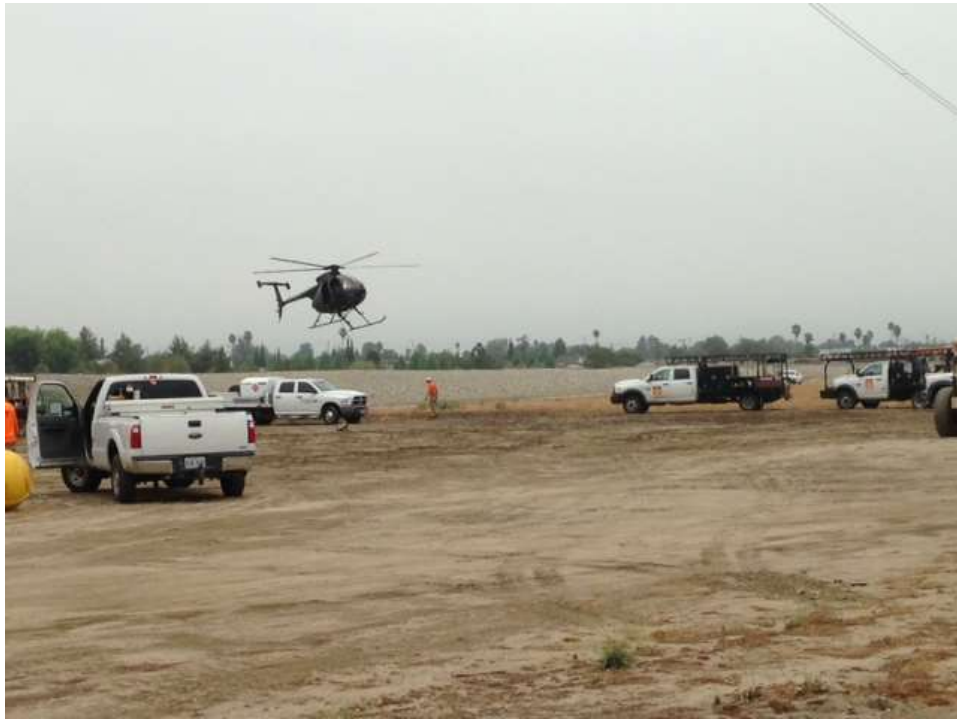
Figure 5: Helicopter activity associated with the 10 freeway crossing, Segment 7.

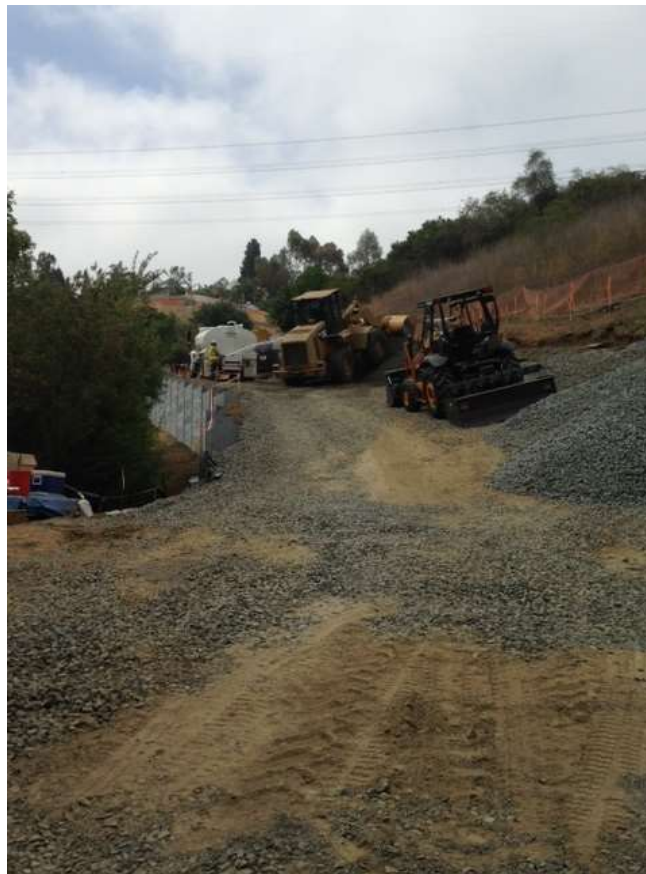
Figure 6: Hilfaker wall and access road construction at Tower M49-T1, Segment 8 Phase 4.

15. BMPs were installed/maintained at various locations.
16. Patriot crews continued the Hilfiger wall installation for the road leading to Tower M49-T1 (see Figure 6).
17. Patriot crews continued grading activities in the landslide area for Tower M43-T3 and finishing other slopes and roadways (see Figure 7).
18. Assembly activities were conducted at 500 kV Towers M42-T5, M42-T5A, M42-T6, M42-T7, and M45-T5.
19. FAA Lighting was installed at Towers M42-T5 and M42-T5A.
20. Wire stringing operations (such as preparation, wire install, clipping wire, and wire cleanup) completed during the subject time period for Towers between M43-T1 through M44-T2, M44-T4 through M45-T1, and all associated wire stringing sites (WSS).

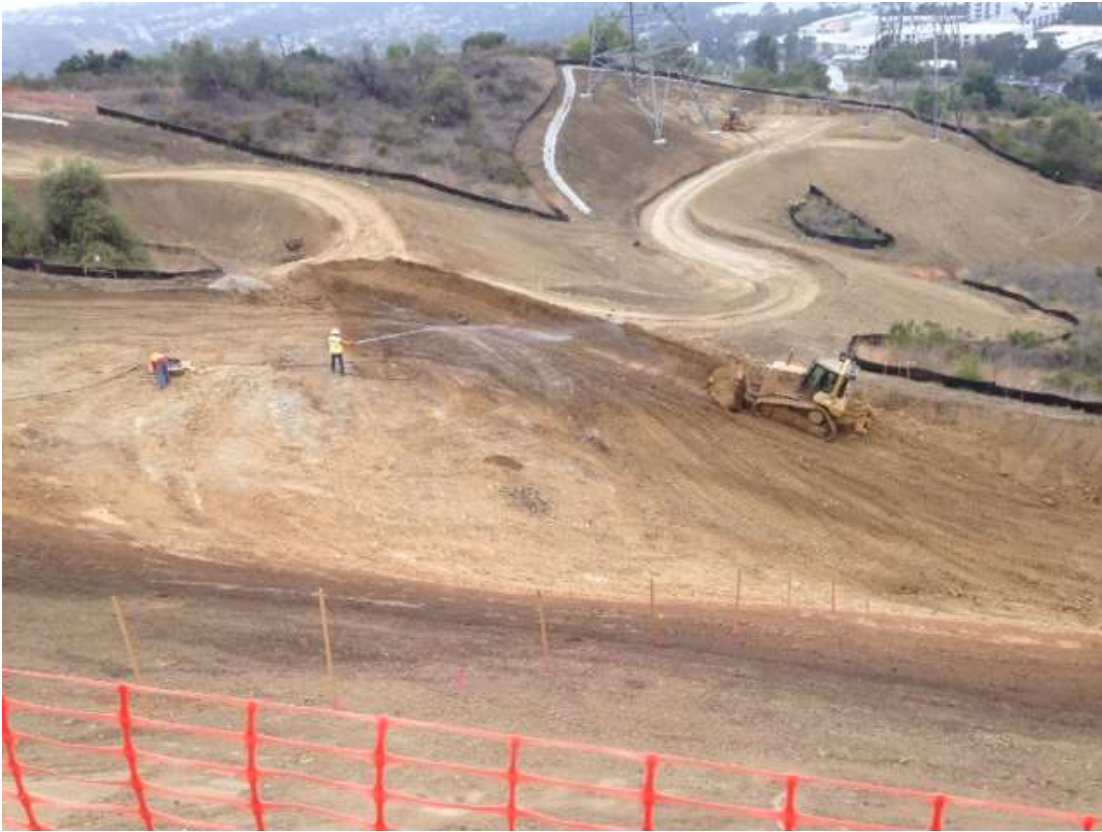
Figure 7: Grading at site for Tower M43-T3, Segment 8, Phase 4.

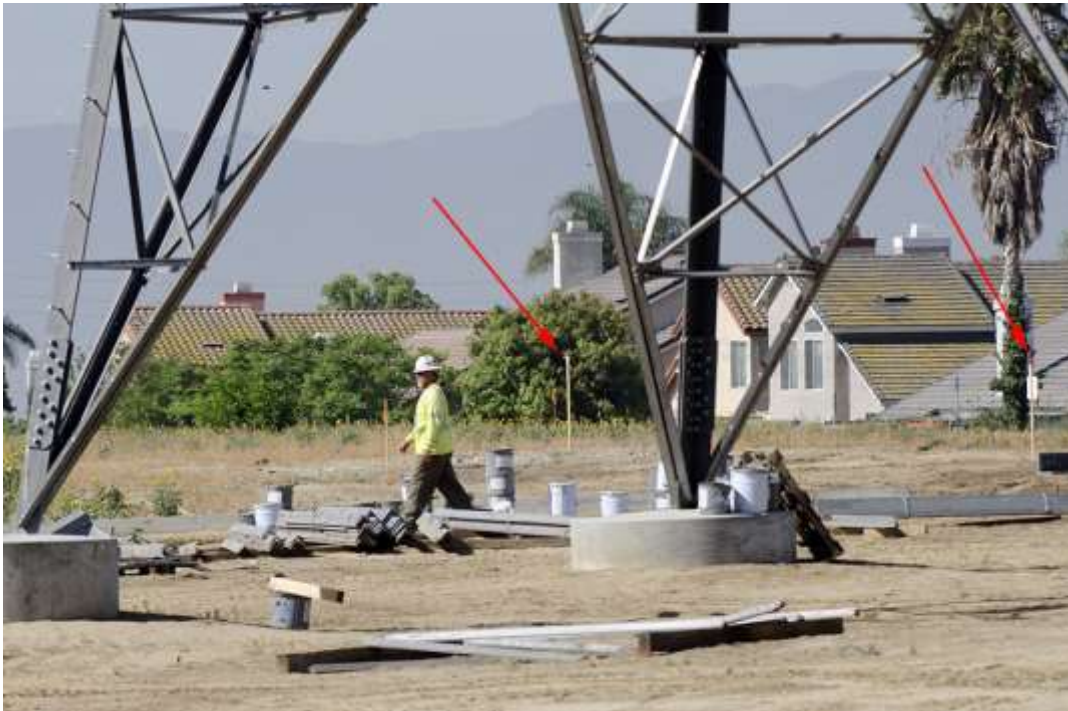
Figure 8: A TRTP construction worker walking into a marked exclusion area for a western burrowing owl. SCE Biologists monitored the owl burrow after this occurred and determined that the owls were not noticeably impacted by the incident, Segment 8, Phase 3. (Photo courtesy of FRED).

8. On June 20, the onsite Biological Monitor observed a worker walking into the Environmentally Sensitive Area (ESA) for an active burrowing owl burrow at Tower M73-T1 on Segment 8, Phase 3 (see Figure 8). One of the owls was seen taking flight when the worker was within approximately 100 feet of the burrow, but the owl did not give any distress calls and may or may not have been responding to being approached. The worker then reversed his course, retrieved some material from within the ESA buffer, loaded it into his truck parked outside the buffer, and drove off in the direction of Tower M72-T3. ESA signs were checked and were installed correctly. The nest was observed for one hour and was not noticeably impacted by the incident.
