**PROJECT MEMORANDUM
SCE TRANSMISSION PROJECTS, SEGMENTS 1–11**

To: John Boccio, Project Manager, CPUC
From: Vida Strong, Aspen Project Manager
Date: August 29, 2014
Subject: Weekly Report 341: August 3 to August 9, 2014

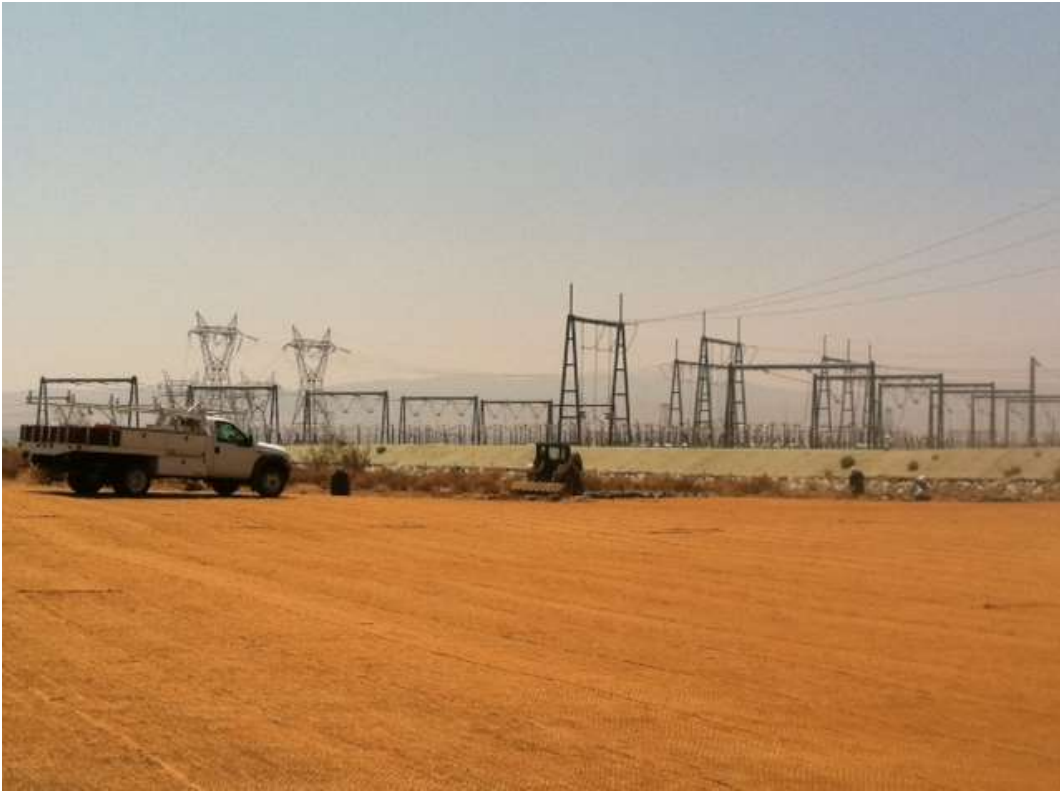
Figure 1: BMP removal at Whirlwind Substation.

5. Segment 10 Telecom: Work has been completed.
6. Whirlwind Substation: Construction of the Whirlwind Substation has been completed. Fence and BMP removal activities continue and are scheduled for completion by mid-August (see Figure 1).

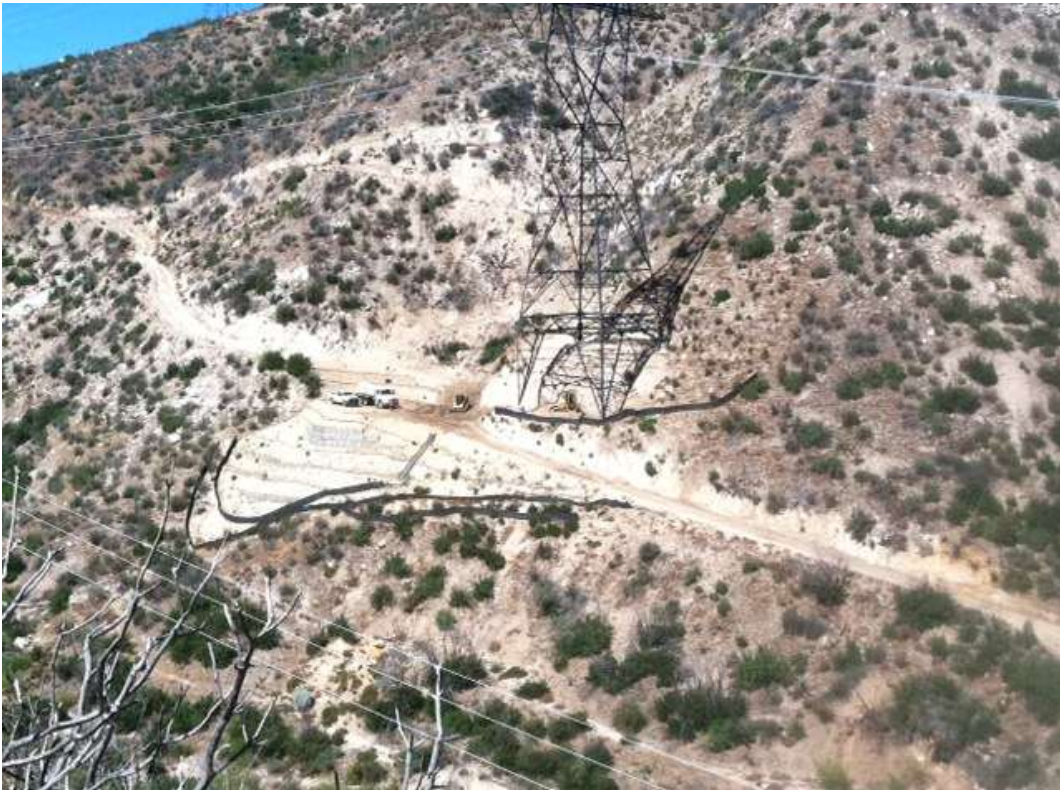
Figure 2: Restoration grading activities at Construct 33, Segment 6A.

3. Road grading occurred at Constructs 9, 14, 15, 33, and 72; Helicopter Support Yard (HSY) 1/2; Puller/Tensioner Site 28/29; and Loop Roads B, C, D, E, and F (see Figure 2).

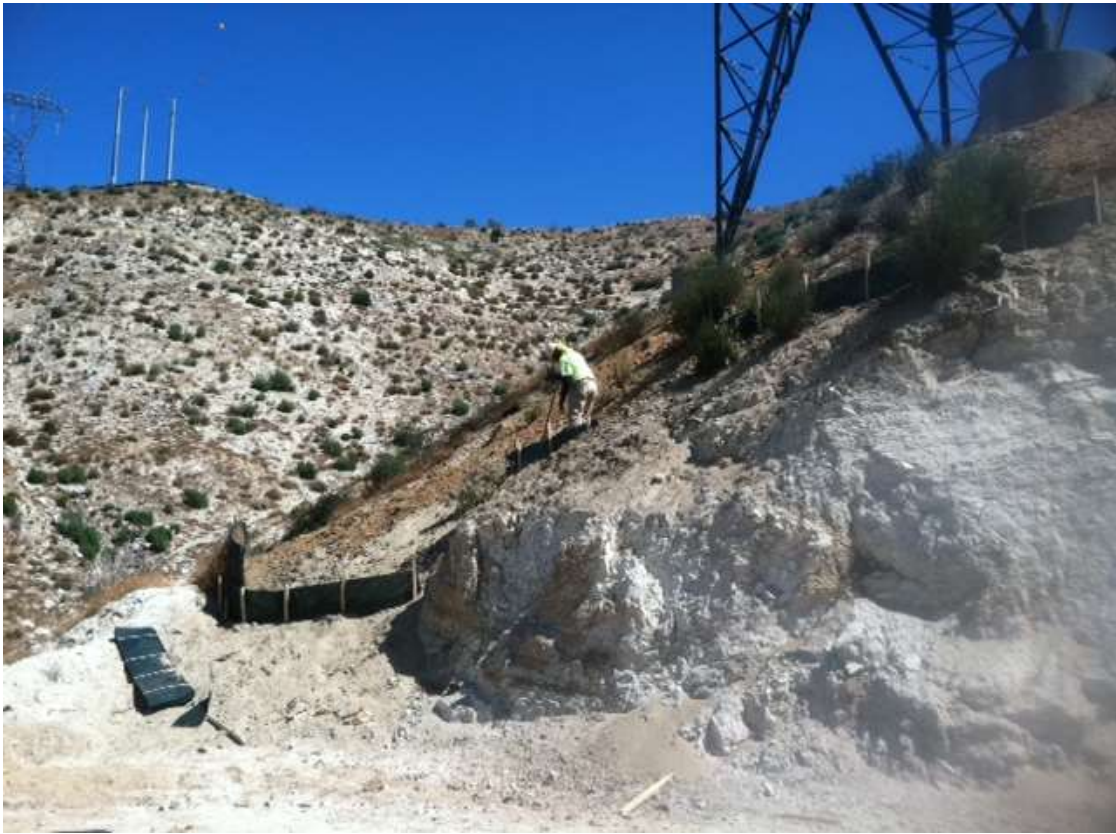
Figure 3: BMP maintenance at Construct 20, Segment 6A.

5. Wire stringing occurred at Construct 113 to connect to the Segment 7 alignment.
6. BMP installation, maintenance, and inspection occurred at various construction locations (see Figure 3).

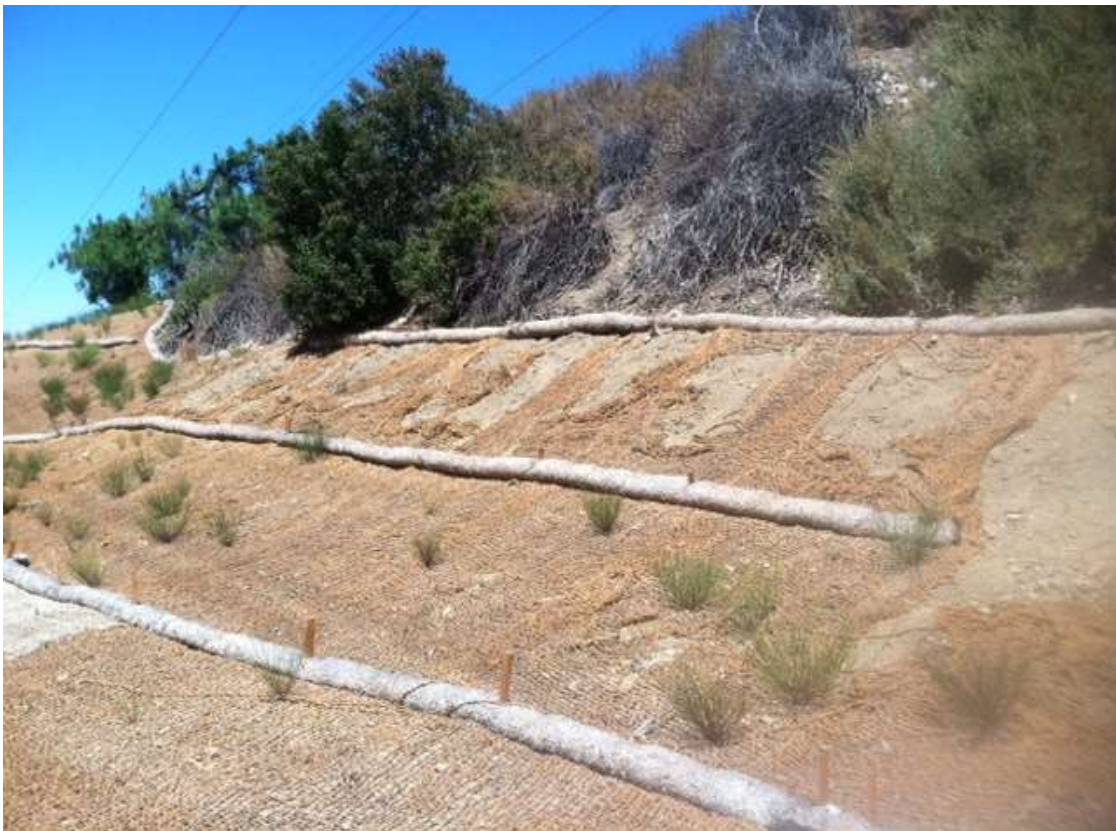
8. Construction activity on Segment 11B has been completed. Restoration and recontouring of temporary work areas is scheduled for fall 2014.
9. On August 5, the CPUC EM reviewed the Chaney Trails Pull site area and found a considerable amount of damage to post construction BMPs. It was noted to the onsite SWPPP personnel of the site situation. On August 8, a maintenance notification was developed within SCE's FRED system regarding the site (see Figure 4).

Figure 4: BMP deficiencies at Chaney Trails Pullsite, Segment 11B.

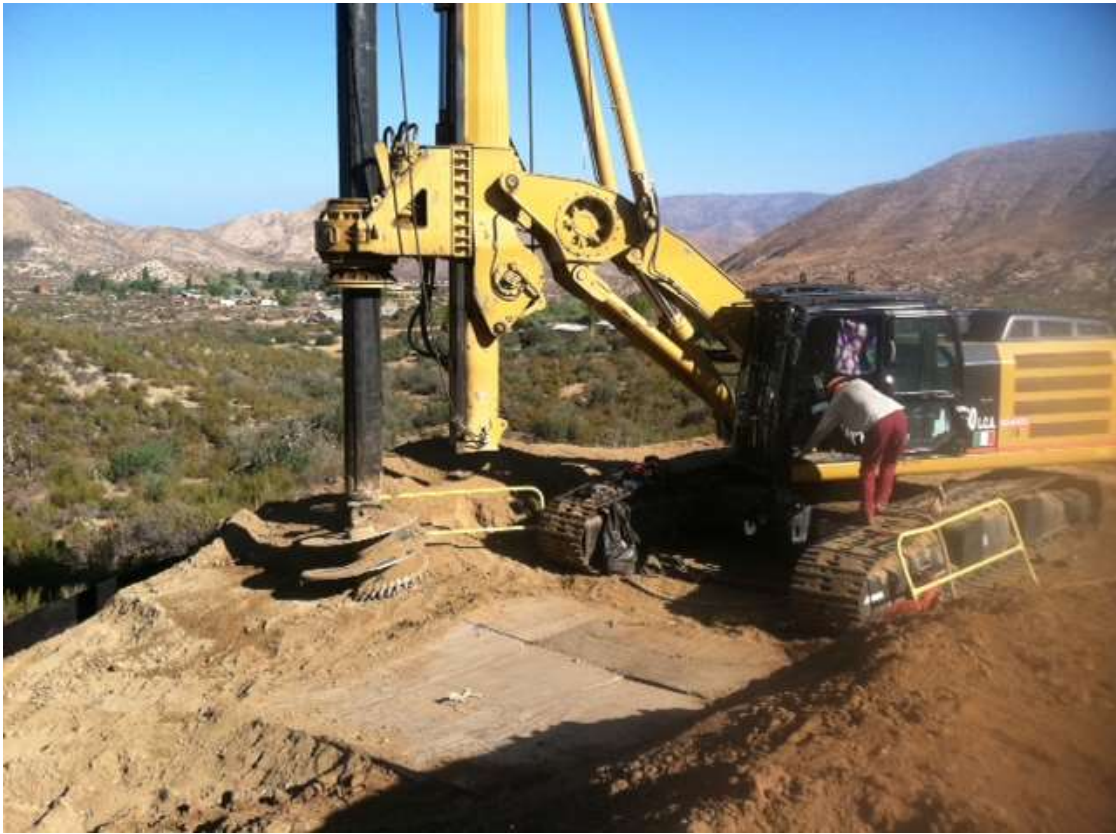
Figure 5: Foundation activities at Construct 15, Segment 11C.

12. Drainage improvements and wet crossing installation/maintenance occurred at Constructs 11AXXX, 12, 13, 20, 21, and 40, and Loop Road N.
13. Foundation excavation and pouring activities occurred at Constructs 11AX, 12, 14, 16, 18, 20, 21, 23, 28, 32, 35, 36, 37, 41, 42 58, 71, and M15-T2 (see Figure 5 and 6).

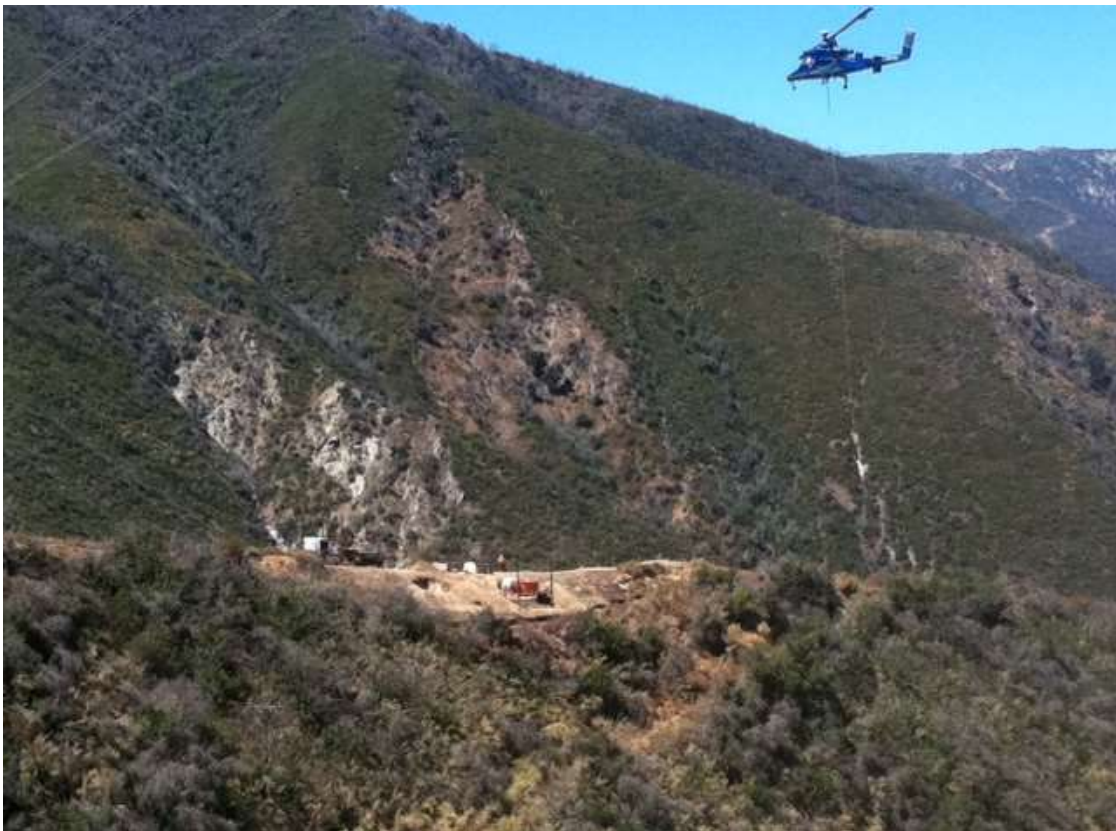
Figure 6: Foundation (micropile) activity at Construct 58, Segment 11C.

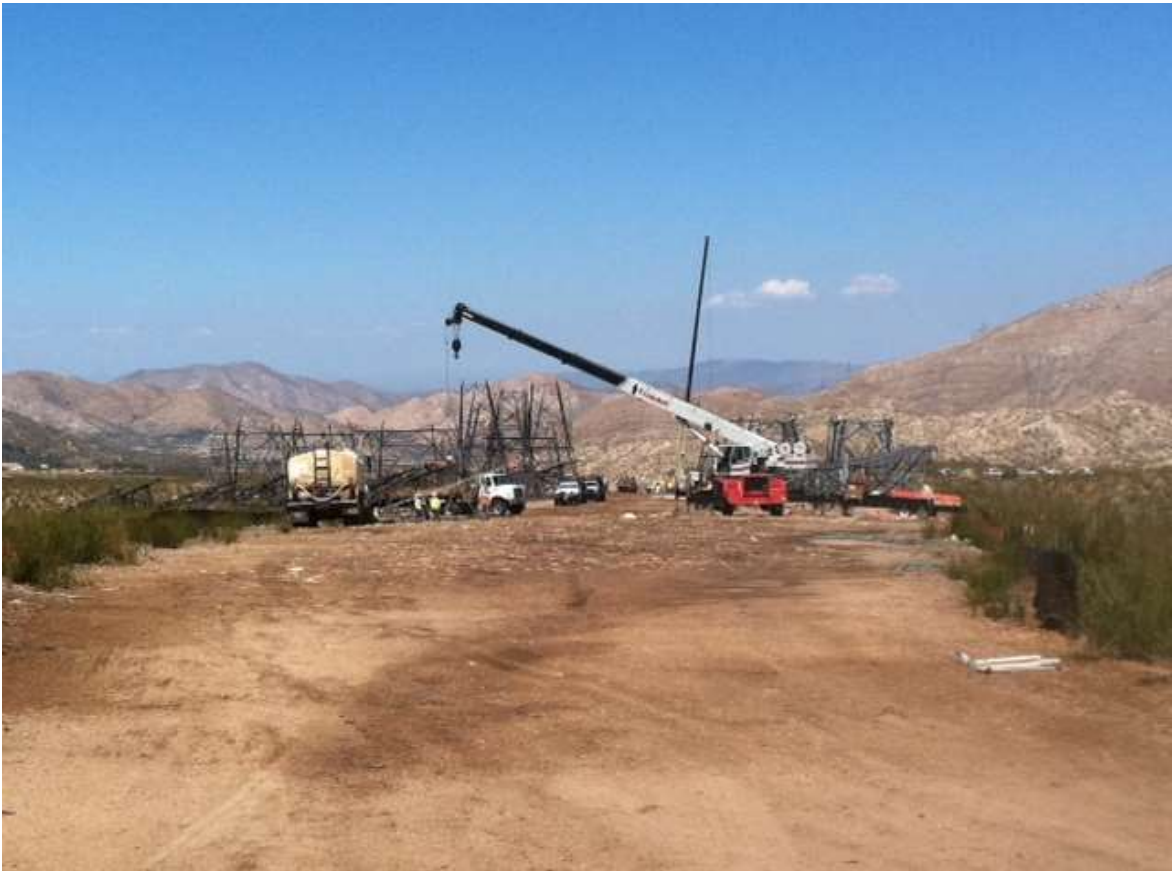
Figure 7: Erection activities at Aliso Canyon HAY, Segment 11C.

14. Structure assembly and erection occurred at Constructs 1, 9, 11AX, 12, 20 to 26, 28, 23, and 32, and Aliso Canyon HAY (see Figure 7).
15. BMP removal occurred at Aliso Canyon HAY.

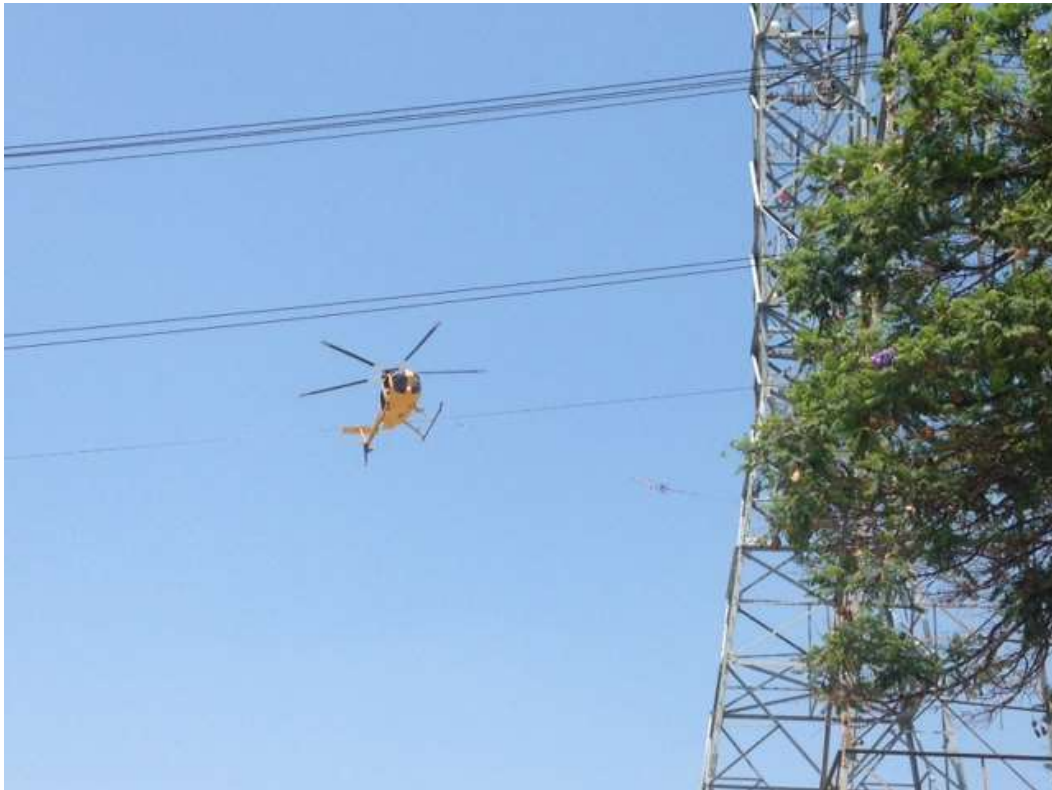
Figure 8: Wire pulling activities in Duarte, Segment 7.

6. PAR conducted splice box/can installation at Towers M22-T1, M27-T2, M29-T4, M59-T1D, M31-T1, and M32.T1.
7. Wire stringing operations (such as preparation, wire install, clipping wire, and wire cleanup) continued at Towers M27-T2 through M30-T1 and M34-T1 through M36-T2 and associated wire setup sites (WSS) (see Figure 8).

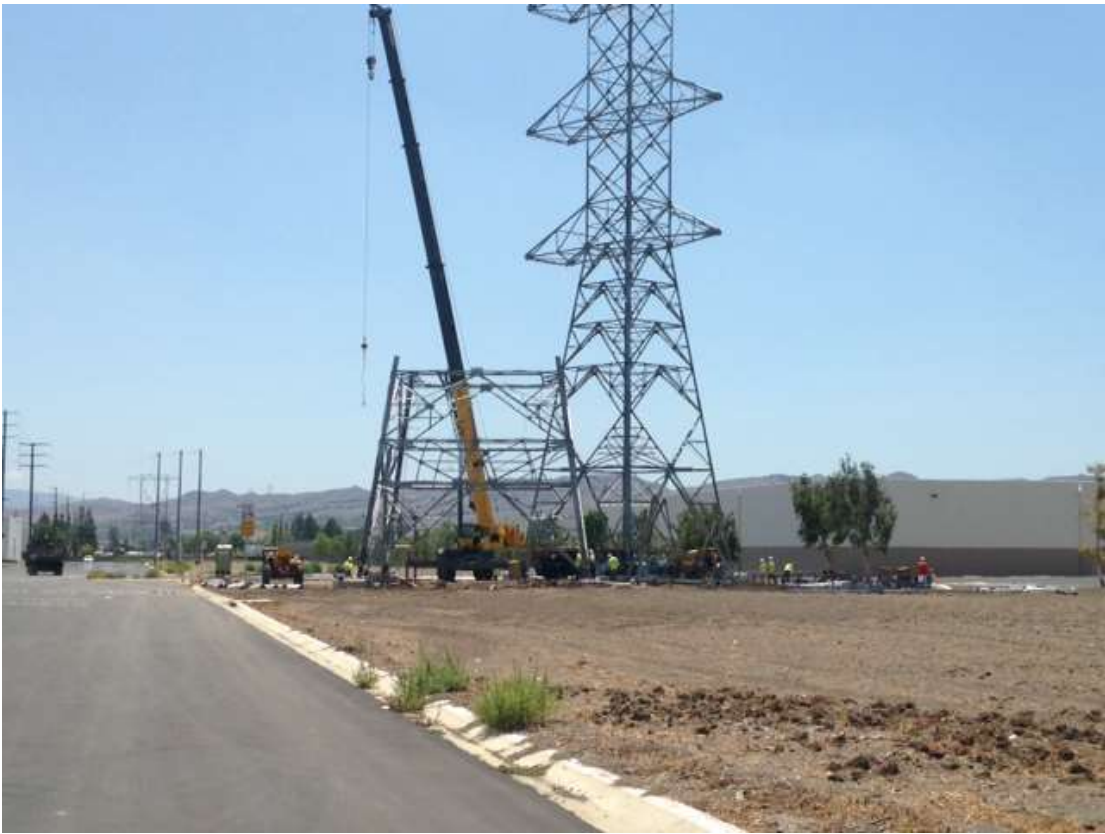
Figure 9: Tower assembly at Tower M65-T3, Segment 8, Phase 1.

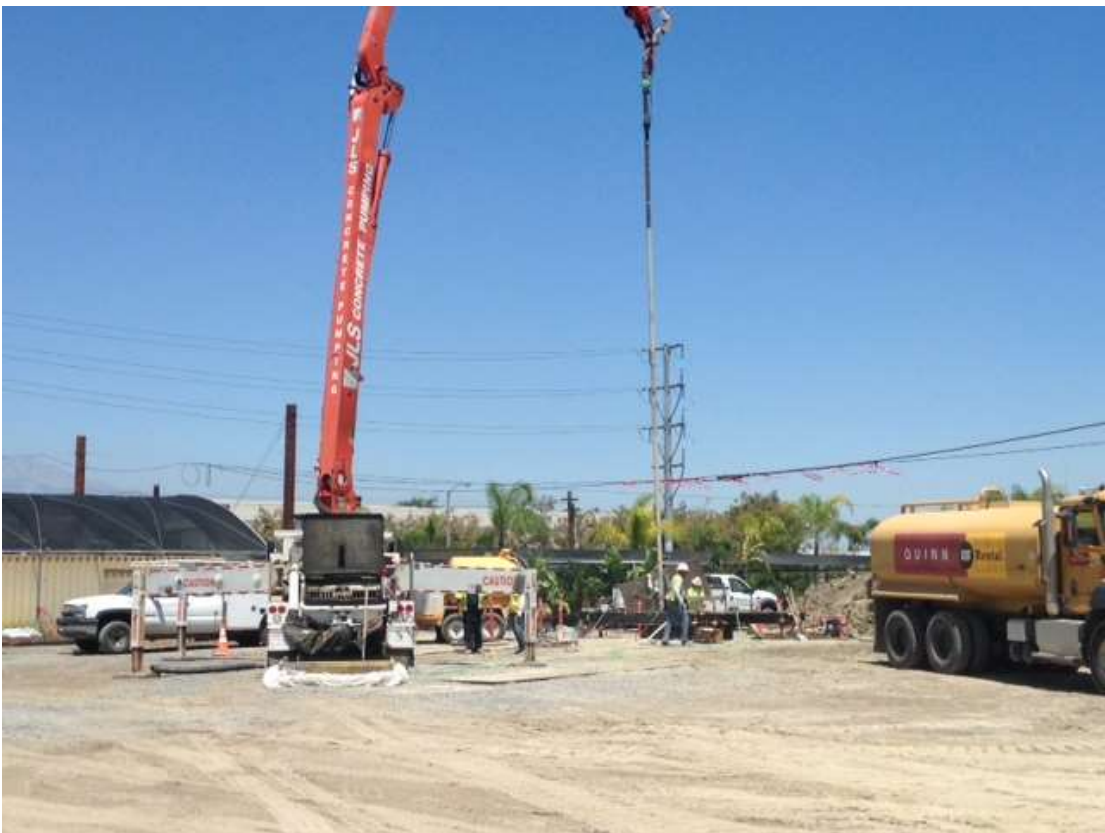
Figure 10: Concrete pour of Tower M66-T1 foundations, Segment 8, Phase 3.

13. BMPs were installed/maintained at various locations. BMP removal occurred at Towers M70-T1 through M73-T1.
14. Henkels and McCoy crews continued foundation installation activities at Towers M66-T1, M67-T4, and M67-T1 (see Figure 10).
15. Henkels and McCoy crews continued assembly activities at Towers M67-T4, M68-T1, M68-T5, M69-T2, and M69-T5.
16. FAA lighting repair occurred at Tower M70-T1.

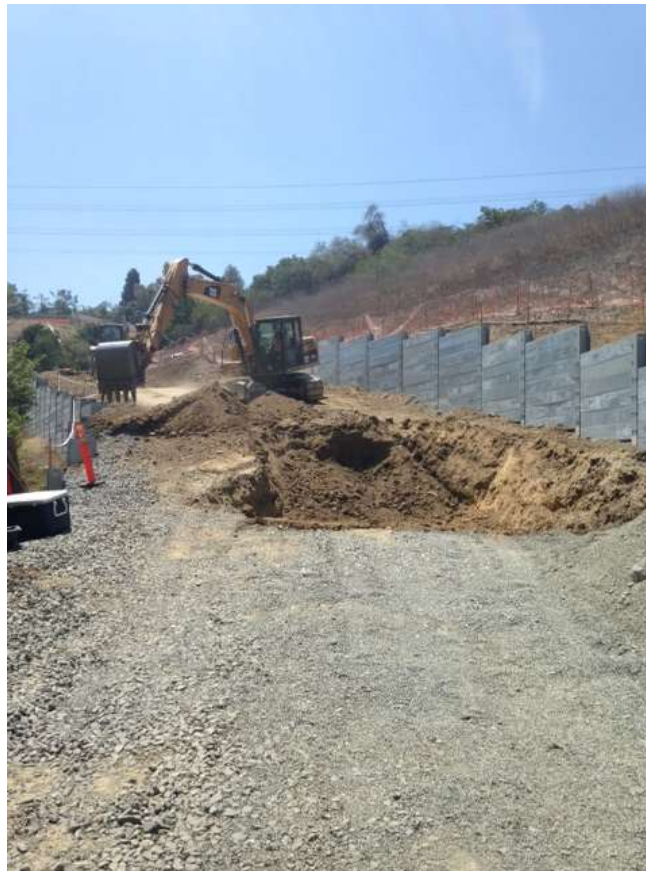
Figure 10: Road grading at Tower M49-T1, Segment 8, Phase 4.

17. BMPs were installed/maintained at various locations.
18. Patriot crew construction on the road leading to Tower M49-T1 included installing lagging, excavating, v-ditch installation, and exporting soil to Tower M43-T3 (see Figure 11).
19. Patriot crews continued grading activities, installing geogrid, and placing fill in the landslide area for Tower M43-T3. Work at the site was suspended on Friday, August 8, while SCE coordinated with the Sanitation District.
20. PAR crews conducted vegetation clearing at Tower M55-T2 and adjacent wire stringing site.
21. PAR conducted tree trimming on the access road leading to Tower M45-T5.
22. PAR conducted assembly activities at Towers M42-T6 and M45-T5.

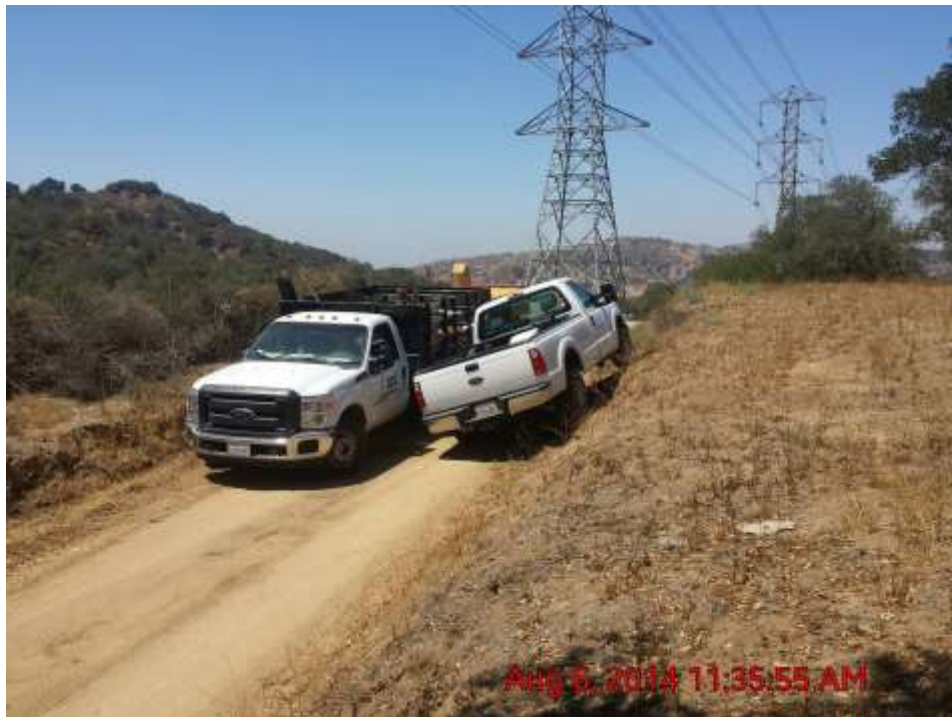
9. On August 6, the onsite Biologist observed a Geo Pacific Services, Inc., pickup truck outside of approved disturbance limits, up a berm, on Segment 8 on the access road to Tower M55-T2 (see Figure 12). The area affected was surveyed and was completely outside approved disturbance limits in coastal sage scrub habitat.

Figure 12: SCE reported a truck pulling of the road shoulder onto native vegetation near Tower M55-T2, Segment 8, Phase 4 (Photo courtesy of FRED).

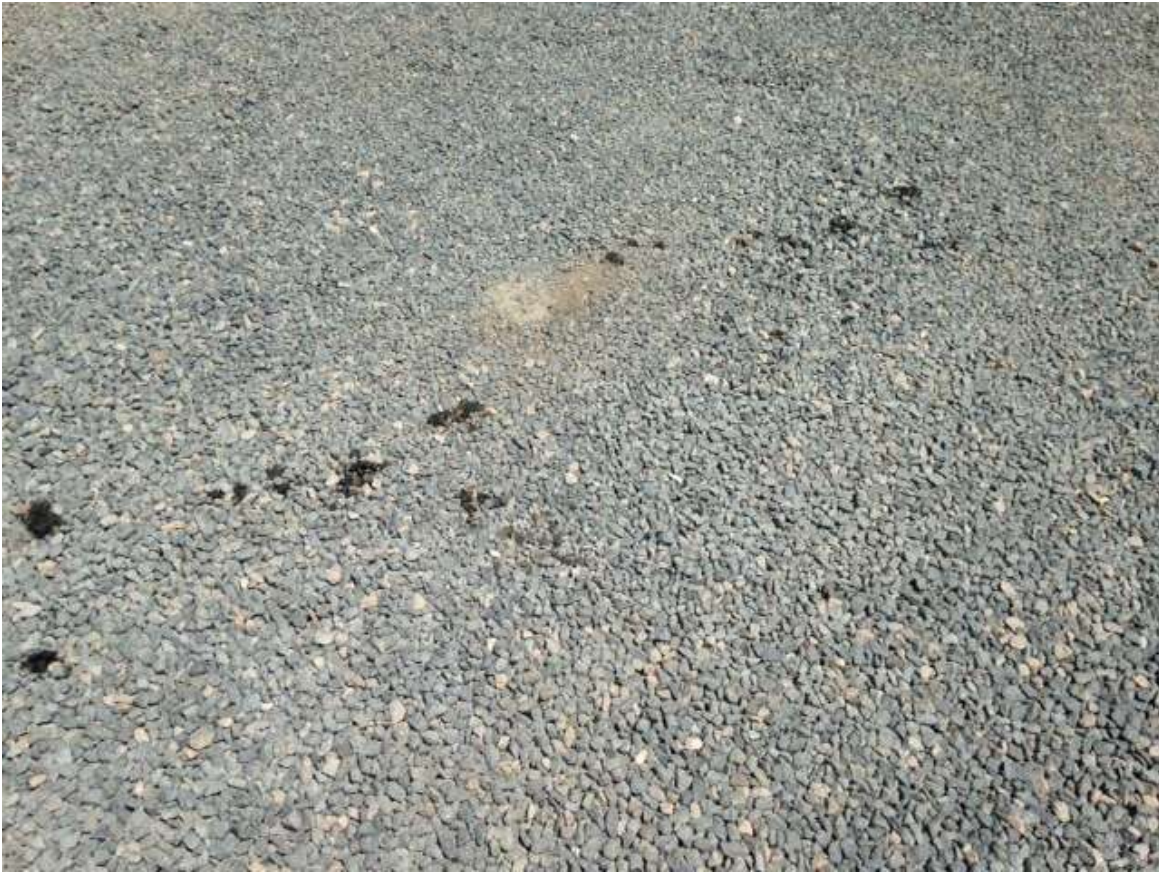
10. On August 6, the CPUC EM observed a small hydraulic leak at the entrance to Tower M66-T1 (see Figure 13). The onsite contractor's environmental representative was informed, as well as the BMCD representative for the Segment.

Figure 13: The CPUC identified a hydraulic leak from construction equipment near Tower M66-T1, Segment 8, Phase 3.
