**PROJECT MEMORANDUM  
SCE TRANSMISSION PROJECTS, SEGMENTS 1–11**

**To:** John Boccio, Project Manager, CPUC  
**From:** Vida Strong, Aspen Project Manager  
**Date:** February 23, 2015  
**Subject:** Weekly Report 368: February 8 to 14, 2015

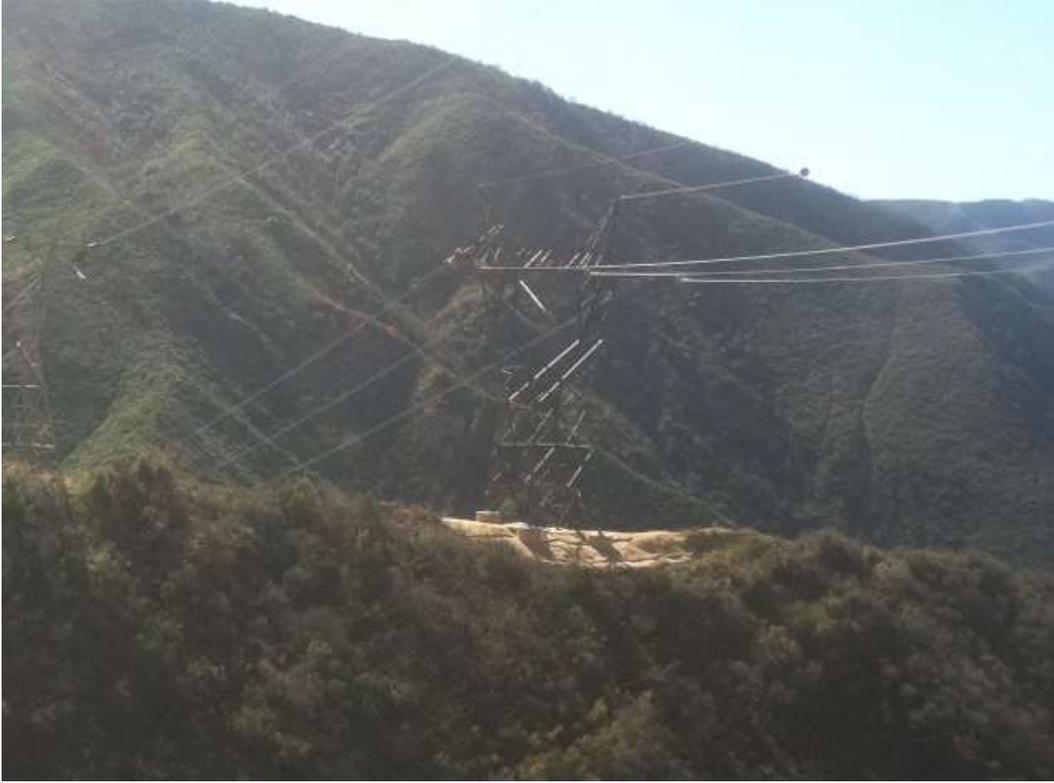
Figure 1: Wire stringing activities at Construct 58, Segment 11C.

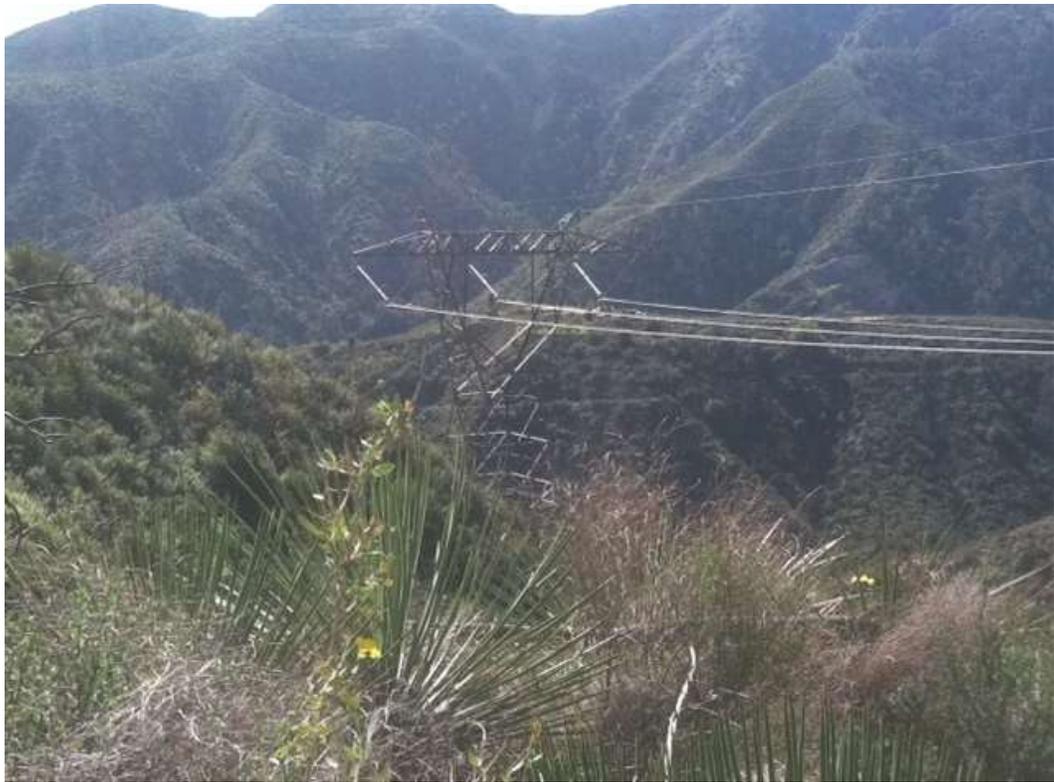
Figure 2: Wire stringing operations at Construct 62, Segment 11C.

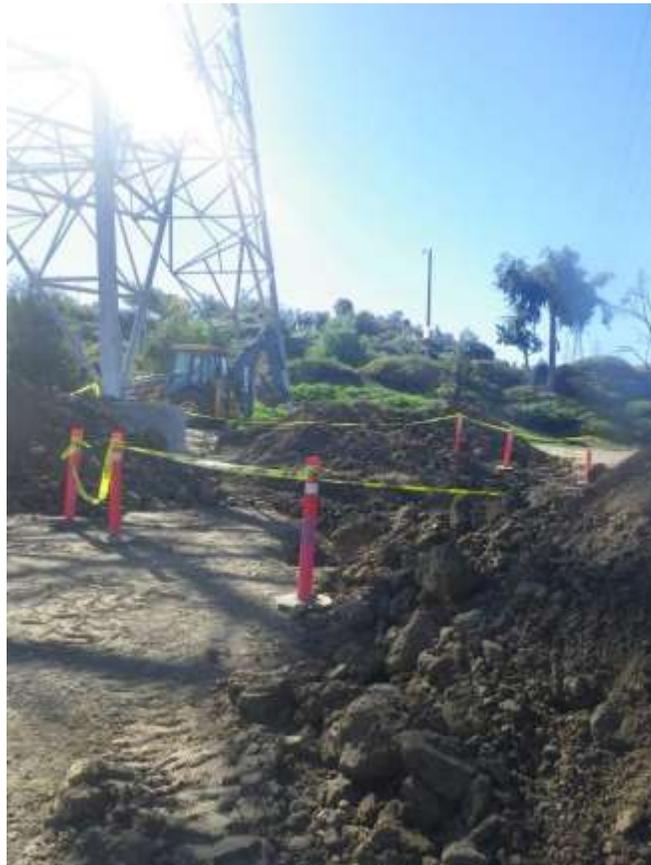
Figure 4: Trenching at Tower M52-T1 Segment 8, Phase 4 (photo courtesy of SCE FRED).

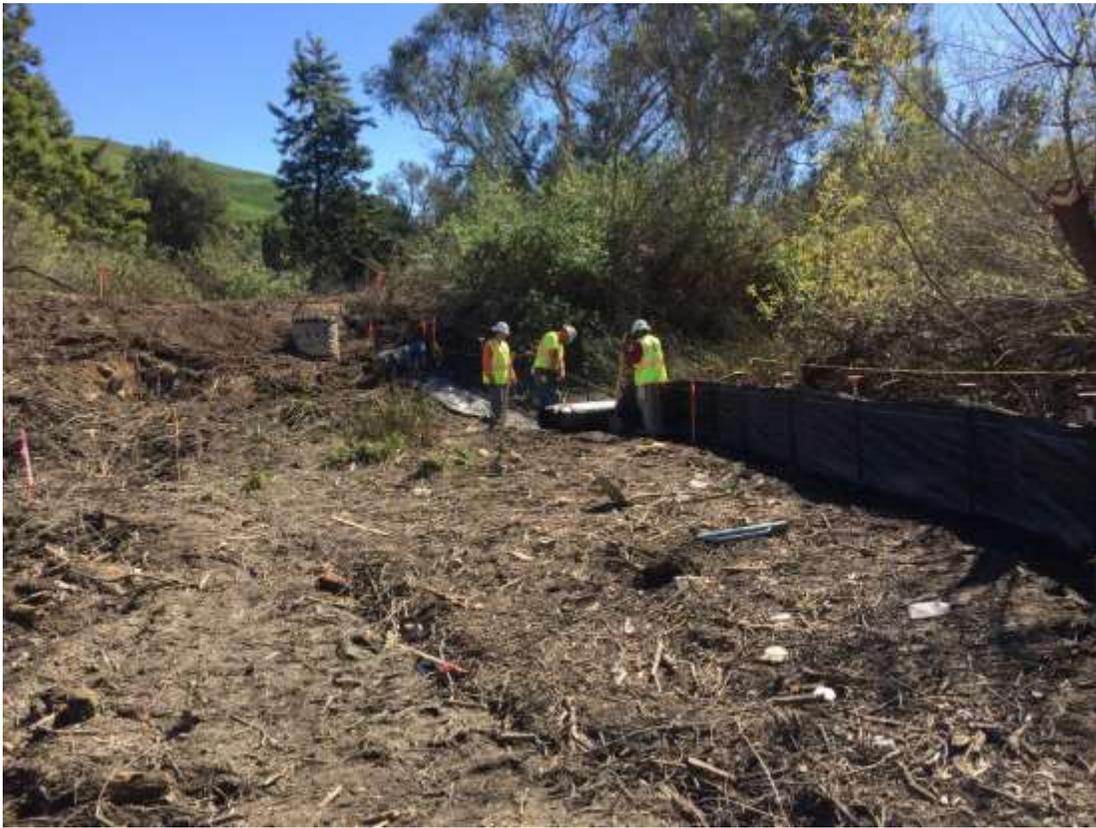
18. BMP crews worked at various locations installing and maintaining erosion control materials (see Figure 5).
19. Dust abatement activities were conducted at approved work areas along the right-of-way.

Figure 5: Installing silt fence BMPs at VC #2, Segment 8, 500 kV Underground.

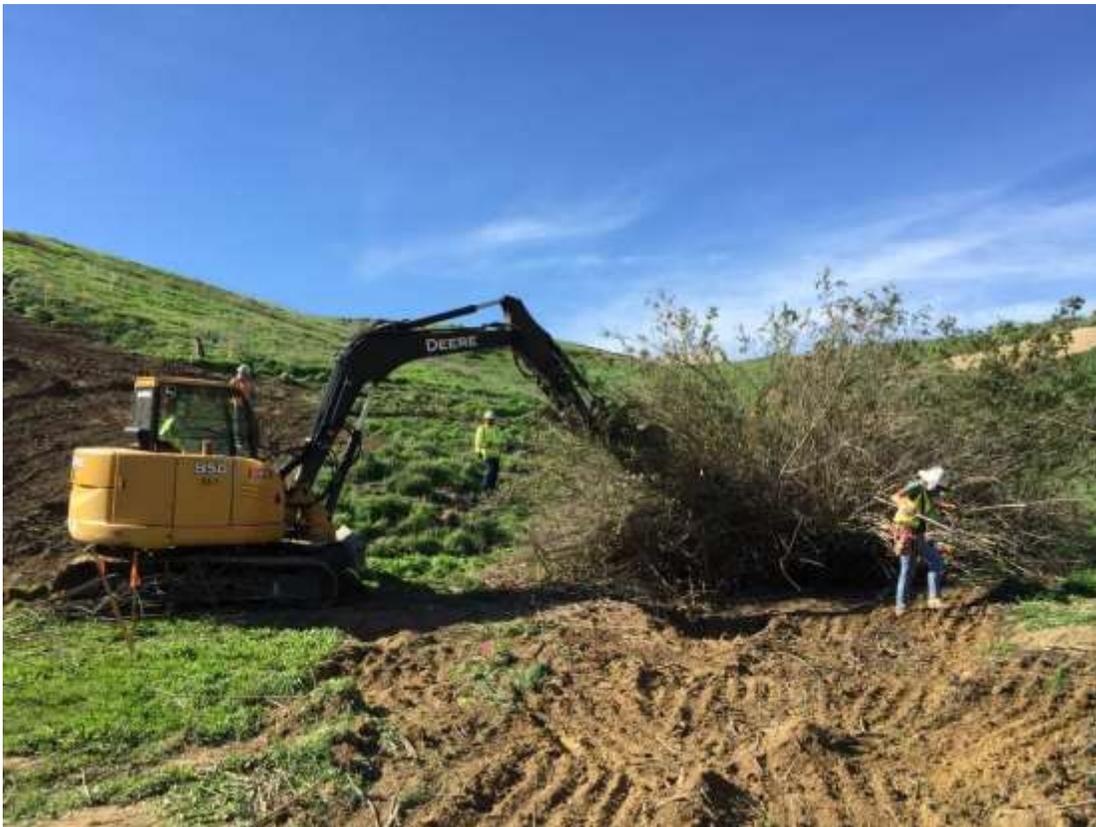
20. Street sweeping took place along paved public roadways adjacent to the right-of-way.
21. Vegetation removal commenced at Vault Cluster (VC) #2 and Restraint Vault (RV) #1 (see Figure 6).

Figure 6: Vegetation removal occurring at RV #1, Segment 8, 500 kV Underground.

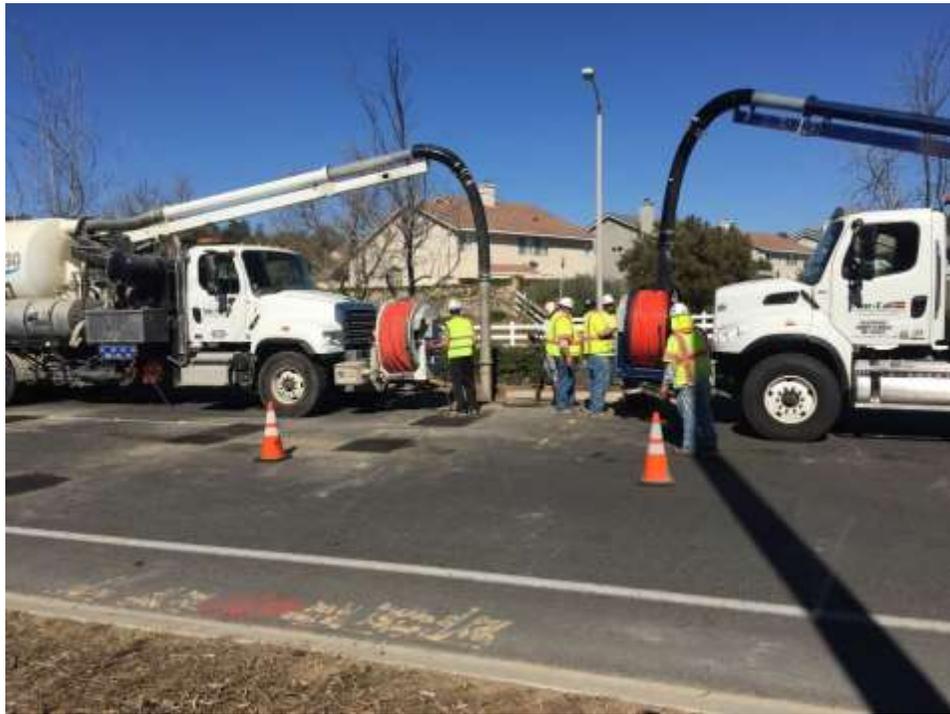
22. Trenching and backfilling occurred between the Foxwood and Maplewood Street crossings.
23. Sawcutting and potholing for utilities continued at the Chino Hills Parkway crossing (see Figure 7).

Figure 7: Potholing for utilities along Chino Hills Parkway, Segment 8, 500 kV Underground.

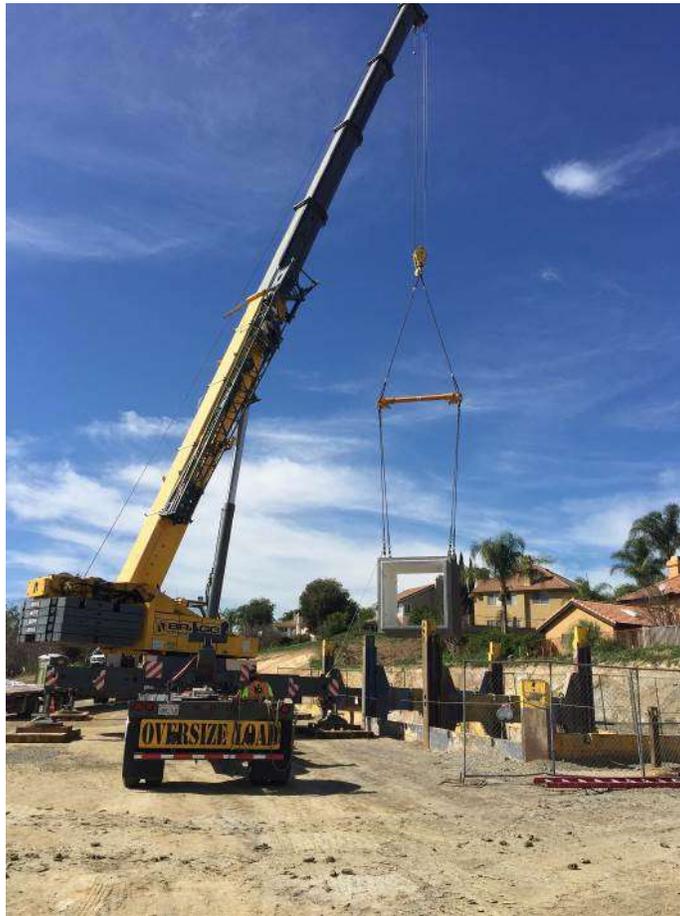
31. Vault cluster excavations and vault placement occurred at VC #5, VC #6, VC #11, VC #14, RV #5, and RV #6 (see Figure 8). The excavations are fenced at the end of each day.

Figure 8: Splice vault installation at VC #11, Segment 8, 500 kV Underground.

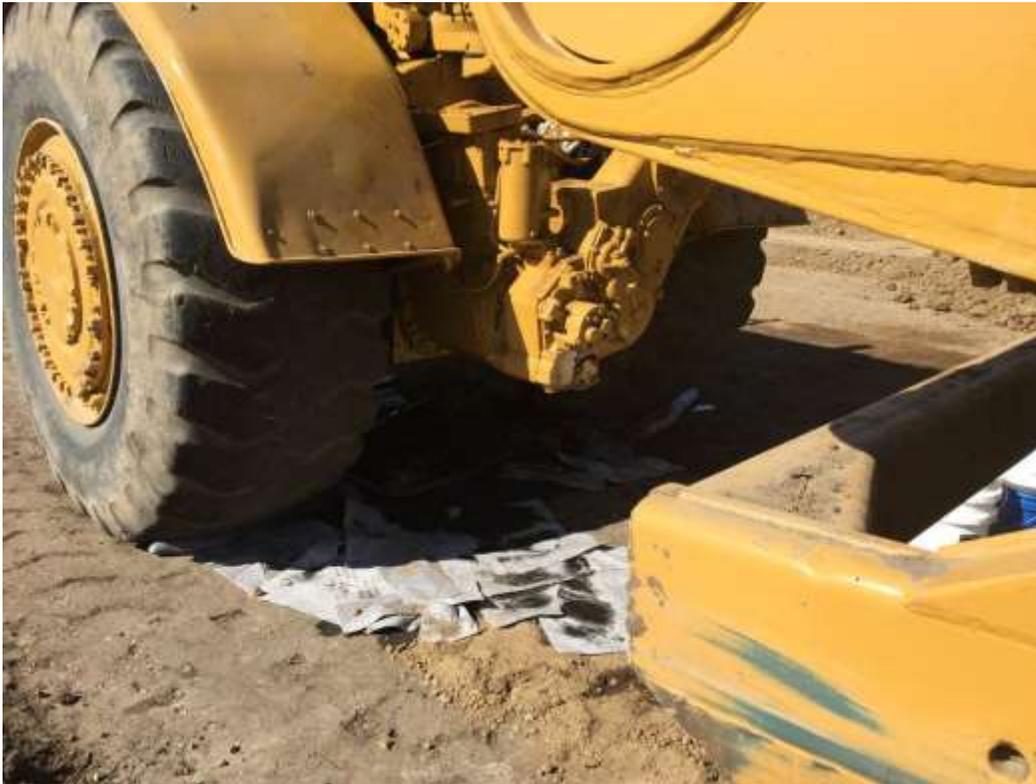
4. Paleontological Monitors were present as appropriate during the reporting period to monitor construction activities along Segments 7 and 8.
5. One spill was reported during the subject week. On February 9, approximately five gallons of hydraulic fluid was released at ETS when a hydraulic line ruptured. The spill was contained using absorbent booms. Absorbent pads were used to soak up the pooled fluid (see Figure 9). Crews were able to remove a portion of the contaminated soil using shovels and front loader. Due to the inability to move the equipment until repairs were conducted, some of the contaminated soil was inaccessible. Repairs were performed on February 10 and the remainder of contaminated soil was removed from the site. In total, approximately 15 cubic yards of contaminated soils were excavated and removed for offsite disposal. SCE reported that there were no impacts to any sensitive resources.

Figure 9: Absorbent pads in place for hydraulic fluid spill at the ETS, Segment 8, 500 kV Underground.

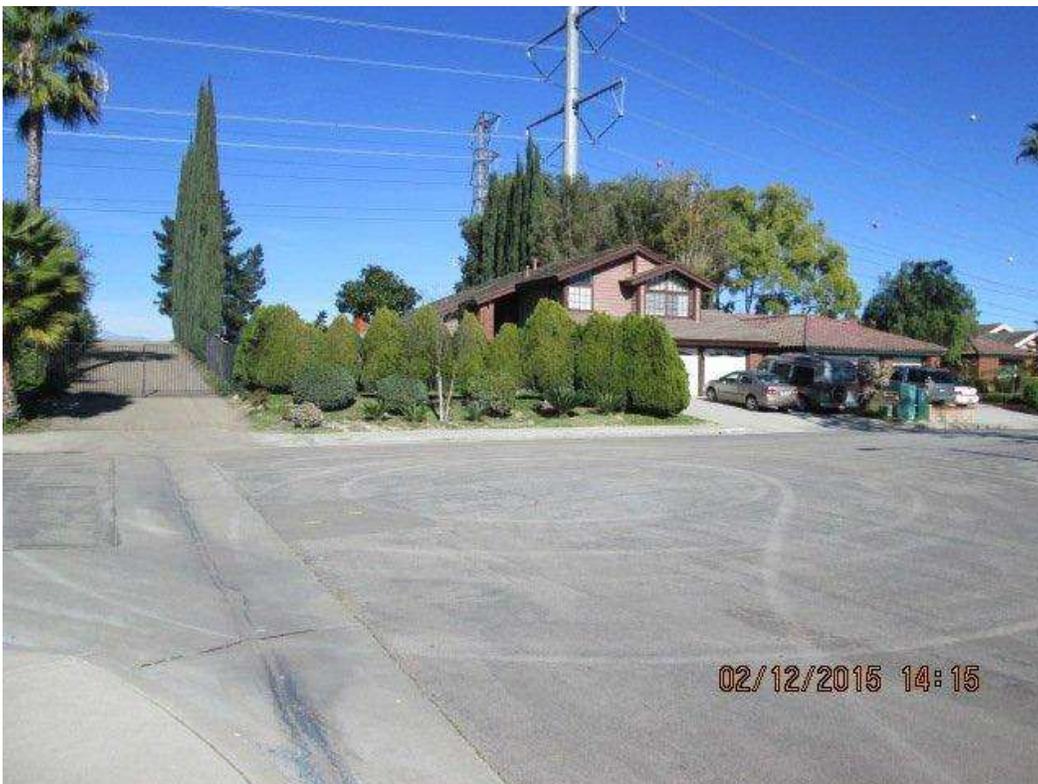
6. Two incidents associated with excessive track-out were reported during the subject period (see Figure 10).
7. On February 9, a frac-out occurred along the eastern edge of the Carbon Canyon Creek Channel access road during HDD drilling and implementation of corrective actions for a previous frac-out. Consequently, approximately 25 gallons of bentonite based drilling fluid was released through asphalt joints at the edge of the access road (see Figure 11) near the creek channel. No fluid was released into the adjacent jurisdictional drainage. Upon identifying the frac-out, the drilling pump was immediately shut down and the surface mud was contained using hand tools and sandbags (see Figure 12). A vacuum truck was mobilized for clean-up efforts. Upon receiving approval from SCE to continue operations, approximately 2800 gallons of loss circulation material (LCM), followed by 1500 gallons of drilling fluid, were pumped into the bore hole to clear the pipe. During the pumping, approximately five gallons of drilling fluid were pushed out of the new frac location. Similar methods were implemented for clean-up. No further release occurred and drilling activities resumed. The appropriate agencies were notified and a final frac-out report was released by SCE on February 12.

Figure 10: Trackout observed along public road near Tower M47-T4, Segment 8, Phase 4 (photo courtesy of SCE FRED).

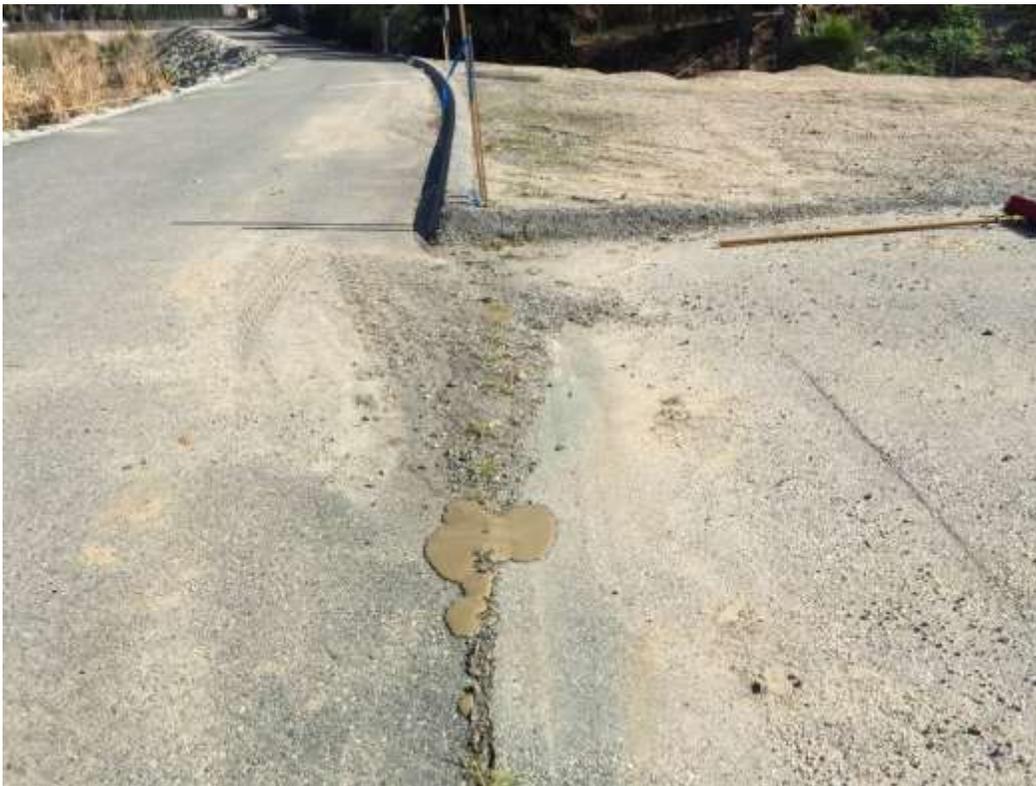
Figure 11: Frac-out material released between asphalt joints, Segment 8, 500 kV Underground.

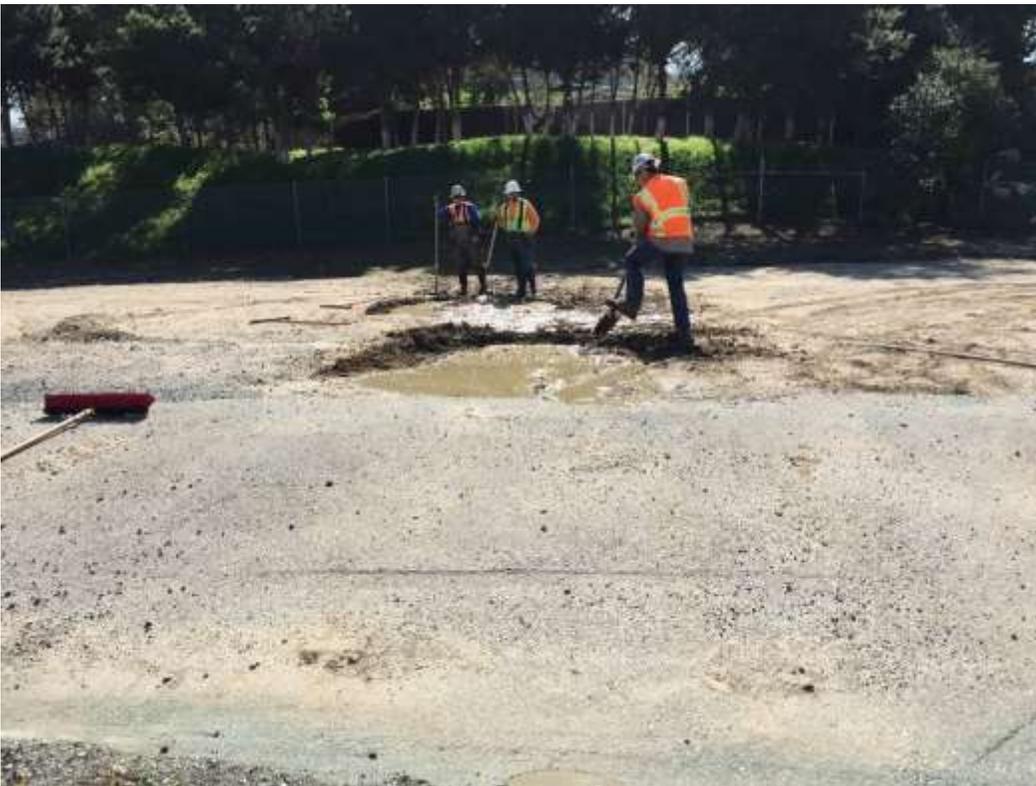
Figure 12: Remedial efforts to contain frac-out material included use of handtools, Segment 8, 500 kV Underground.
