PROJECT MEMORANDUM

ANTELOPE TRANSMISSION PROJECT, SEGMENTS 1, 2 AND 3A

To: John Boccio, Project Manager, CPUC
Justin Seastrand, Project Manager, ANF
From: Vida Strong, Aspen Project Manager
Date: June 9, 2009
Subject: Weekly Reports 70 and 71: May 10 to May 23, 2009.

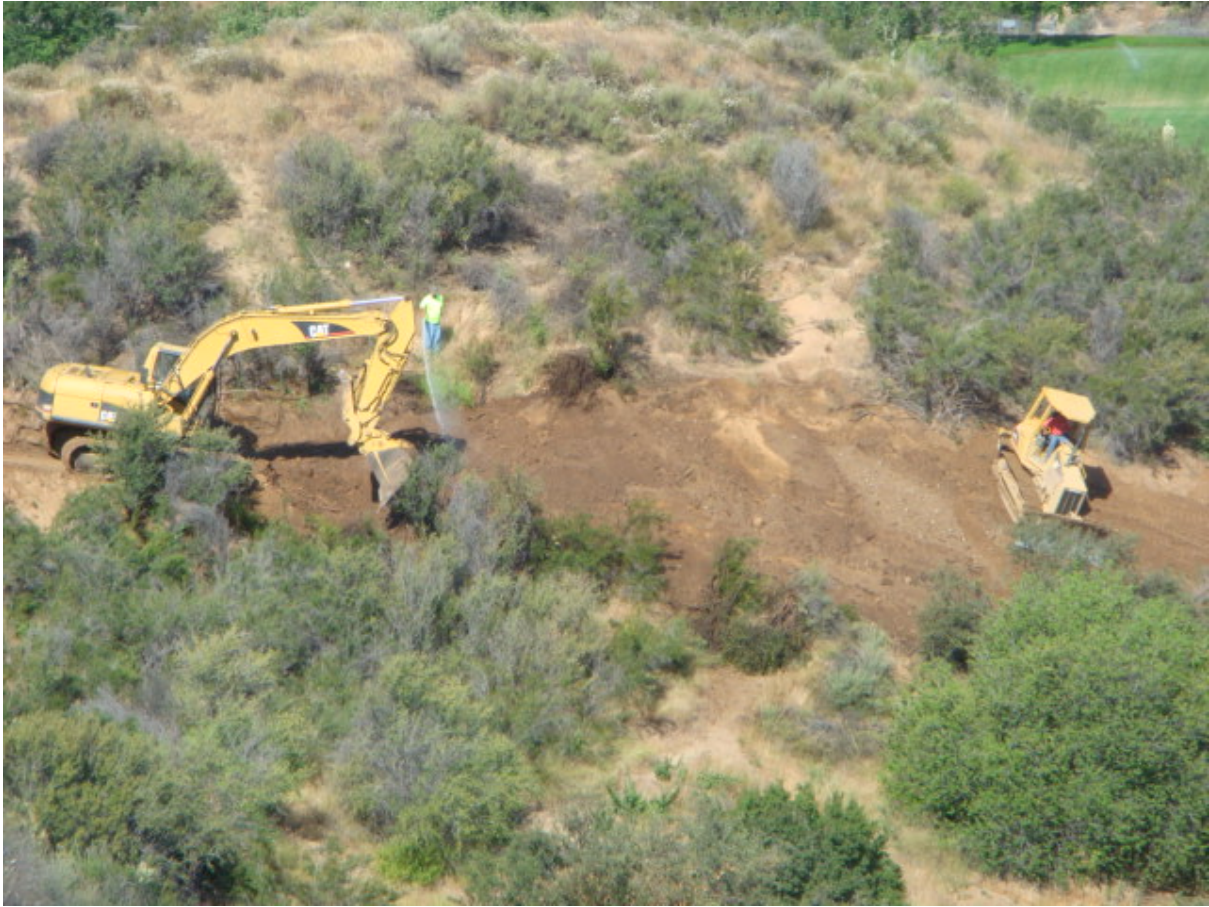
Figure 1: Shoofly road re-compacting at SF 4 in Section 1. Revegetation is planned for later this year.

3. Conductor removal on the 220 kV wreck-out began between Kelly Johnson Parkway and McBean Road in Santa Clarita. Once the wire is removed, dismantling of the remaining 13 towers will take place.
4. Road recontouring of the temporary Shoofly access roads has been completed (see Figure 1). Revegetation of these areas is planned for later this year. A site tour and final walk-through of the Shoofly roads is planned with SCE, Aspen, and Burns and McDonnell.

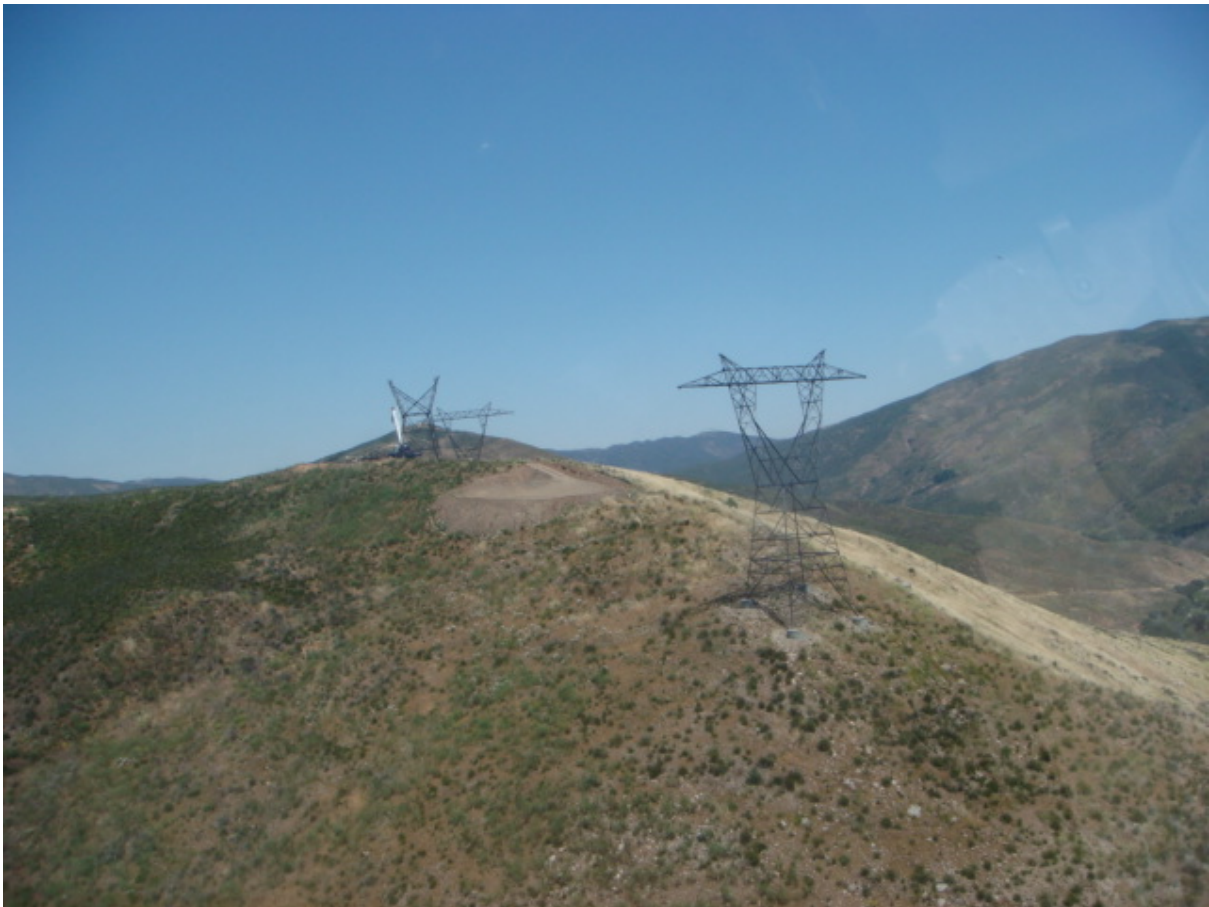
Figure 2: Tower assembly on the ANF. Note the disturbance area at the first tower (helicopter construction) and at the second tower (conventional construction).

5. Tower section assembly is occurring at the tower assembly areas on the ANF and in nearby yards (see Figures 2 and 3).
6. The heavy lift helicopter, an Ericsson Sky Crane, is scheduled to begin June 1st to fly in and assemble tower sections for structures 31, 57-87.

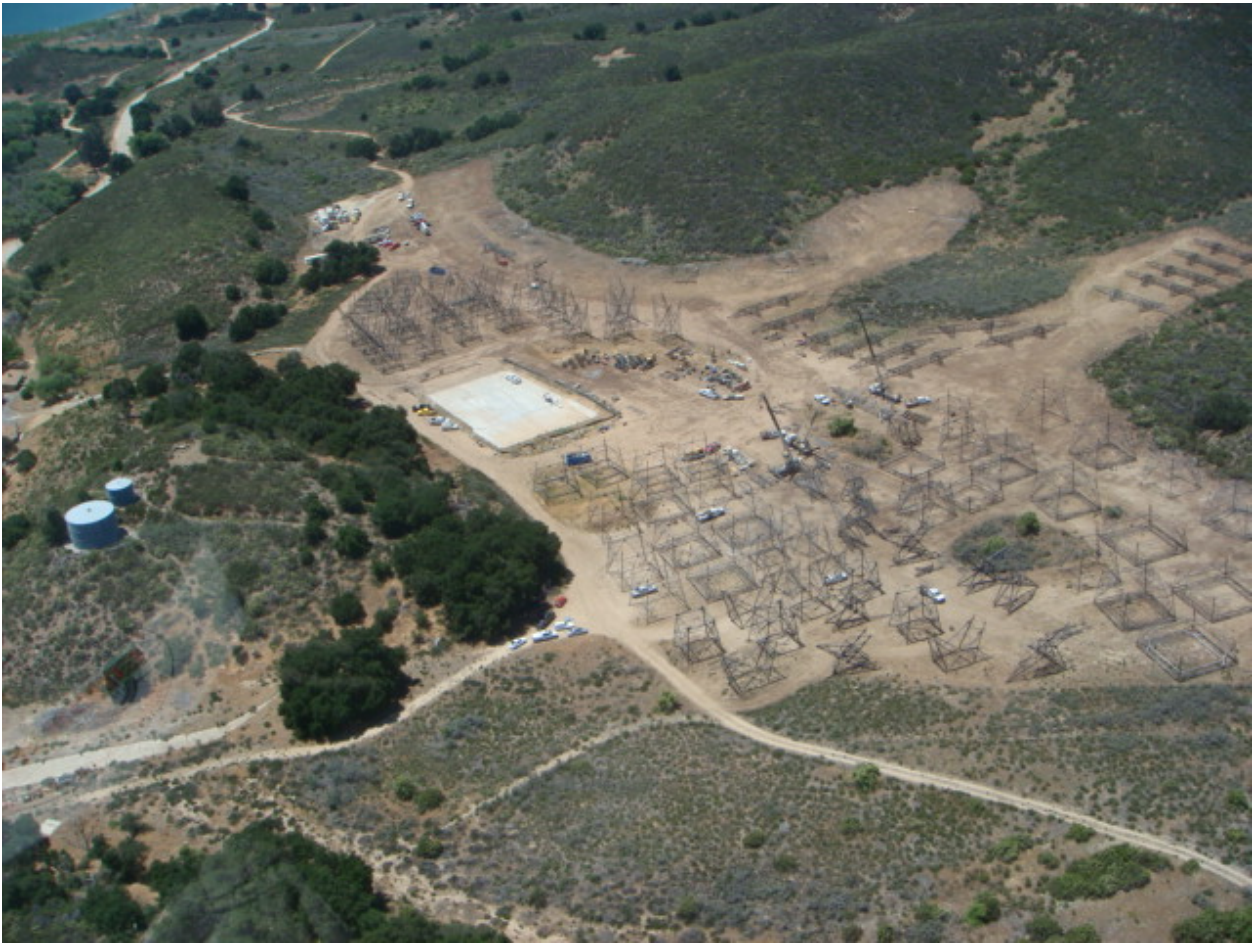
Figure 3: Tower section assembly at the Hydrant Yard to be flown into place with the Sky Crane.

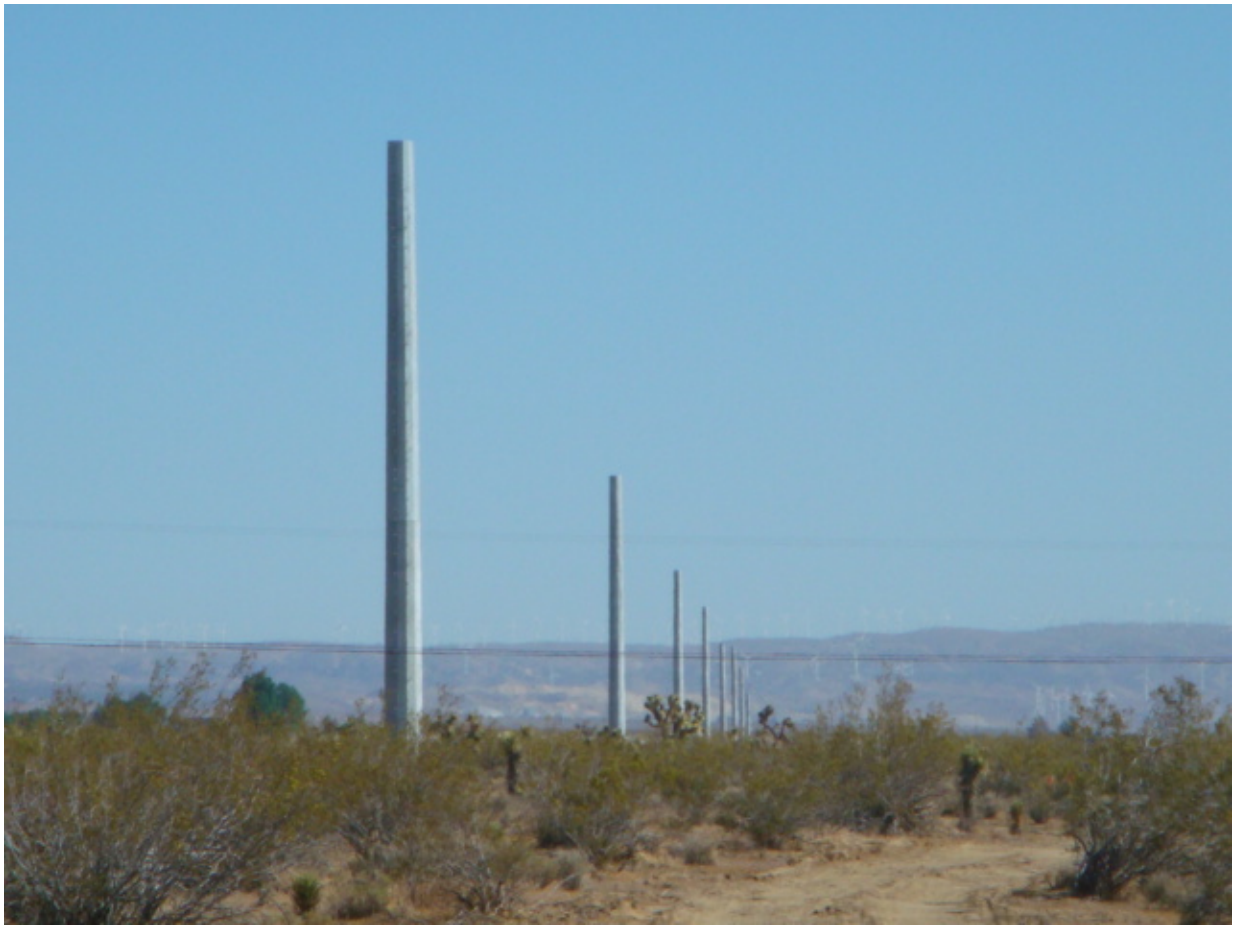
Figure 4: Tubular Steel Pole (TSP) bases in place in Segment 3A

4. Assembly of the Tubular Steel Pole base sections have occurred between the Antelope substation and Tower 81 (see Figure 4).
5. Tortoise proof fencing was replaced surrounding tower sites 9-11 because the original material was not strong enough to withstand the windy conditions. The material used for the tortoise fencing was approved by USFWS and CDFG. The agencies recommended that the fences be regularly monitored in case animals become trapped inside or become entangled in the fencing itself.

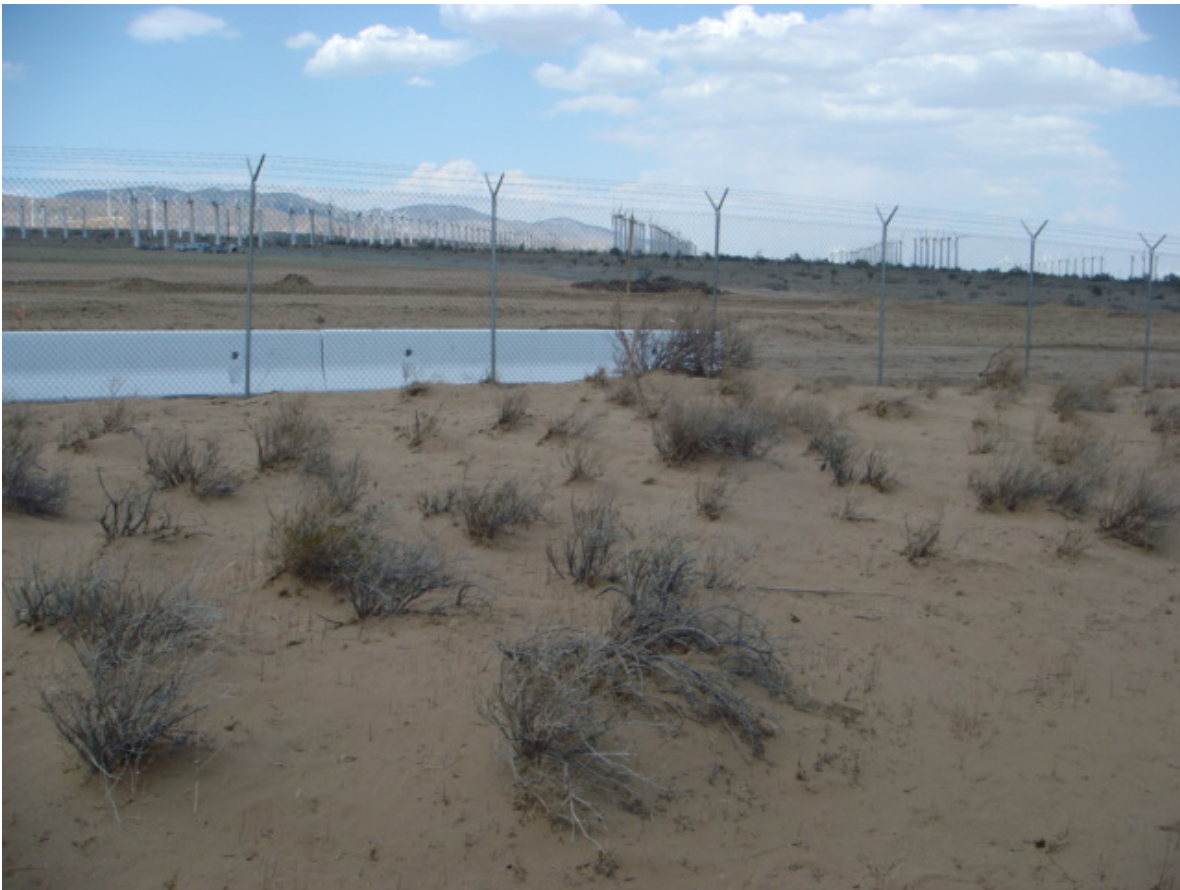
Figure 5: K-rail installed along the tortoise fencing surrounding the Windhub Substation site to protect off-site sand drifts in the area of the tortoise burrow.

6. Dust at the Windhub Substation site has continued to be a problem and has affected areas outside of the fence. SCE has installed k-rail and plywood along the fence closest to the tortoise burrow to prevent dirt from covering the burrow (see Figure 5).
7. As proposed in the Segment 3A stream crossing report, several drainages require protection prior to construction activity to protect streambed and banks. Once these areas are addressed, construction can proceed in these areas.
8. Capping of access roads for the protection of cultural resource sites is required in Segment 3A. To date, none of the access roads have been capped. The CPUC EMs have requested a timeline of when this is expected to occur.
