PROJECT MEMORANDUM

ANTELOPE TRANSMISSION PROJECT, SEGMENTS 1, 2 AND 3A

To: John Boccio, Project Manager, CPUC
Justin Seastrand, Project Manager, ANF
From: Vida Strong, Aspen Project Manager
Date: July 17, 2009
Subject: Weekly Reports 76 and 77: June 21 to July 4, 2009.

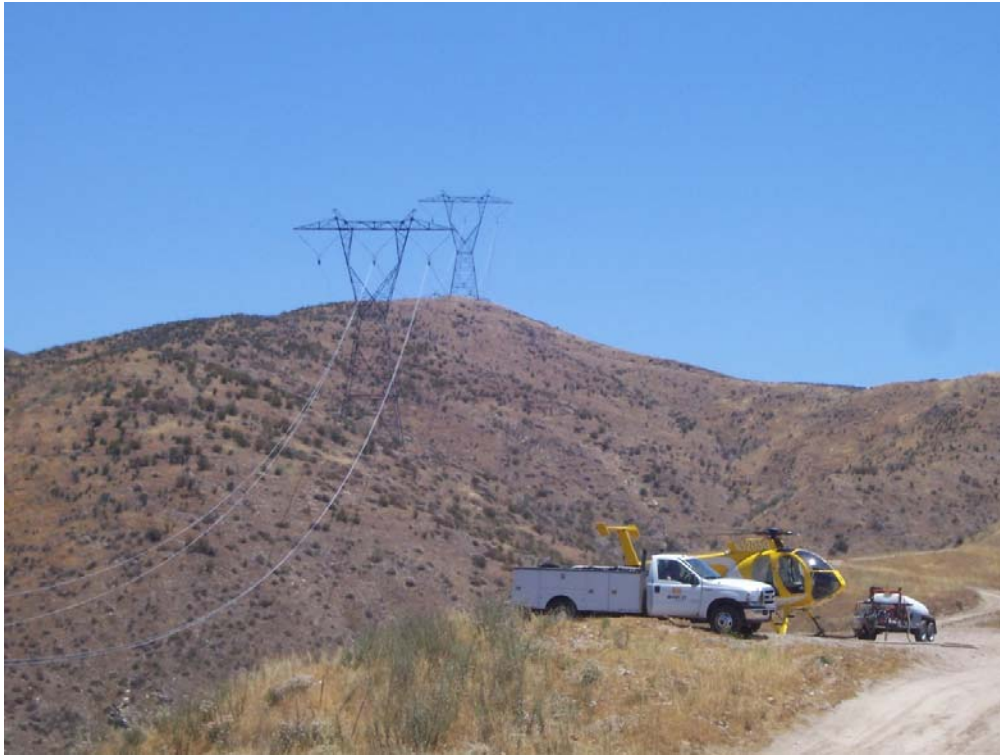
Figure 1: Wire stringing between Towers 33 and 41 Segment 1, Section 2.

1. PAR crews began wire conductor installation (hanging travelers, wire stringing, clipping in, and sagging) between Towers 33 and Tower 41 in the ANF (see Figure 1).
2. During the wire conductor installation, a conductor splicing method using implosives was used due to the inaccessibility of adequate splicing locations between towers on the ANF. The implosive splicing took place at the wire stringing site near Tower 41 for each phase of the conductor.
3. SCE's biological subcontractors continued to remove weedy material from stockpiled topsoil piles on the ANF.

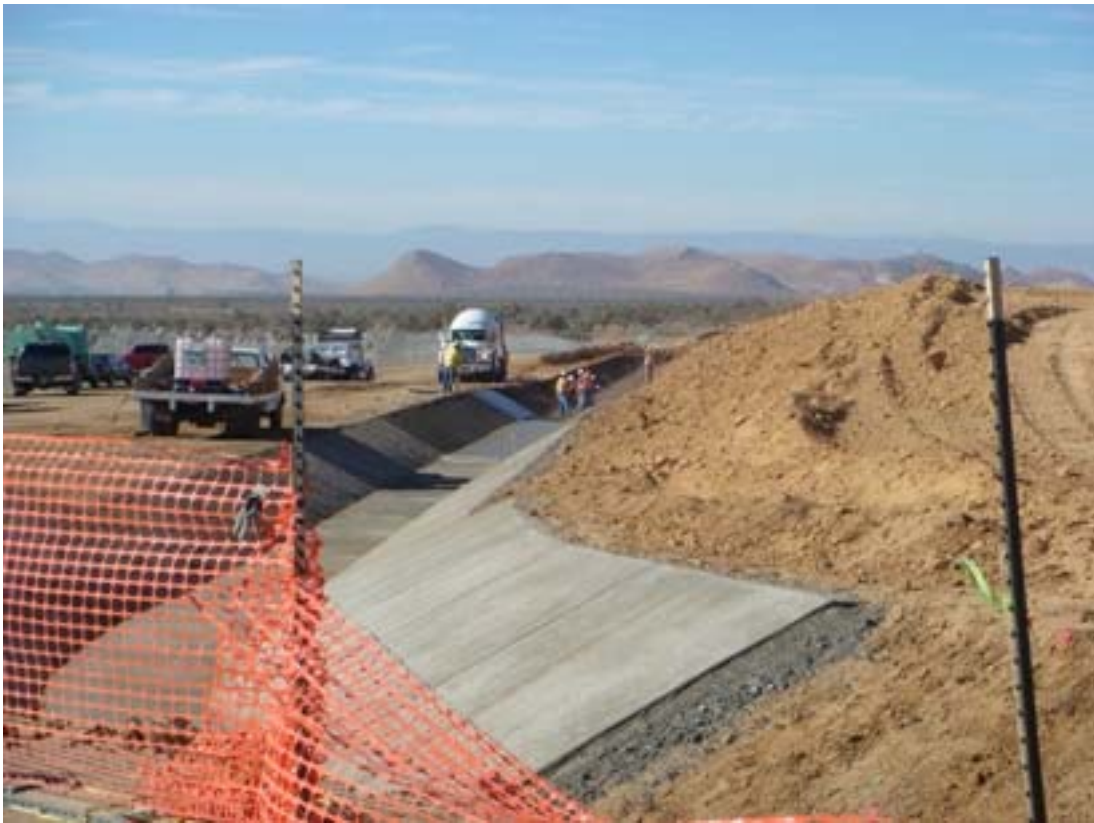
Figure 3: Concrete drainage channel at the Windhub Substation.

6. Tortoise proof fencing surrounding tower sites 9-11 is being regularly monitored for entrapped animals.
7. Grading at the Windhub Substation site continued. The well for a permanent water source has been completed. Use of two water sites along Tehachapi Willow Springs Road has been discontinued. A concrete-lined drain is currently under construction at the substation site to contain and divert water offsite.
