**Alligator Rock - North of Desert Center
Key Viewpoint 31
Southbound Kaiser Road**

**DEVERS-PALO VERDE NO. 2
TRANSMISSION LINE PROJECT
Visual Resources
Figure D.3-32A / 32B**

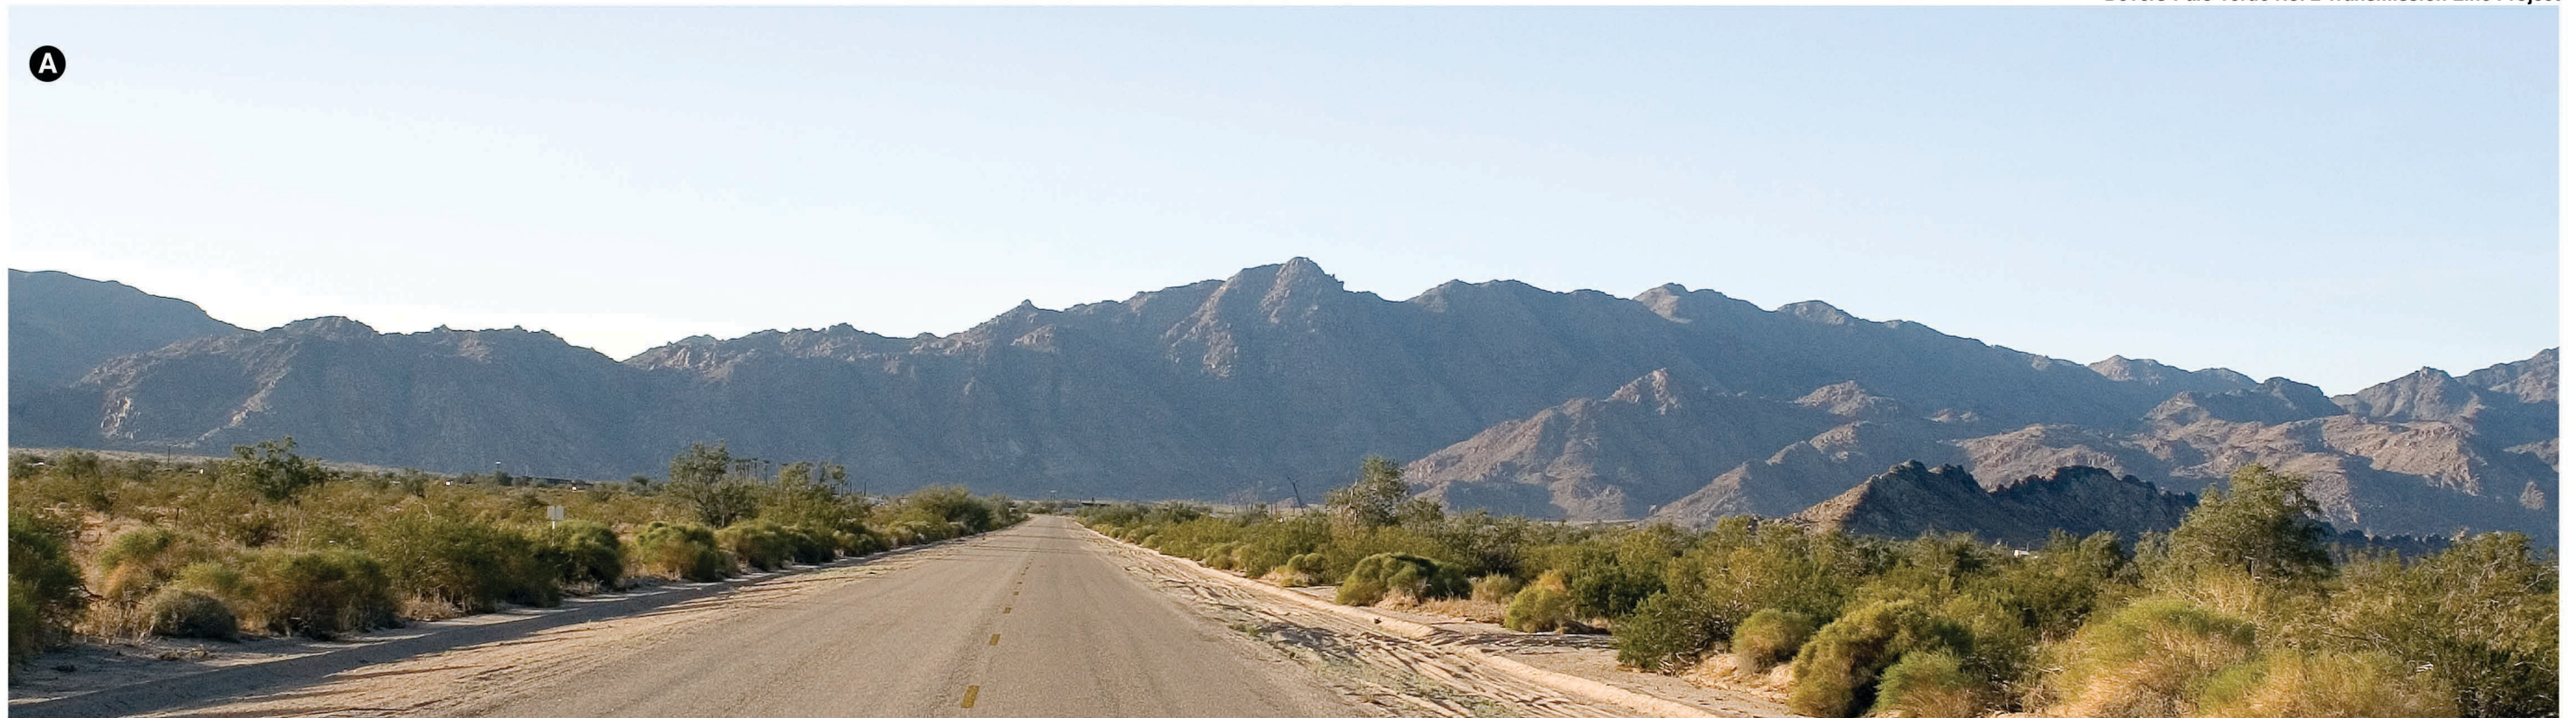
A The **existing view** to the south, toward the Alligator Rock-North of Desert Center Alternative and the Chuckwalla Mountains beyond. This view is from KVP 31 on Kaiser Road, approximately one mile north of I-10.

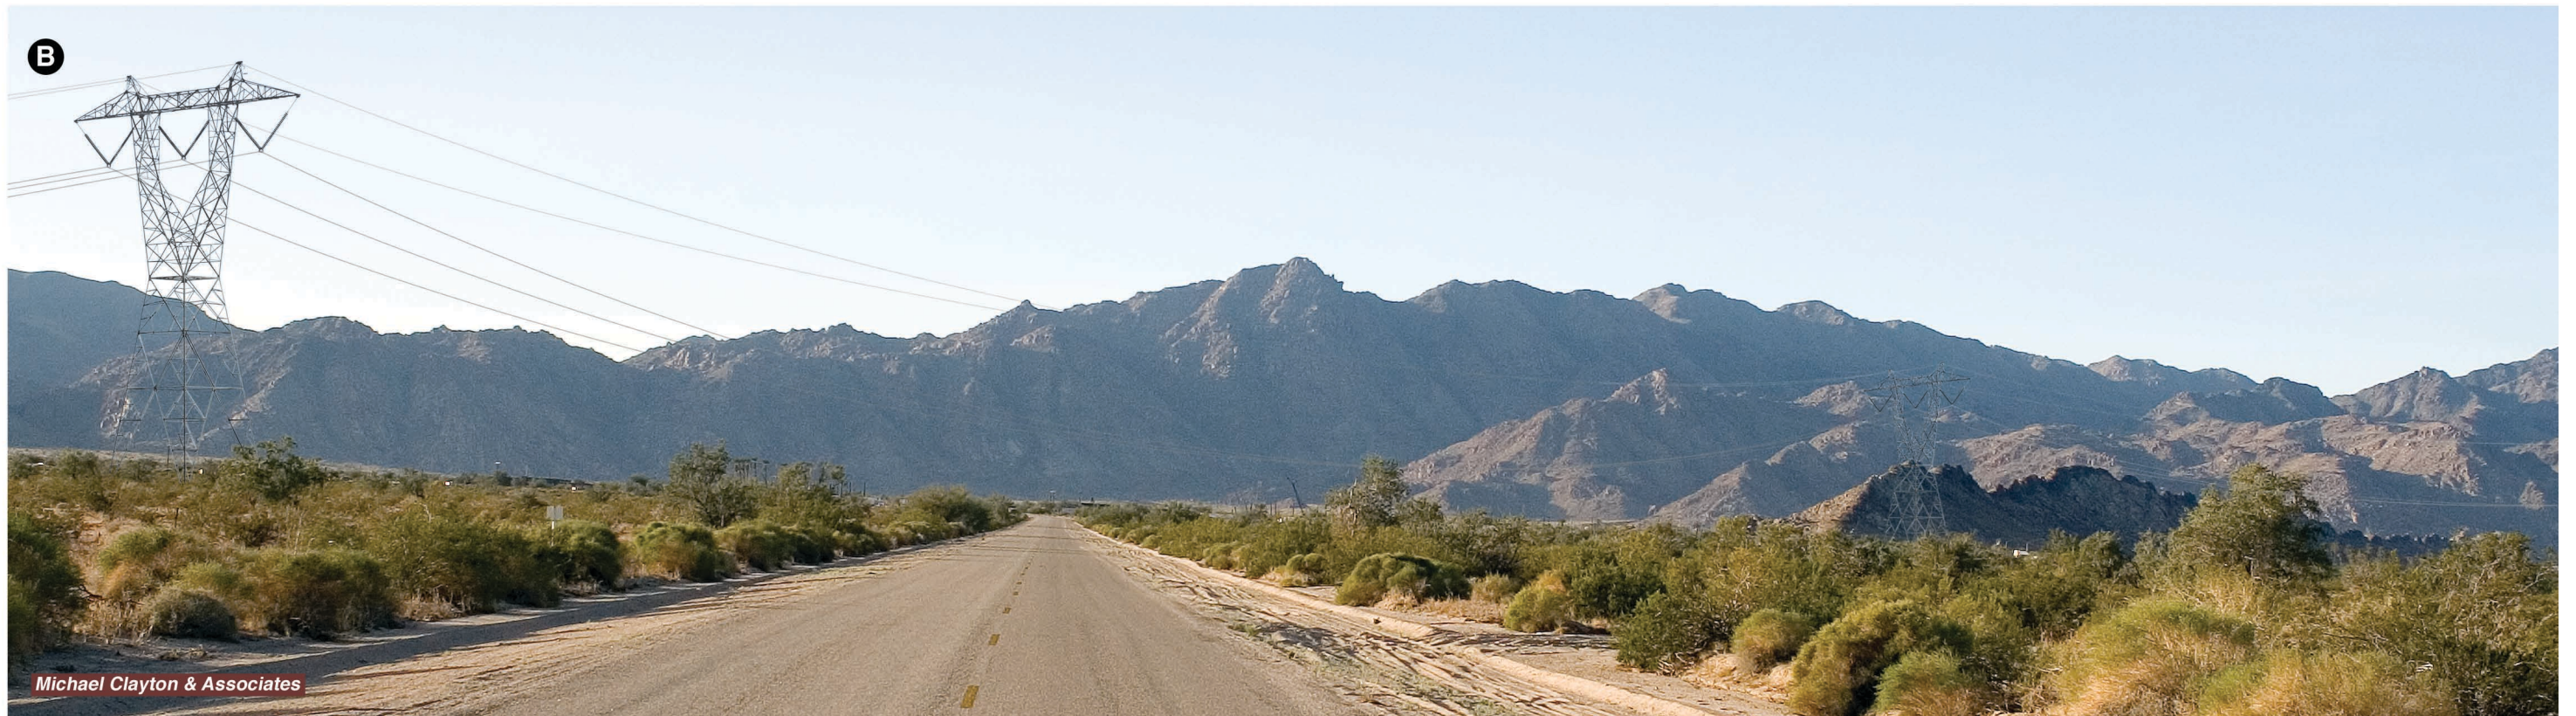
B This image presents a **photosimulation** of the alternative route as it passes north of Desert Center and I-10 and spans Kaiser Road. The undulating ridge of Alligator rock is also visible in the right portion of the image.
