PROJECT MEMORANDUM PG&E JEFFERSON-MARTIN 230KV TRANSMISSION PROJECT

To: Billie Blanchard, CPUC
From: Vida Strong, Aspen Project Manager
Date: July 13, 2005
Subject: Weekly Report #25: July 3, 2005 – July 9, 2005
CPUC Environmental Monitors (EM): Jody Fessler and Jenny Slaughter

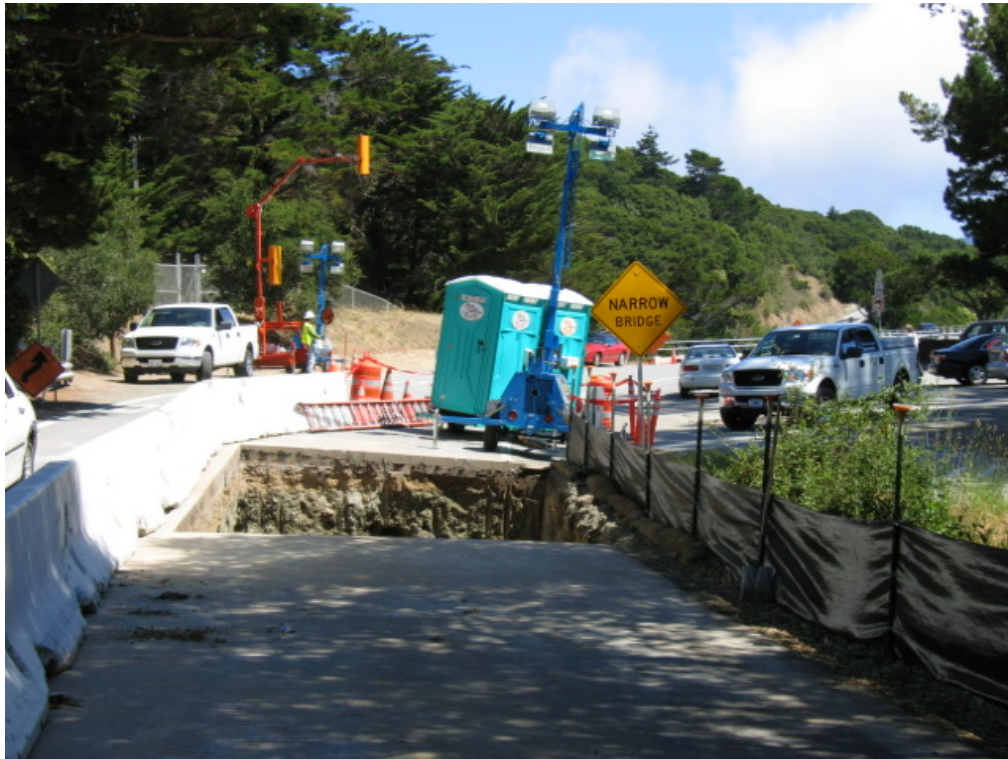
Figure 1 – Location of Manhole #22b, Segment 1, July 6, 2005

4. On the night of July 5th, excavation of Manhole #22B on Skyline Boulevard began. The manhole was shored and gravel placed in the bottom of the pit during the night shift. The manhole vault was installed on Wednesday night, the area backfilled with cement slurry on Wednesday and Thursday nights, and the area paved over on Friday night.

On July 6th, the CPUC EM was notified that there had been difficulty attempting to set the manhole shoring in Manhole 22B excavation. Apparently the crane could not set the shoring box without impacting trees overhanging in the roadway. The shoring was not placed and the hole was left open the following day, with K-rail set up and traffic control around it. The CPUC EM attended a site visit to discuss how the vault would be installed by moving the crane to the opposite side of the excavation to avoid the trees. It appeared that the only place to put the crane was near or on top of some vegetation along the side of the road on the south side of the excavation. After a survey was conducted of the vegetation, a call was placed to the CPUC Project Manager to seek permission to set the crane on the vegetation if needed because of the safety concerns with the un-shored excavation. The CPUC EM attended the crane set up later that night and it was set up to avoid the vegetated area.

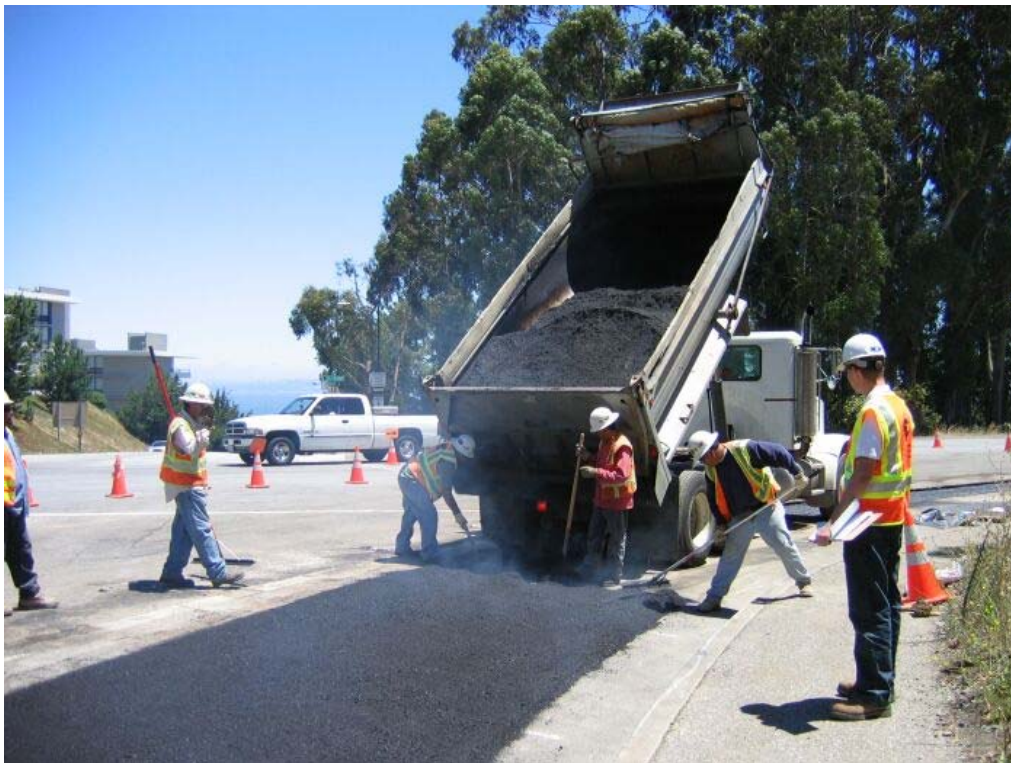
Figure 2 – Crews paving on corner of Trousdale Drive and Skyline Boulevard, Segment 2 Underground, July 8, 2005

1. On July 5th, trench excavation continued on Skyline Boulevard between Manholes #35 and #34. The trench was excavated throughout the week, conduit installed, and cement slurry poured over the conduit. Approximately 340 linear feet of conduit was installed in the trench during the week. Paving was done on Friday in this area (Figure 2).

2. Crews conducted trenching activities on Trousdale Drive and the corner of Trousdale Drive and Skyline Boulevard throughout the week. The area was paved over on Friday.

On Friday, the CPUC EM noted that protection around the storm drain on the corner of Trousdale Drive and Skyline Boulevard was not protecting the storm drain from water running off the asphalt roller. The issue was brought to the attention of construction management and they immediately fixed the problem. The CPUC EMs observed that all other Segment 2 underground construction activities were in compliance with mitigation measures adopted in the EIR and other permit requirements. Erosion controls were in place around the construction areas.

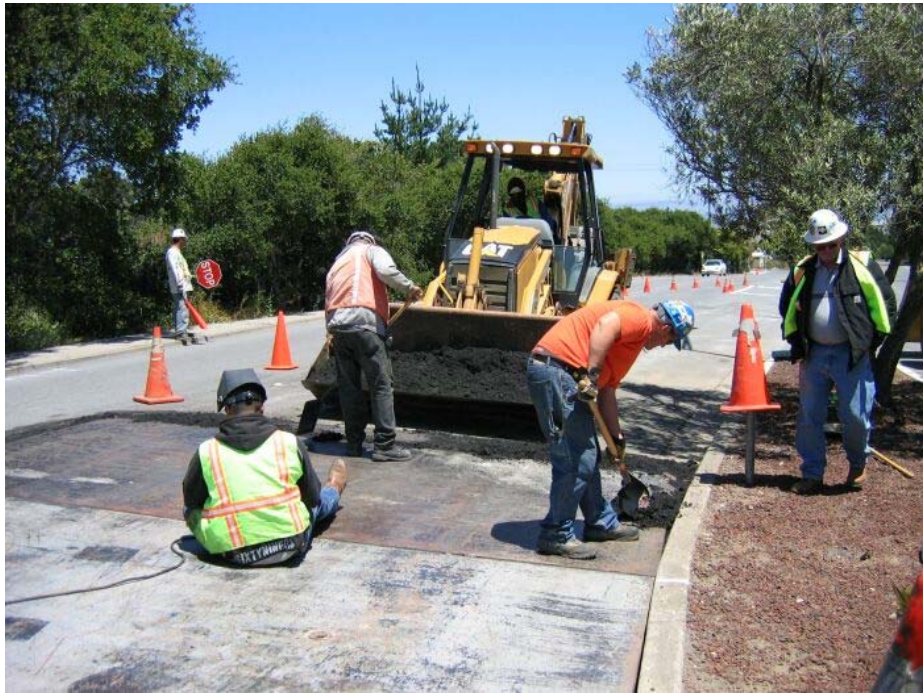
Figure 3 – Crews plating Manhole #40 on San Bruno Avenue, Segment 3, July 8, 2005

1. On Tuesday, pot-holing activities commenced on Huntington Avenue and continued throughout the week.
2. On Wednesday, crews pot-holed the area around Manhole #40 on San Bruno Avenue. On Thursday and Friday the manhole pit was excavated and shored and pea gravel was placed in the bottom of the pit. The manhole pit was plated at the end of each day with steel plates (Figure 3).
3. Traffic controls were set up around the work areas. Traffic controls included signs, cones, and flaggers to help direct traffic around the construction sites.
4. Crews continue to use their staging yard under Highway 380 just east of Huntington Avenue.

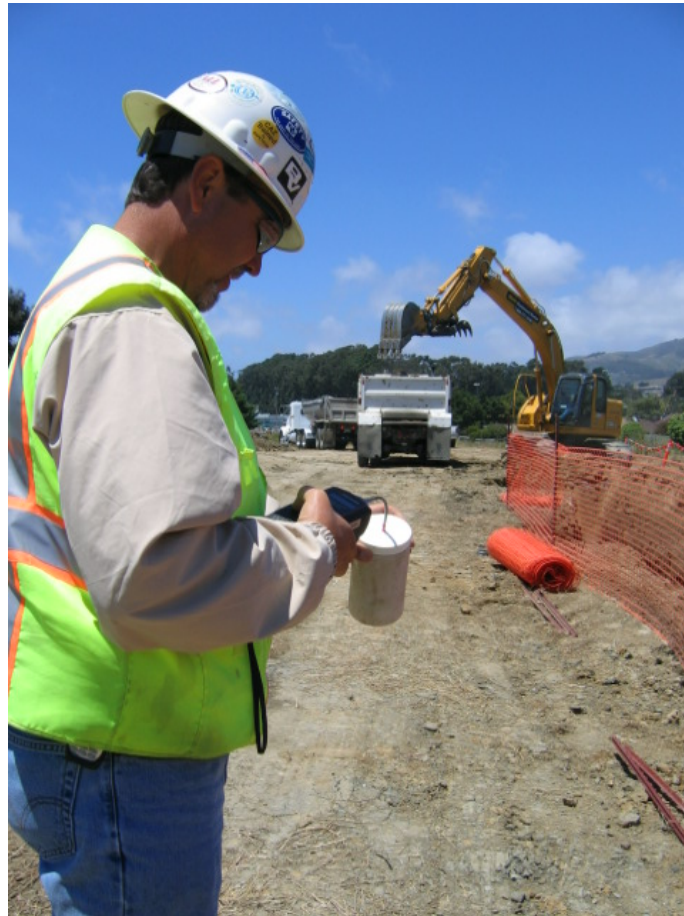
Figure 4 – Conducting soil monitoring test from trenched materia north of S. Spruce Street, Segment 4, July 8, 2005.

1. Trenching activities continued this week north of S. Spruce Street in the BART right-of-way. The trenching operations are north and south of Manhole #50. The trench was excavated and shored, conduit installed, and cement slurry poured over the installed conduit. The B&V Inspectors conducted the required soil/air monitoring at that site throughout the week. Construction crews also did visual and odor monitoring for contaminants at the site.

On July 6th, the calibrator for the photoionization air monitoring equipment arrived on-site. The CPUC EM observed air/soil monitoring activities.
