PROJECT MEMORANDUM SDG&E – MIGUEL-MISSION 230 kV #2 PROJECT

To: Jensen Uchida, CPUC
From: Vida Strong, Aspen Project Manager
Date: November 17, 2004
Subject: Weekly Report #15: November 7, 2004 – November 13, 2004
CPUC Environmental Monitor (EM): Christopher Meyer

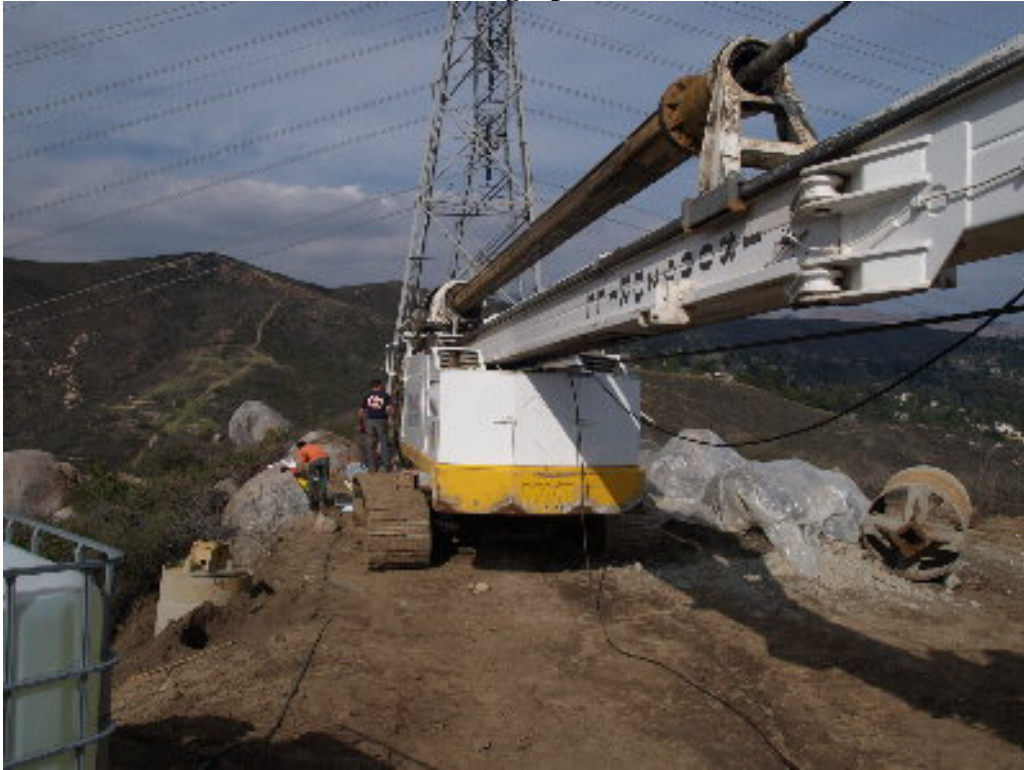
A drilling crew continued work on the hard bedrock at Tower Site 1300, but was not working briefly due to mechanical problems with the machine (see Figure 1). Several different drilling machines and crews have worked on the exceptionally hard material at this site and the drilling was completed during the subject week.

Figure 1 – The drilling machine at Tower Site 1300 was being repaired during the site visit.

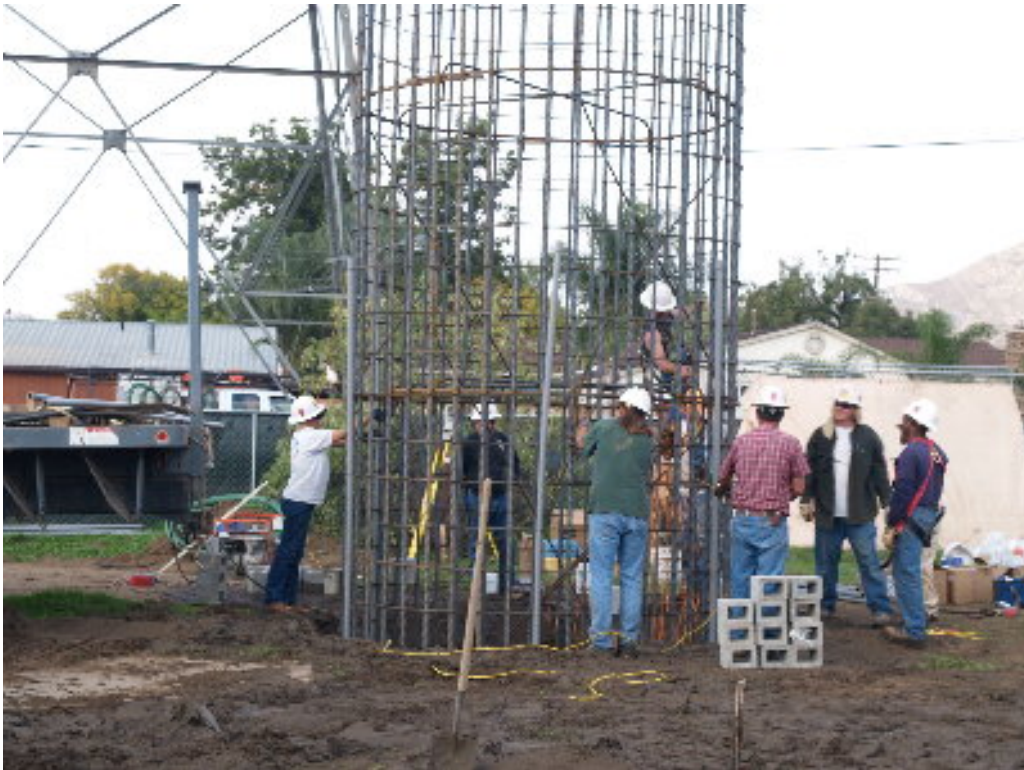
Crews worked at Tower Site 1210 on preparing the excavation and rebar cage for the concrete pour. One crew worked on the rebar cage as it was held vertically by the crane (see Figure 2). The concrete pumping truck was set up on-site, but the concrete mix delivered was not correct for the foundation (see Figure 3). The bottom of the excavation is below water table and there were problems with collapsing side walls and sediment filling the base of the hole. By the time the correct concrete mix was delivered, the pour could not be completed by the 7:00 p.m. construction time limit. SDG&E informed the CPUC EM that work would proceed late to complete the work at Tower Site 1210. It was agreed that stopping the work overnight could result in structural problems with the hole and result in additional time working at the site. The water pumped from the wet hole was placed in a Baker Tank for use by water trucks throughout the project (see Figure 4).

Figure 2 – The crew at Site 1210 worked on the rebar cage.

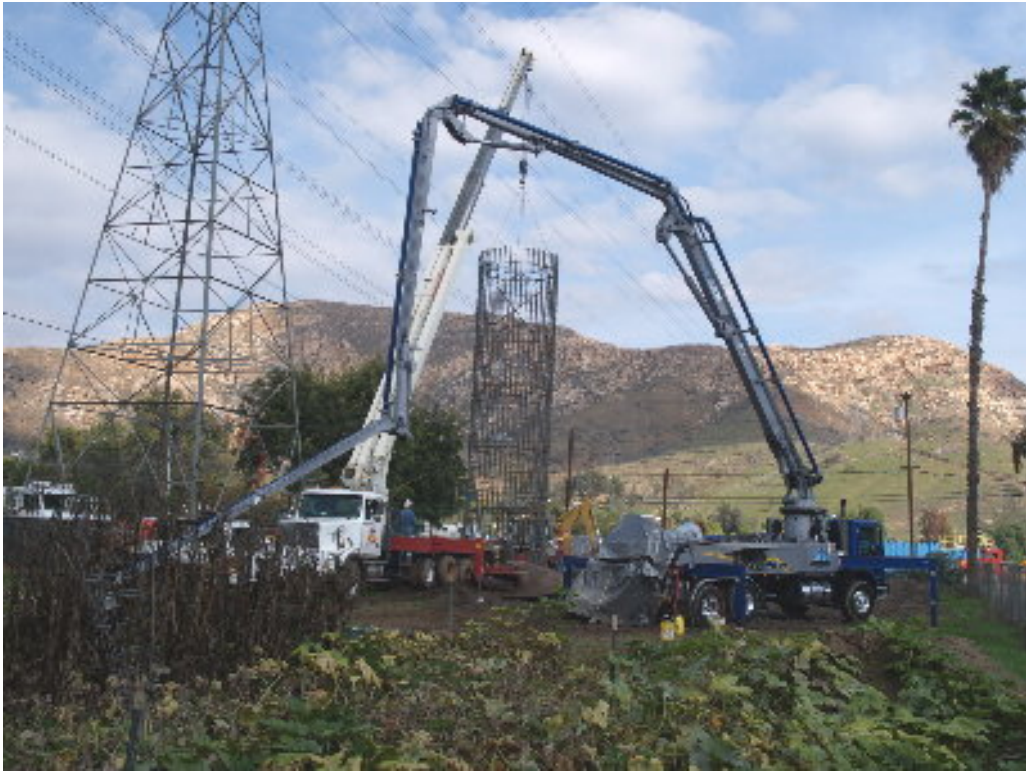
Figure 3 – The concrete pumping truck set up at Tower Site 1210.

The property owners surrounding Tower Site 1210 were notified of the problem with the concrete pour and the one-time need to work past 7:00 pm. SDG&E will work to address any concerns/complaints raised. No complaints from local residents have been received at this point.

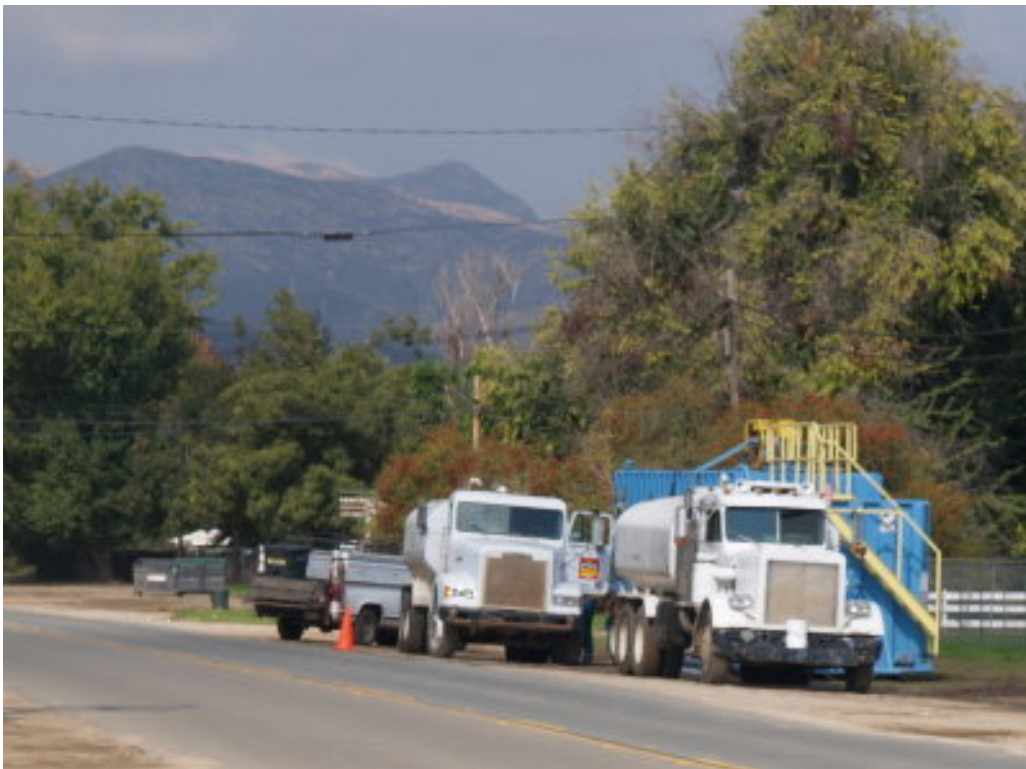
Figure 4 – The water pumped from the wet hole at Tower Site 1210 was used throughout the project including use for dust control on access roads.

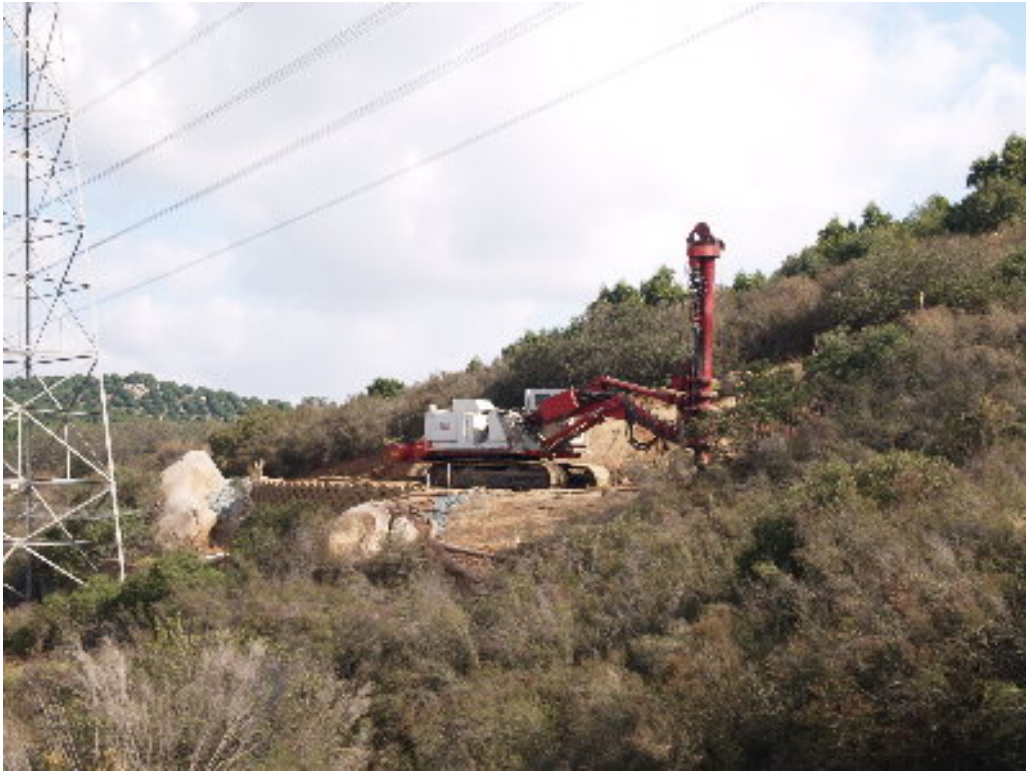
A tracked drilling machine worked at Tower Site 932 above the block wall (see Figure 5). The access road has been repaired, but is not easily passable by light trucks at the water crossing.

Figure 5 – The Low Drill at Tower Site 932 worked above the block wall on the pad site.

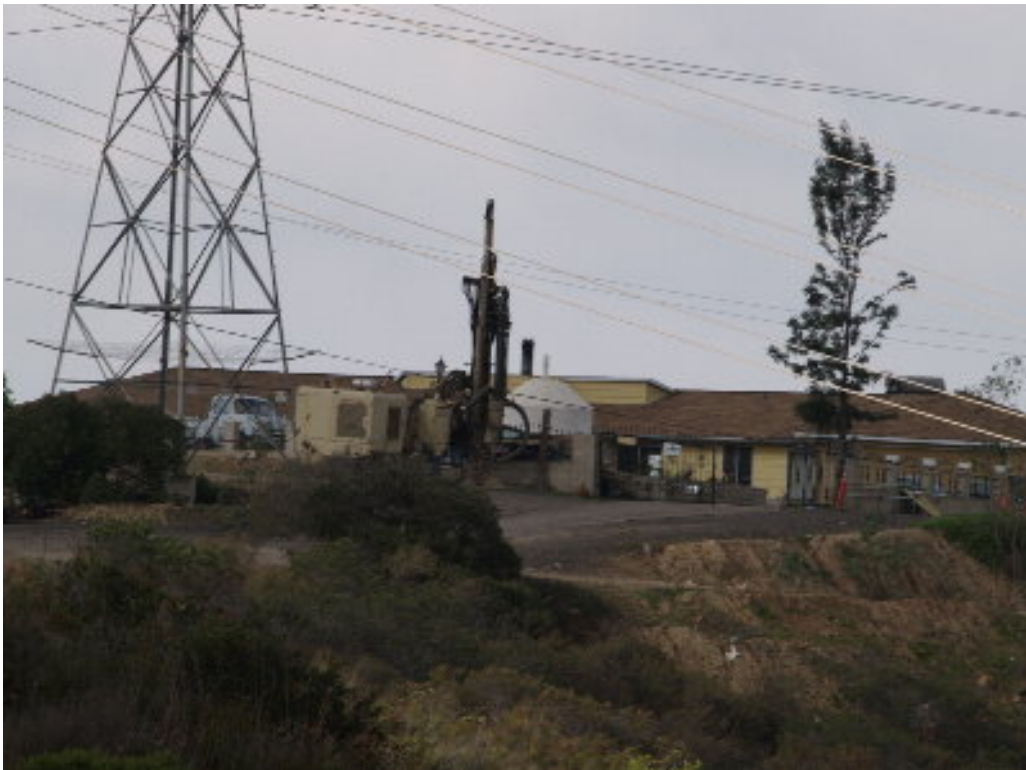
The grading crew delivered concrete blocks to Tower Site 181 for the block wall during the subject week. The Air Track drilling machine worked at Tower Site 211 during the week. The site is directly adjacent to a house (see Figure 6). The Air Track was originally moved to Tower Site 221, because the operator used the wrong access road and traveled a short distance overland outside the right-of-way.

Figure 6 – The Air Track drilling machine moved to Tower Site 211, adjacent to a residence, to start work.

The Essex EI flagged the off right-of-way route taken by the Air Track at Tower Site 221 and SDG&E will stabilize and restore the impacted area.

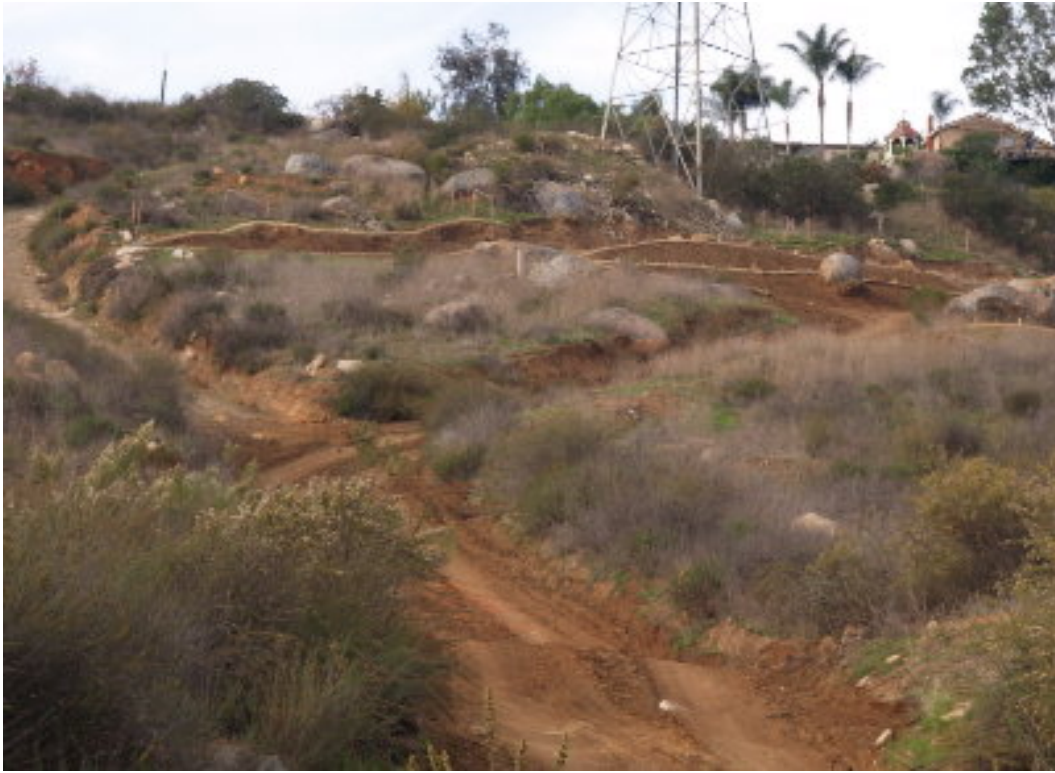
The CPUC EM noted that the contractor has used the time between the storms to address many of the SWPPP issues from the previous weeks. The BMPs at Tower Site 440 were repaired by crews during the week (see Figure 7).

Figure 7 – The BMPs at Tower Site 440 have been repaired.
