**Figure 3.14-22a**  
**Existing Conditions**  
**for KOP-Center-7**  
**Northbound Upper Big**  
**Tujunga Canyon Road**  
**(Alternative 2, Segment 6)**

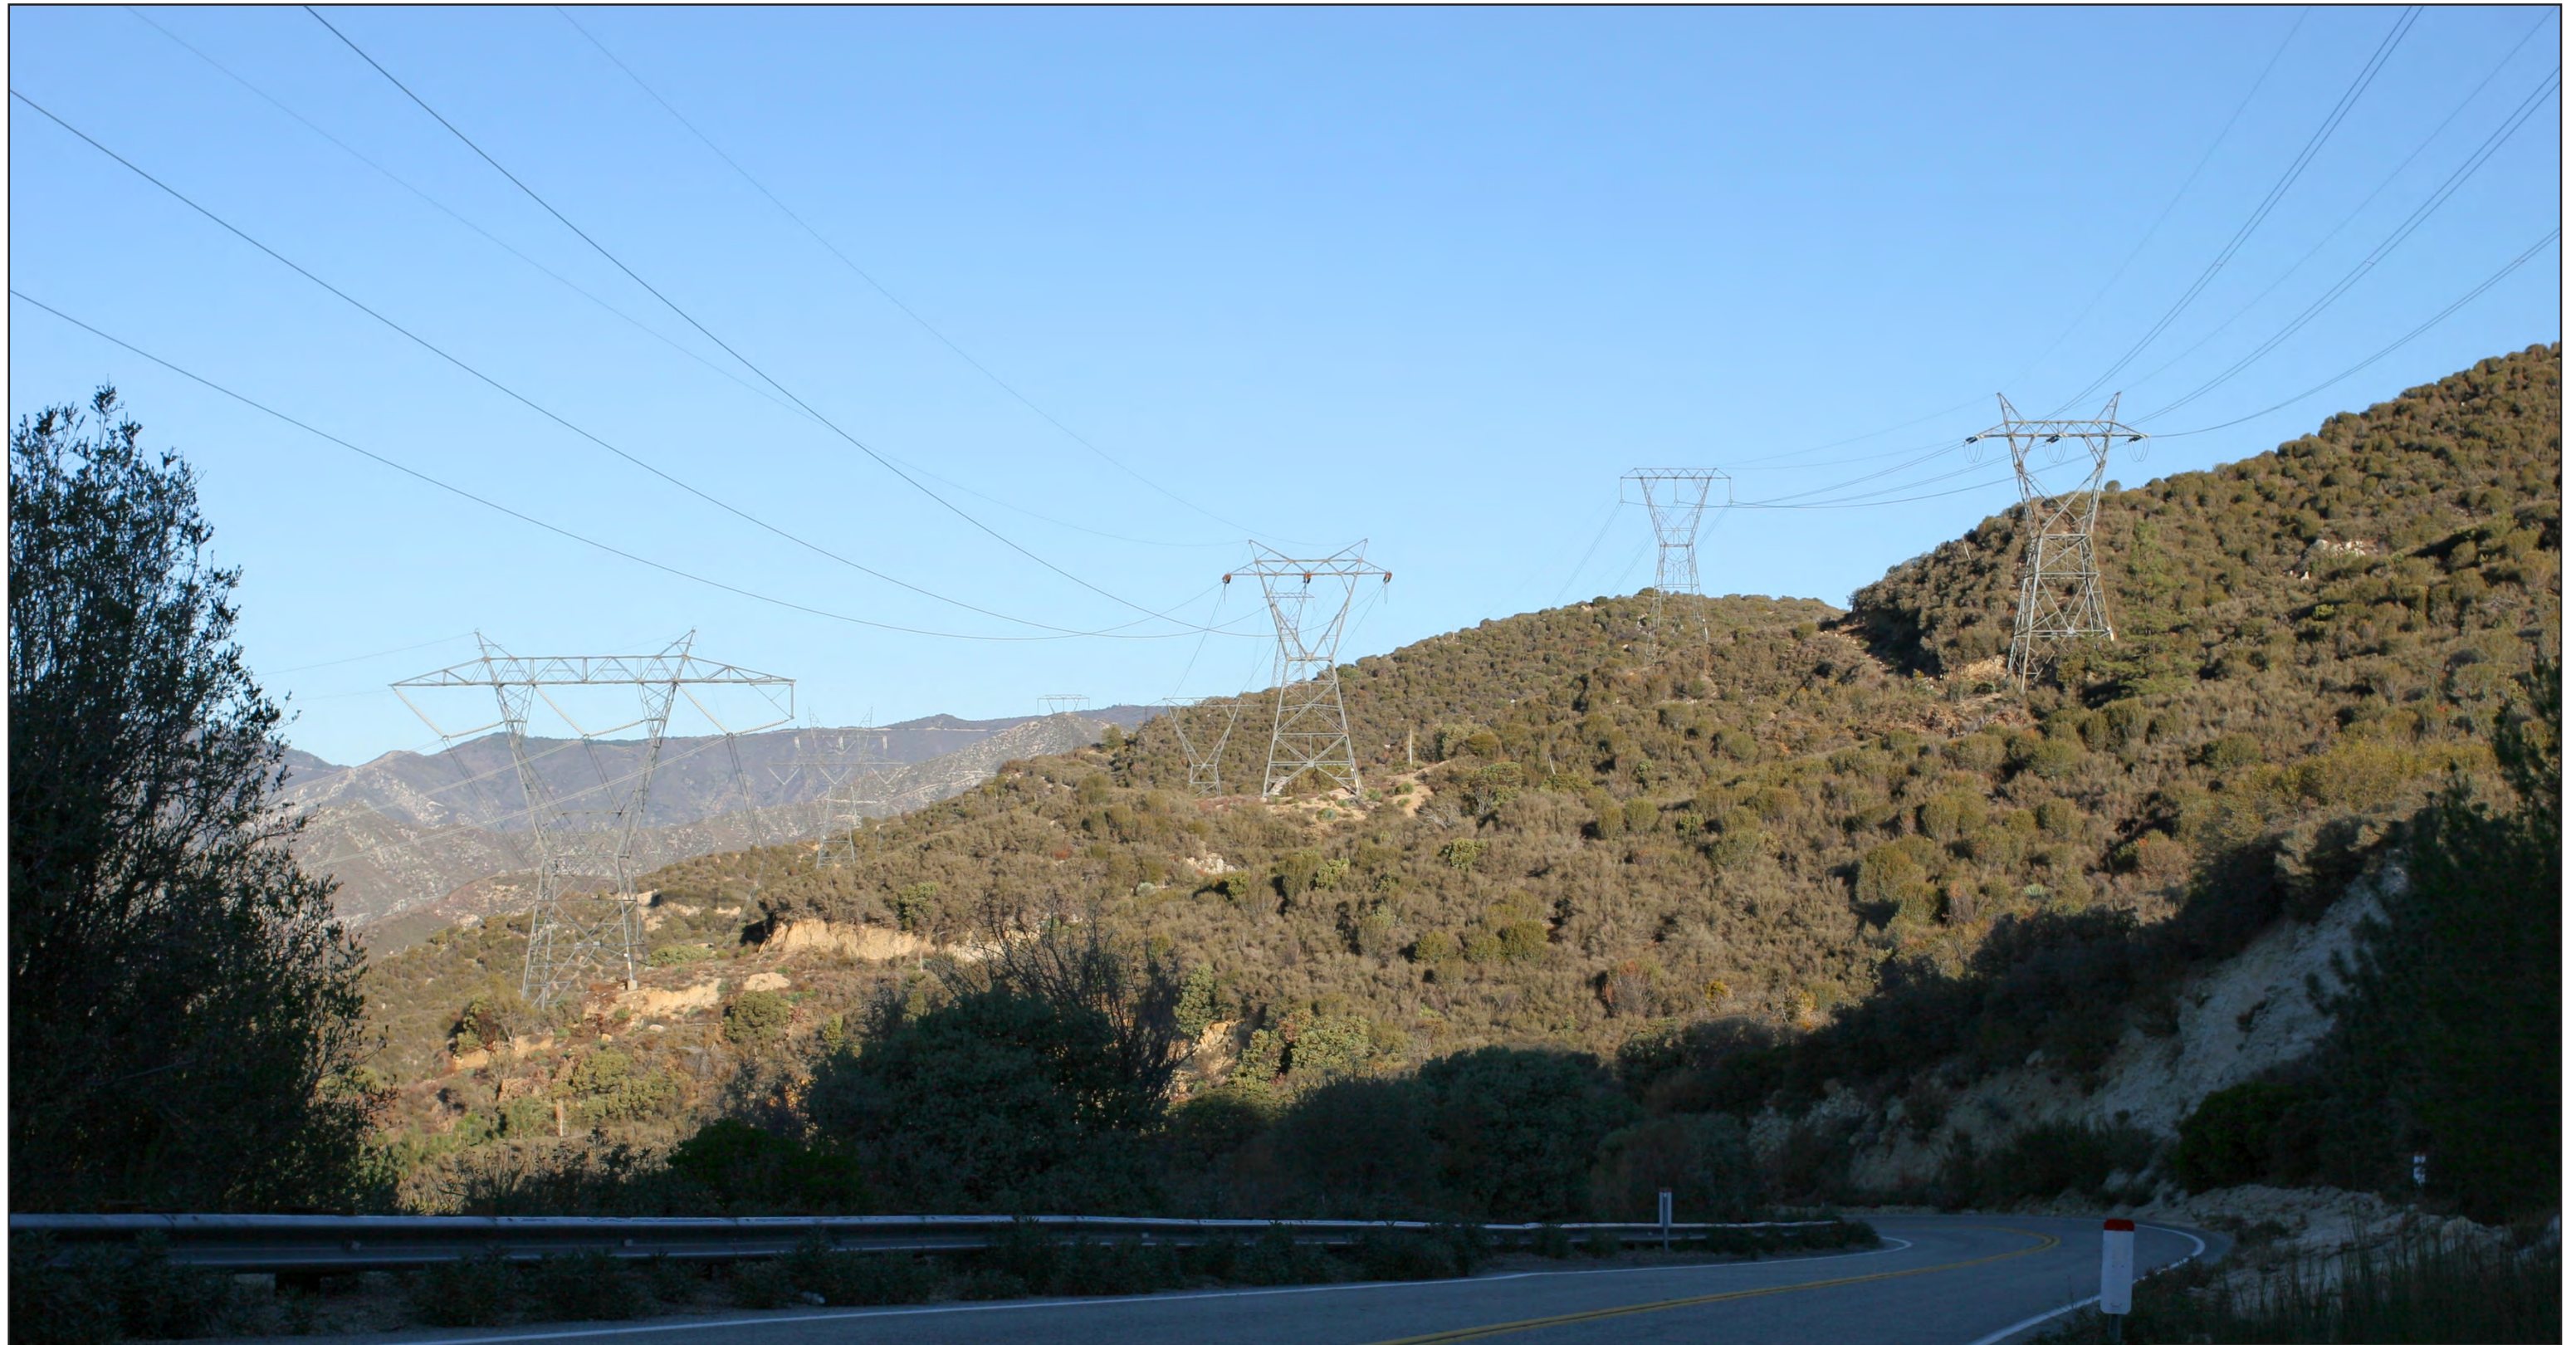
**Existing Scenic Integrity: High, with Areas of Unacceptably Low.** KOP-Center-7 is located on Upper Big Tujunga Canyon Road, approximately one-air-mile north of the Angeles Crest Scenic Byway, headed northbound and looking north. The landscape visible from Upper Big Tujunga Canyon Road, in general, and KOP-Center-7, specifically, is predominantly natural-appearing, consisting of foreground and middleground landscapes with dense, dark green chaparral and evergreen tree-covered mountainsides. There are interesting vegetative patterns in this landscape view that are created by the folded terrain and microclimates. The moderate slopes and rolling terrain are not as visually dominant as the terrain in many other parts of the Forest and therefore the transmission lines in this corridor have a stronger visual presence. Although vegetation appears fairly intact, the overall view from this KOP, and for approximately three miles along this road, is dominated by the road and existing transmission line corridor with tall lattice towers. The natural landscape exhibits a high degree of intactness and scenic integrity, except for the highly discordant transmission line structures and access/spur road cutslopes, which detract from scenic integrity. These manmade features are visually excessive and begin to totally dominate the landscape character, leading to a rating of unacceptably low scenic integrity for the utility corridor.

**Scenic Integrity Objective: High.** In the 2005 Forest Plan, the entire landscape in this vicinity is mapped as High SIO, where the management direction states that human activities should not be visually evident. Human-caused deviations may be present but must repeat the form, line, color, texture, and pattern common to the natural landscape character so completely and at such a scale that they are not evident.
