**Figure 3.14-69b (Revised)**  
**Visual Simulation**  
**for KOP-Center-6**  
**Southbound Upper Big Tujunga**  
**Canyon Road**  
**(Alternative 6, Segment 6)**

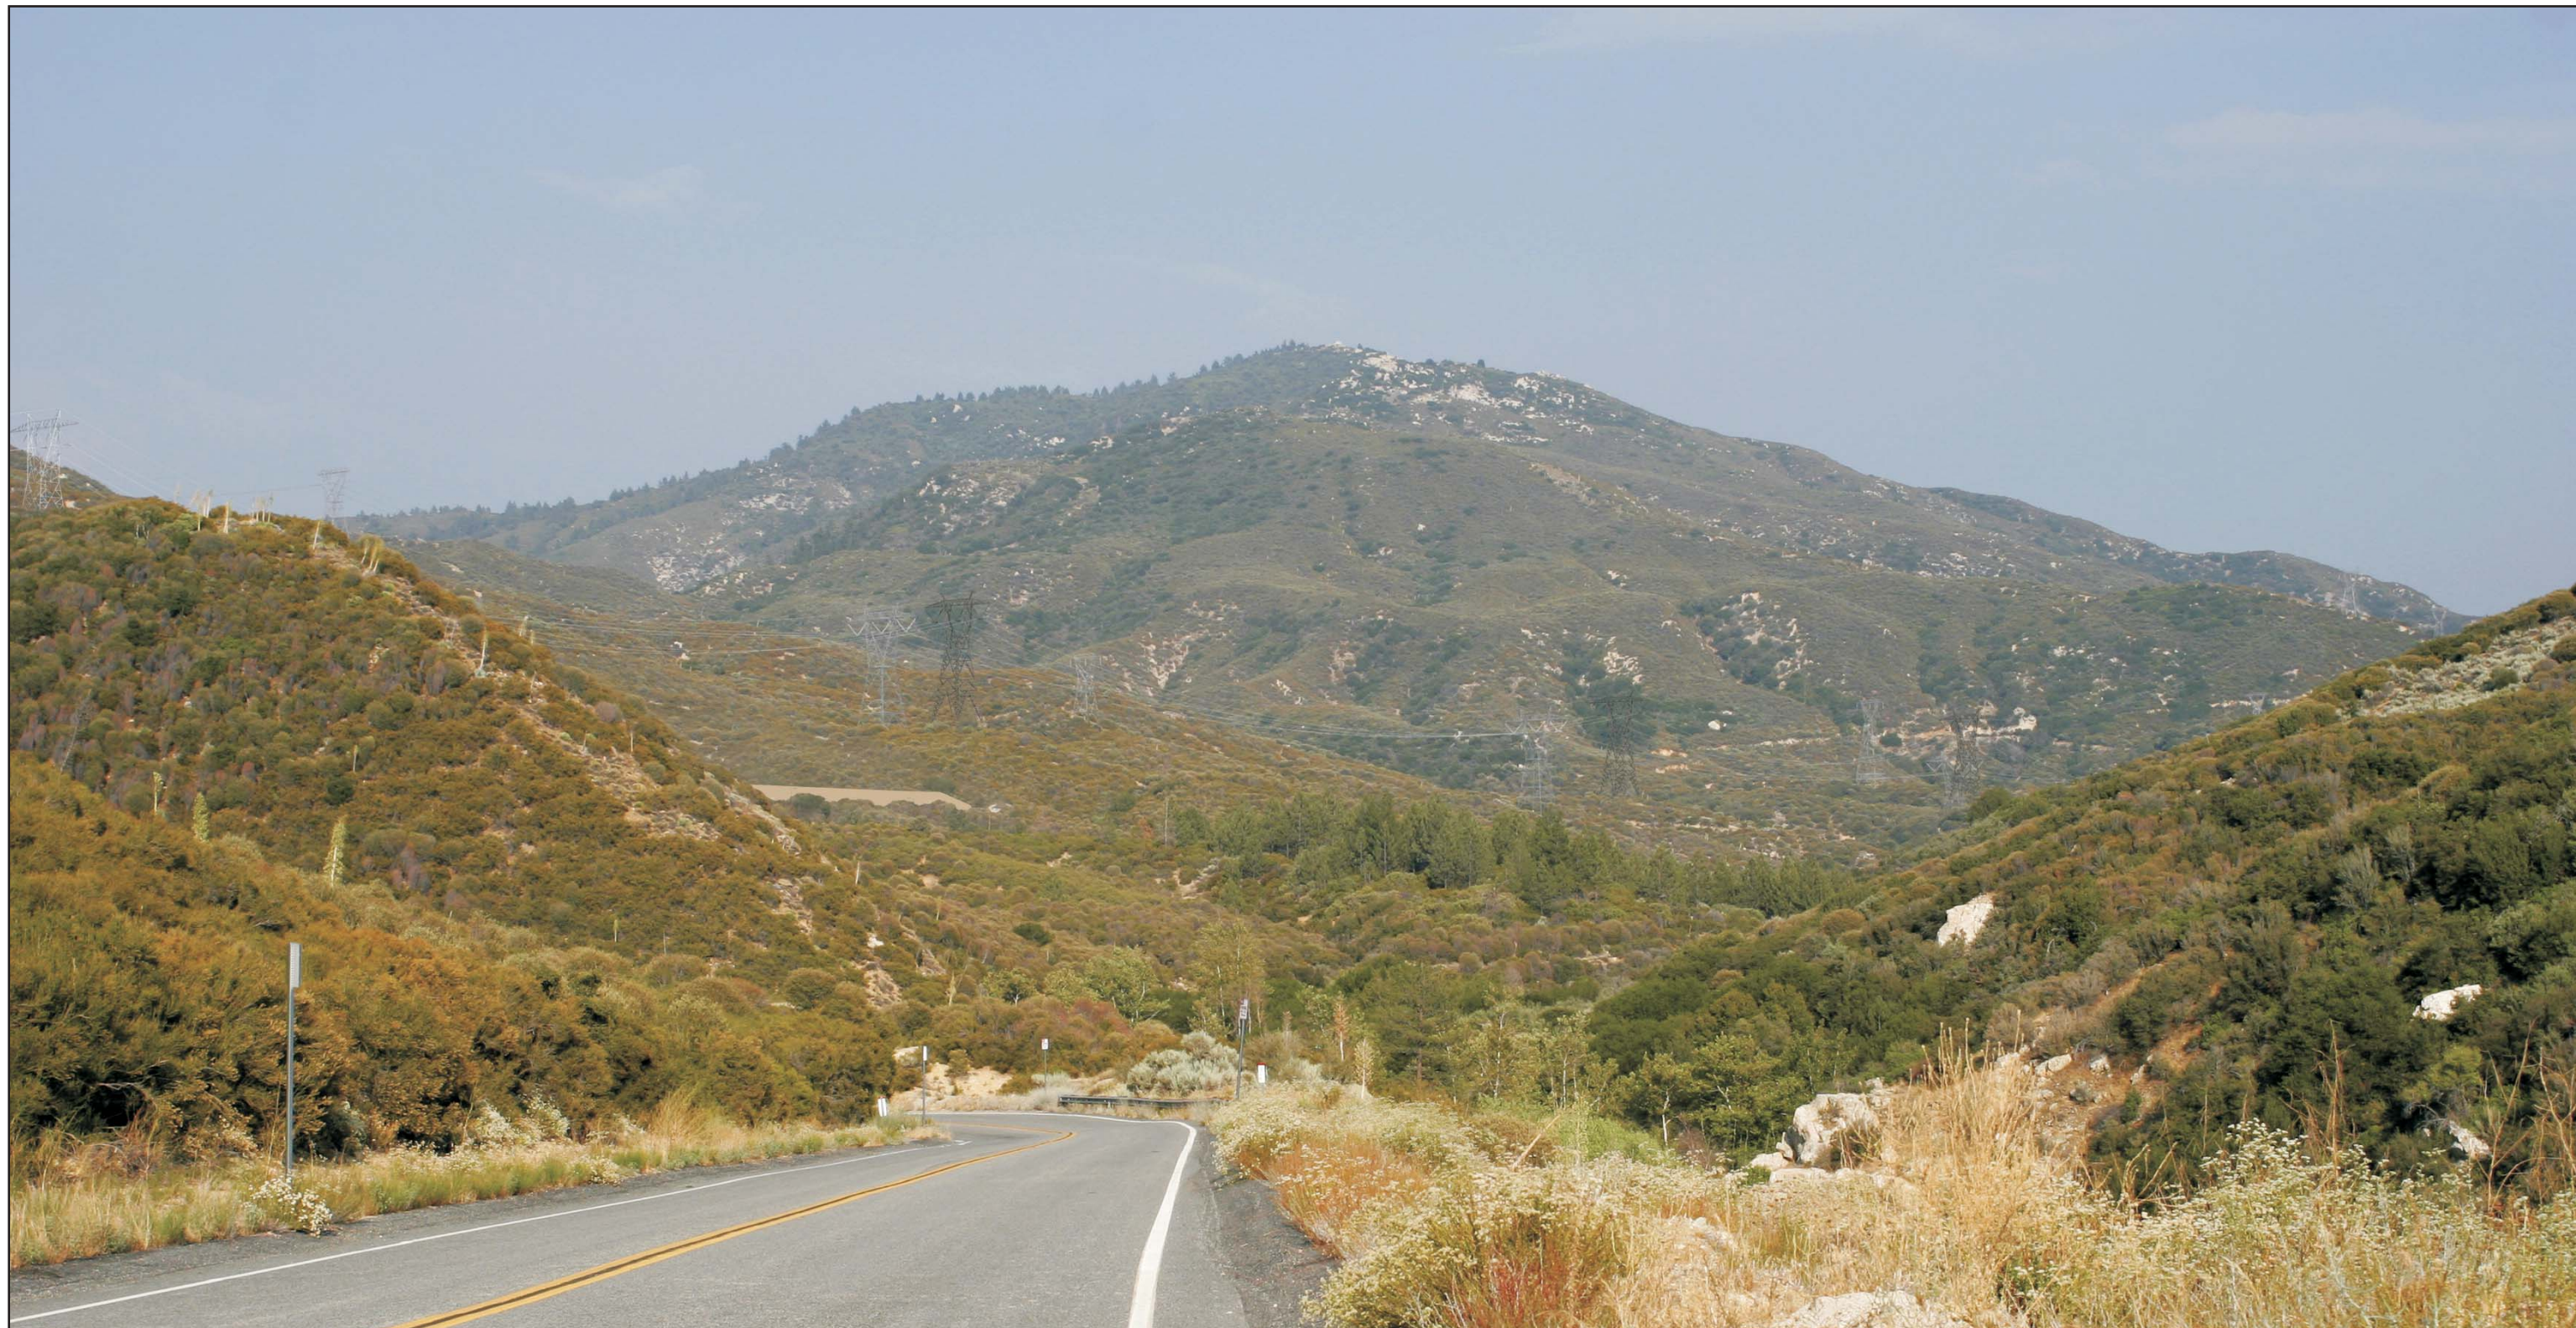
**Future Scenic Integrity: High, with Areas of Low.** The Maximum Helicopter Alternative (Alternative 6, Segment 6) would construct a large helicopter staging area on a flat area near the Upper Big Tujunga Canyon Road, separated by a steep hillside that has an existing fuelbreak on top. In this area of Segment 6, the Alternative 6 transmission line would be constructed by helicopters, and existing access roads and spur roads would not be re-opened. Other than the transmission line corridor, the landscape has predominantly natural-appearing existing landscape character and achieves High SIO. After revegetation of the helicopter staging area, and because LSTs would be medium or dark colored steel, the new transmission line would achieve low scenic integrity.

**Adverse Visual Impacts.** In the vicinity of KOP-Center-6, implementation of the Project would result in adverse visual impacts V-1, V-3, V-4, V-5, and V-7, as detailed in Table 6-1.

**Mitigation Measures.** Implementation of Mitigation Measures (MMs) would reduce adverse visual impacts to a certain degree, but the Project would create strong adverse contrasts of form, line, color, texture, and scale. It would continue to not meet the High SIO established for this area. MMs would include: V-1 – Clean up staging areas, storage areas, marshalling yards, access and spur roads, and structure locations on a regular periodic basis; V-2b – Treat surfaces with appropriate colors, textures, and finishes; V-3b – On NFS lands, provide restoration/compensation for impacts to landscape character and visual quality; V-4b – Slope-round and re-contour in areas as prescribed; V-4c – Avoid locating new roads in bedrock on NFS lands; and V-4d – Dispose of excavated materials as prescribed.
