## **PROJECT MEMORANDUM PG&E – TRI-VALLEY 2002 CAPACITY INCREASE PROJECT**

**To:** Roosevelt Grant, CPUC  
**From:** Vida Strong, Aspen Project Manager  
**Date:** January 16, 2003  
**Subject:** Weekly Report #17: January 6, 2003 – January 12, 2003  
**CPUC Environmental Monitor (EM):** Anne Sweet

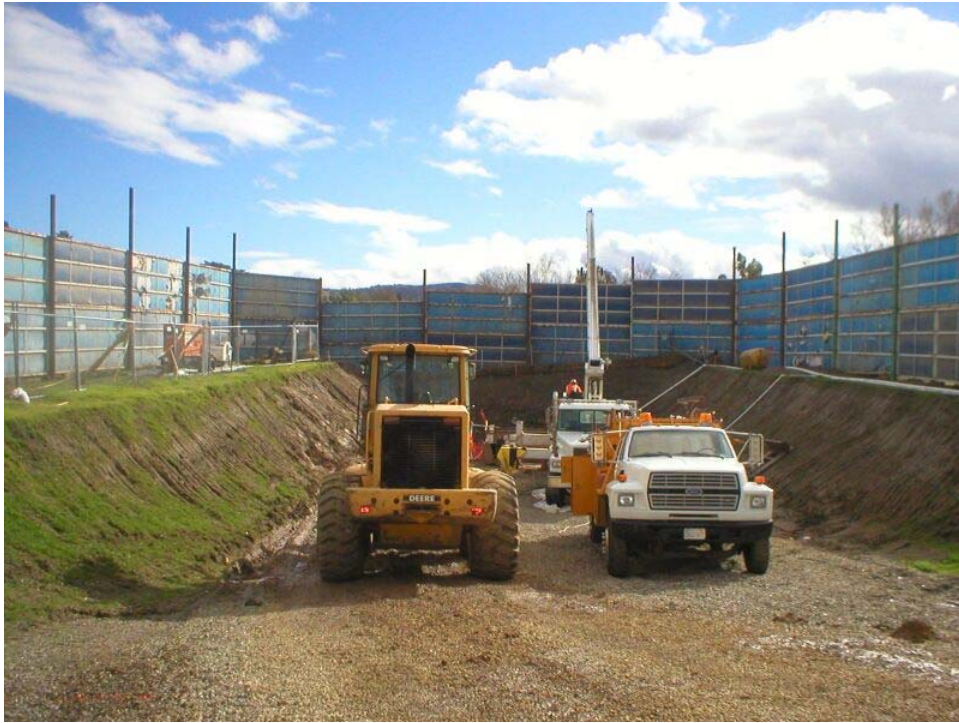
Figure 1

On Monday, January 6, the CPUC approved Variance Request 2, which asked for extra work space to construct a soundwall around the northern Arroyo del Valle bore pit. The wall construction restarted and was completed on Wednesday January 8 (see Figure 1). 24-hour boring operations began upon completion of the wall. By Saturday, January 11, the pipe stem had been jacked under the crossing approximately 200 feet. Crews continued to de-water the northern and southern pits; however, on Thursday, January 6, during shoring installation at the south bore pit, a hazardous materials spill occurred. Approximately 15 gallons of hydraulic fluid was released from a break in an excavator hose. Fluid was sprayed over a large area within and surrounding the bore pit. The Essex EI was immediately contacted. De-watering of the southern bore pit was stopped and clean-up began. Soils impacted by the spill were scrapped and a Baker tank was brought to the site to contain the hazardous materials. Absorbent pads were laid atop the water at the bottom of the pit to soak up the fluid. Per requirements outlined in the de-watering plan, the Regional Water Quality Control Board was notified of the spill. By the end of the subject week, clean up of the spill was complete. The water samples collected at the site tested below Basin Plan limits and de-watering to the local storm drain re-started at the southern bore pit.

Arroyo del Valle northern bore pit. Note the sound wall constructed around the site.

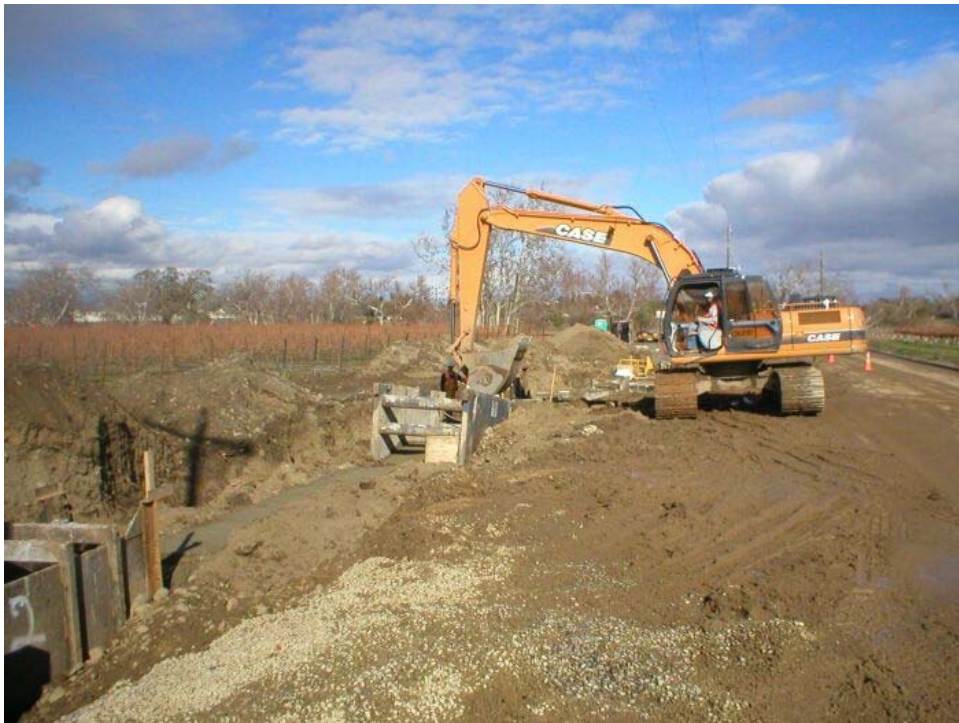
Figure 2

Crews continued work on vaults 4A and 4B and associated tie-ins from Stations 54+00 to 56+00 (see Figure 2) and vaults 3A and 3B at Stations 35+00 to 38+00. The tracking of dirt onto roadways persists; however, efforts are being made to continually clean the roads (see Figure 3). Crews completed installation and tie-in work on vaults 2A and 2B from Station 17+50 to 19+50

Construction of tie-ins at the Vault 4A and 4B location.

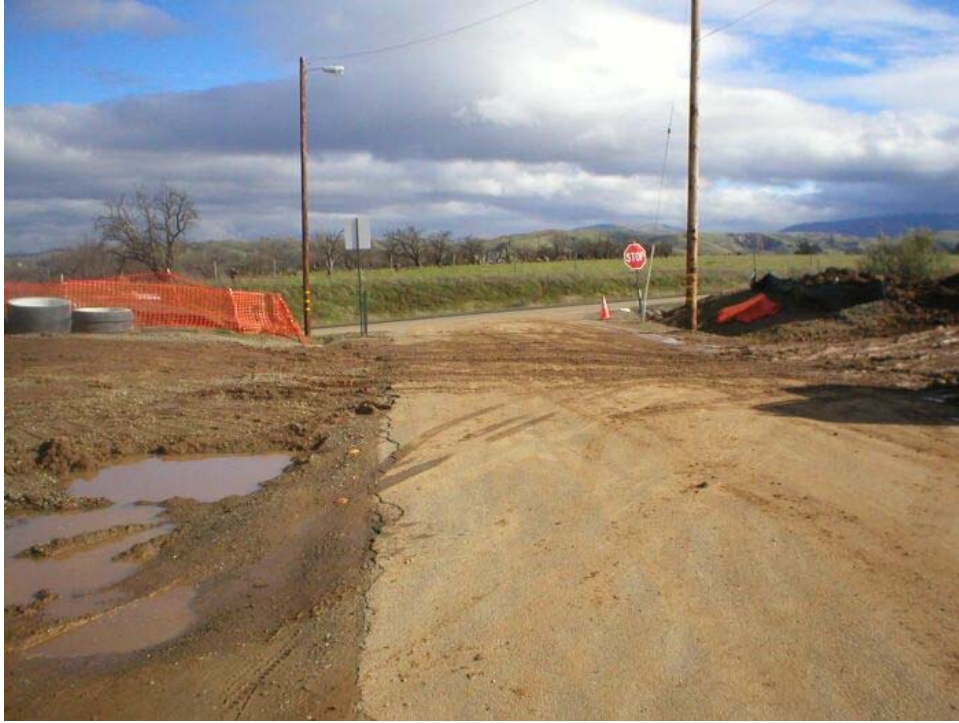
Figure 3  
Dirt tracked into the road near the Vault 3A and 3B construction.
