PROJECT MEMORANDUM

PG&E – TRI-VALLEY 2002 CAPACITY INCREASE PROJECT

Subject: Weekly Report #36: May 19, 2003 – May 25, 2003

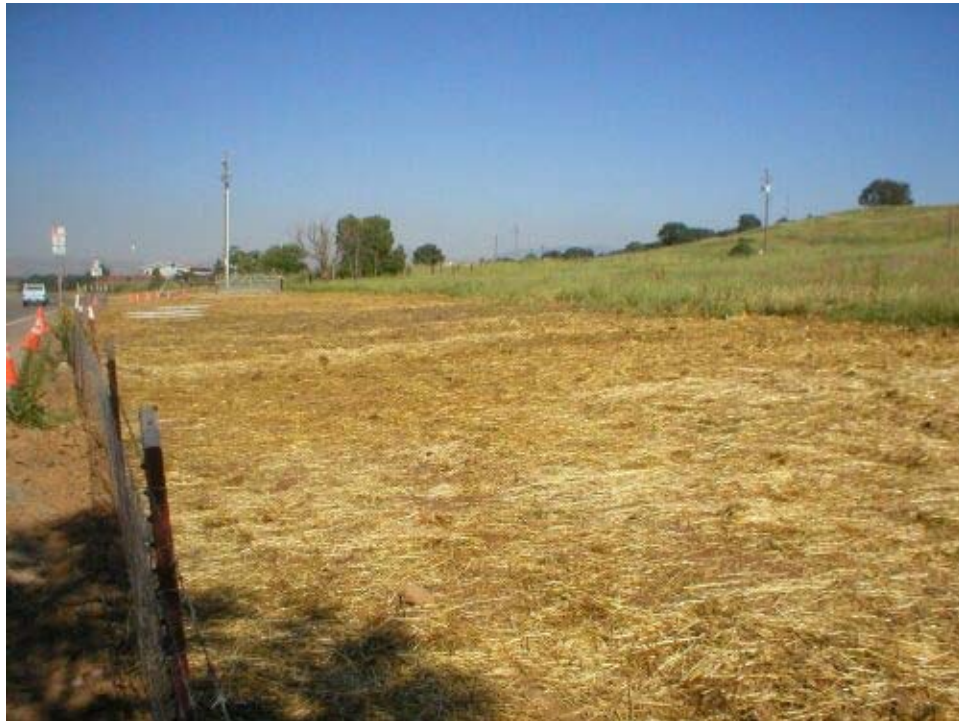
Figure 1 – Mulch cover applied for erosion control approaching the Vault 15 area.

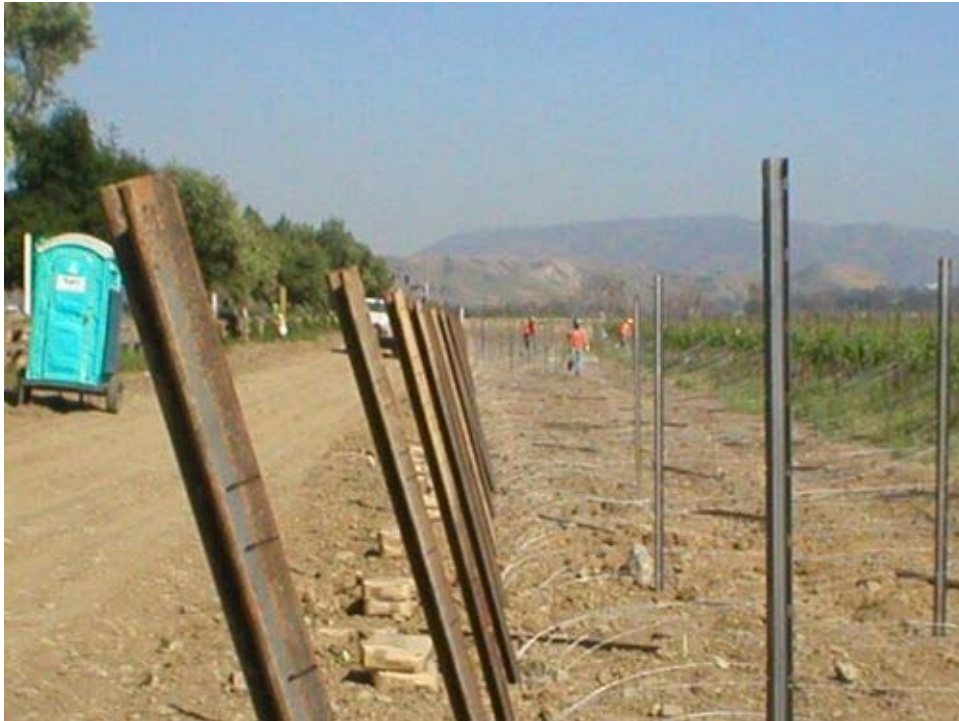
During the subject week, fiber-splicing at numerous vault locations was observed along the project route. Crews also repaved over portions of the installation along "Old" Vineyard Road. Crews have installed jute netting and seeded the sloped area near the northern intersection of New Vineyard Road and "Old" Vineyard Avenue. Crews have installed mulch and have seeded along the graded area near the Vault 15 location (see Figure 1). Crews have also continued vine row restoration efforts along "Old" Vineyard Avenue (see Figure 2). Traffic Control Plans were implemented.

Figure 2 – Vine row replacement work along “Old” Vineyard Avenue.

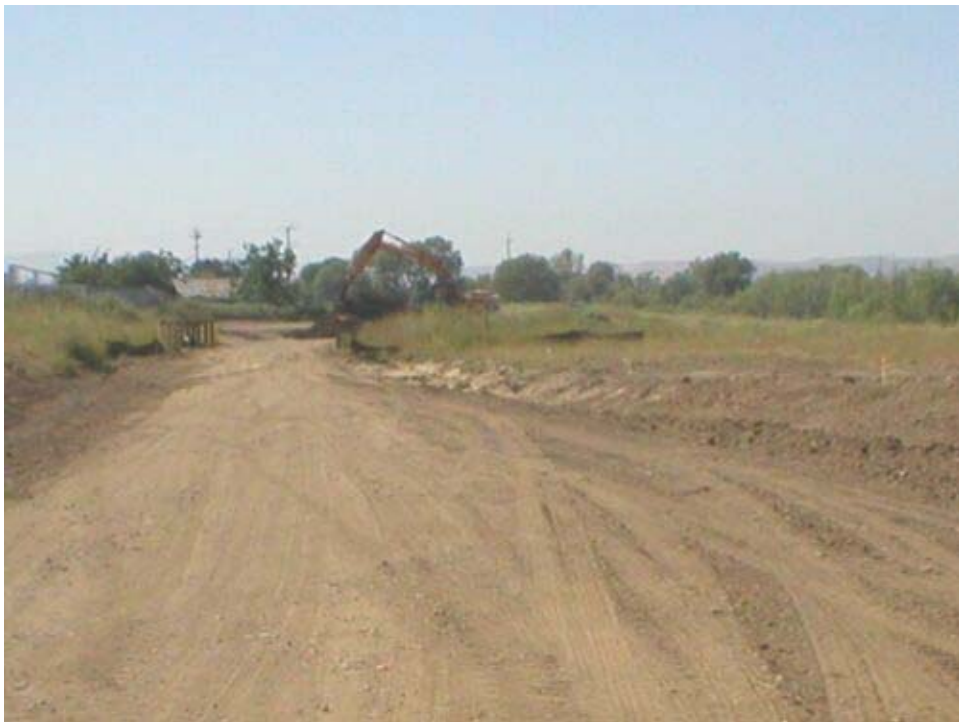
At New Vineyard Road, fiber-splicing crews were on-site at the Vault 12 location. A small area near the Vault 12 location was re-excavated and additional concrete was poured over the existing installation. The area was then backfilled and graded. Crews also continue road restoration efforts (see Figure 3).

Figure 3 –New Vineyard Road restoration efforts.
