PROJECT MEMORANDUM PG&E – TRI-VALLEY 2002 CAPACITY INCREASE PROJECT

To: Jensen Uchida, CPUC
From: Vida Strong, Aspen Project Manager
Date: September 22, 2005
Subject: Weekly Report #76: September 11, 2005 – September 17, 2005
CPUC Environmental Monitor (EM): Anne Sweet

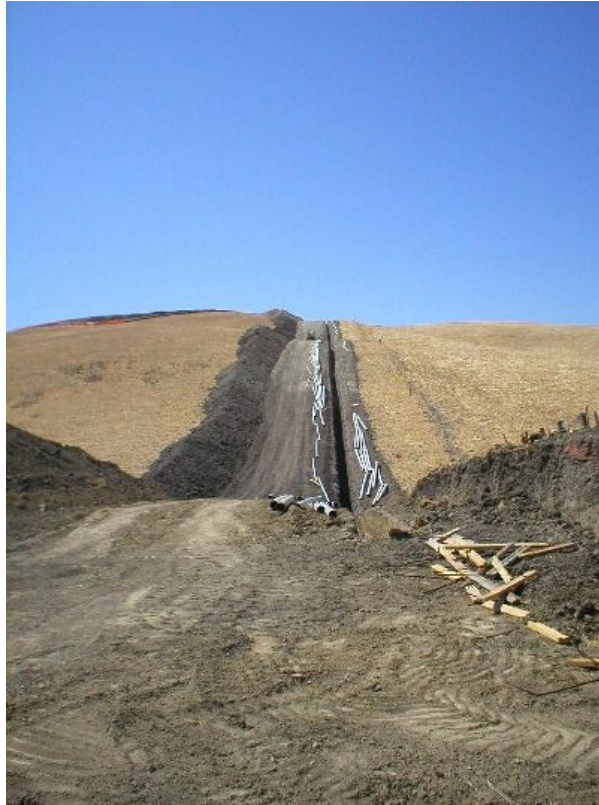
Figure 1 – Trench line proceeding past Road 5 approaching the Transition Station, September 14, 2005.

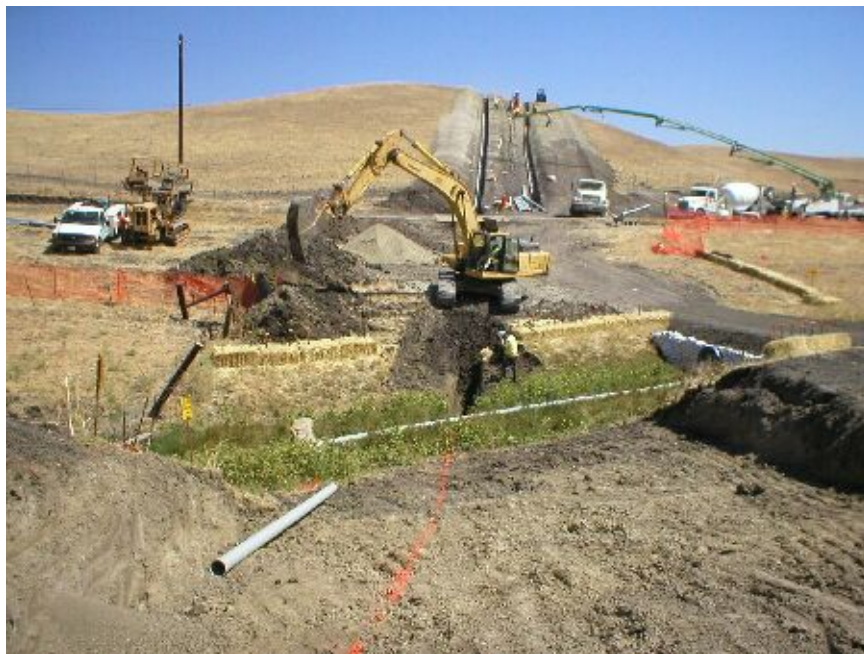
Figure 2 – Trenching operations proceeding through Cayetano Creek, September 14, 2005.

Note the trenching operations in the background: concrete is being pumped up to the top of the slope.

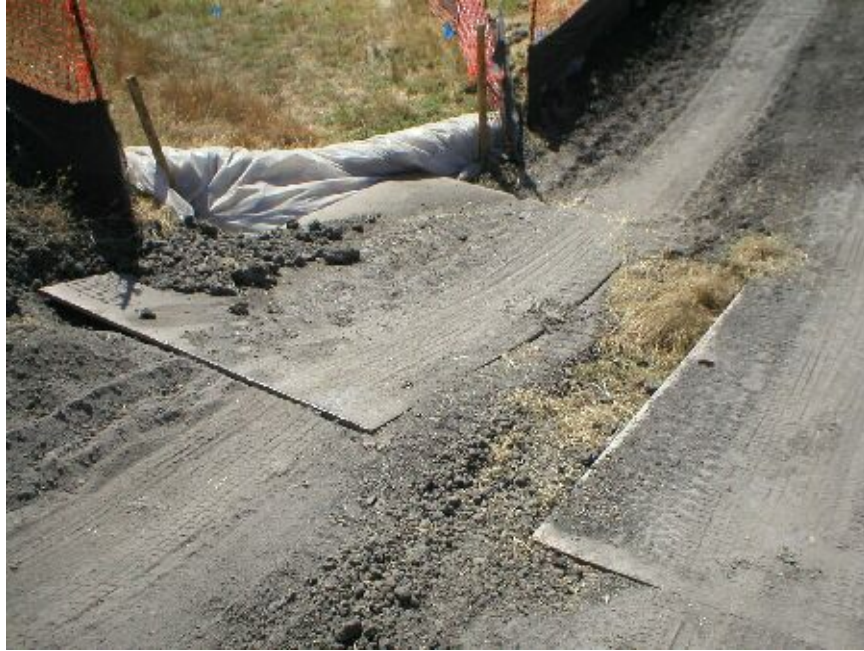
Granite Construction continued disking and grading along Access Roads 6 and 7 during the subject week. The CPUC EM informed the PG&E EI that the temporary steel plate crossing of Cayetano Creek has shifted and dirt and spoils have gotten into the streambed (see Figure 3).

Spoils have gotten into Cayetano Creek at the temporary steel plate bridge crossing. The CPUC EM informed the PG&E lead EI of the issue.

Figure 3 – Steel plate temporary bridge over Cayetano Creek,
September 14, 2005.
Note the spoils within the streambed.

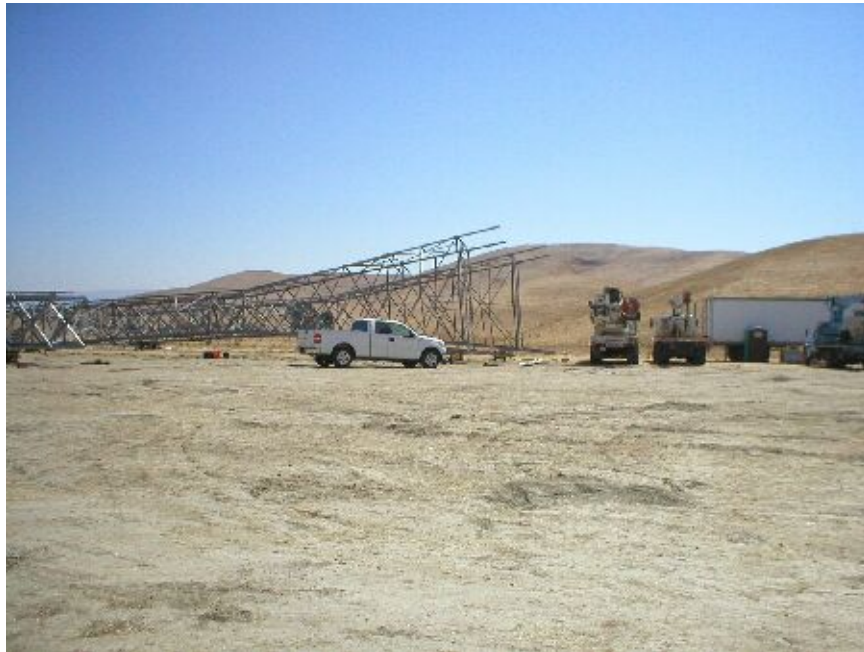
PG&E crews continued to work on Towers 5 and 6 and at the Doolan Canyon Road laydown area constructing tower segments (see Figure 4). Materials are being transported to and from the work sites via helicopter or truck. A biological monitor was monitoring the tower crews during the week.

Figure 4 – Tower construction at the Doolan Canyon Laydown area,
September 14, 2005.
